## C.E. White Seat Mounting Bolt Omitted

# BULLETIN

**Models Affected: Model Year 2008-10 All American (A3RE) Rear Engine**

S 1 0 S E

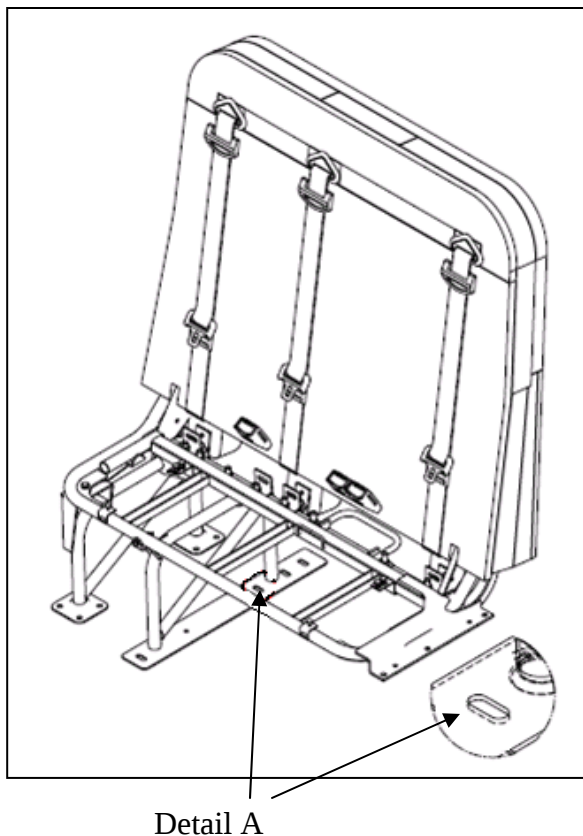
**Figure 1**

A required mounting bolt may have been omitted in the center leg of the C.E. White Student Safety Seat.

1. Park the vehicle on a level surface, apply parking brake, turn engine off, remove ignition key and chock wheels.
2. Locate the hole in the middle seat leg indicated in figure 1.

Install a 3/8" bolt, washer and nut in the center support leg per instructions below.

3. Drill a 13/32" hole through the floor in the location indicated.
