## SERVICE CAMPAIGN BULLETIN

**CAMPAIGN REF :** 020  
**TITLE :** Correct tire and loading information label  
**DOCUMENT # :** 11 P 002  
**AFFECTED VEHICLES :** 12C Coupe

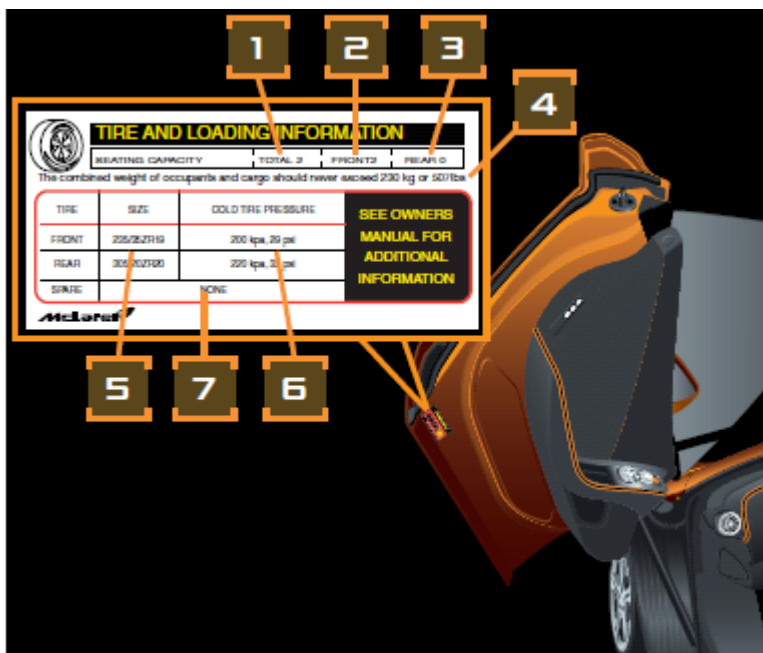
The label is located on the inner edge of the passenger door, as per the image below. It contains the following information:

- The maximum number of occupants (1) divided between the front (2) and rear (3) of the vehicle.
- The vehicle capacity weight (4), which includes the weight of the driver, passenger and cargo.
- The size of the tires (5) with which the vehicle was originally equipped.
- Cold inflation pressures for the front and rear tires (6).
- Details of the spare wheel (7), even though this will not be applicable for this model.

1. Open passenger door and peel off the Tire and Loading Information label, ensuring the remaining residue of the label is cleaned away.

2. Attach a new tire and loading information label in exactly the same place as the previous label.
