Service Bulletin

Bulletin No.: PI0756B

Subject: Retrofit Procedure for New Corded Folding Top Cover Installation to Original Design Frame

Models: 2011-2012 Chevrolet Camaro Convertible

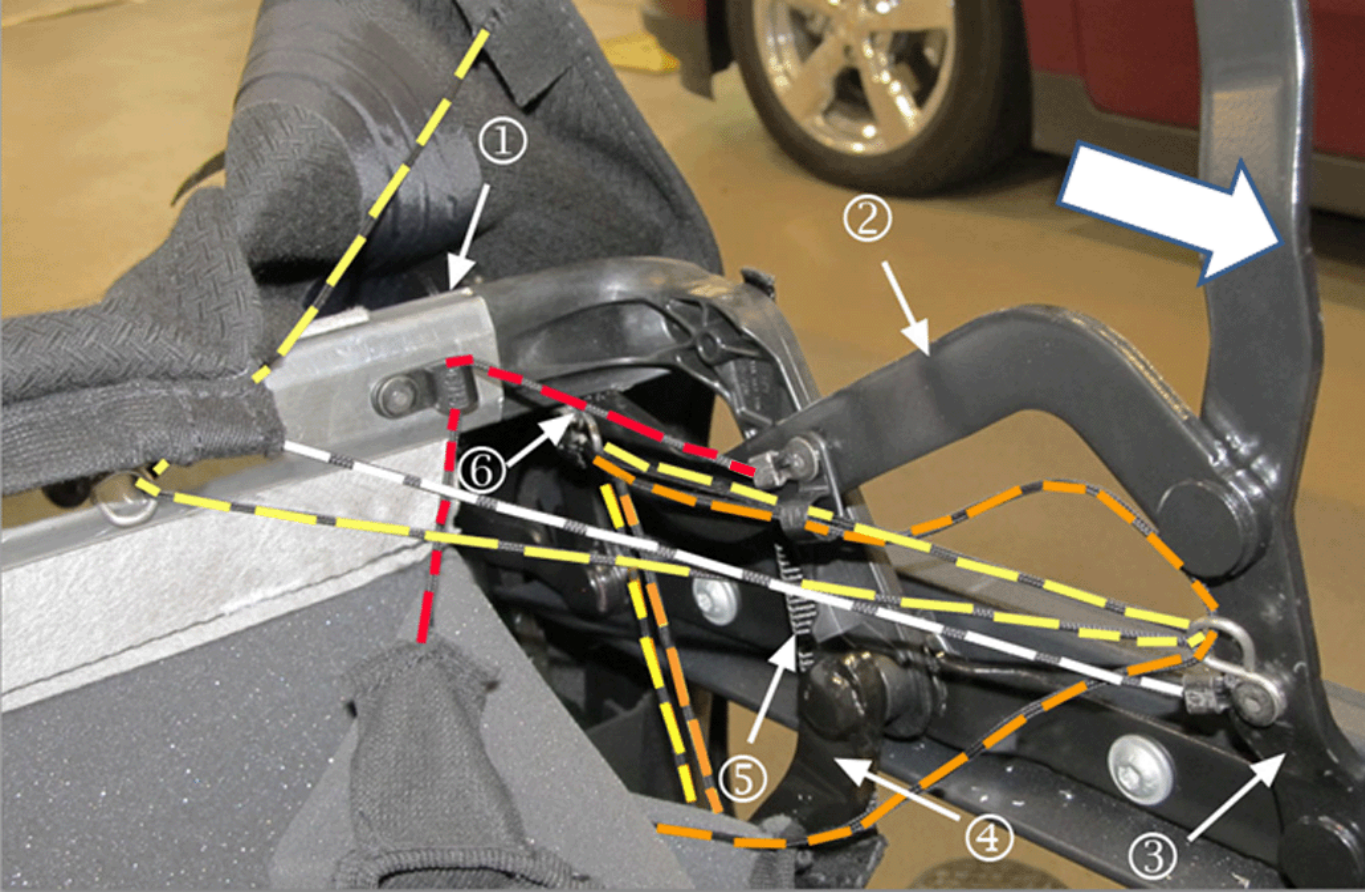
Inboard/Left Side View of Cord Routing and P-Clip, Eyelet and Straps Orientation

Important: The three cords added to each side of the top cover are color-keyed with paint dots on the cord eyelets only. The white, yellow and orange colors were added to the graphics below to represent the color-key of the eyelets. The headliner cord was shown in red for illustration purposes only; the end eyelet of the headliner cord DOES NOT have a color-key designation.

Note: The graphics above are views with the top in mid-open position and the right side views would mirror the left. The top frame links and strap callouts referenced later in the instructions are noted in the key below.

- (1) #2 Bow
- (2) Control Link
- (3) Rear #1 Bow Link
- (4) Balance Link
- (5) Headliner Strap
- (6) Rear Top Cover Strap

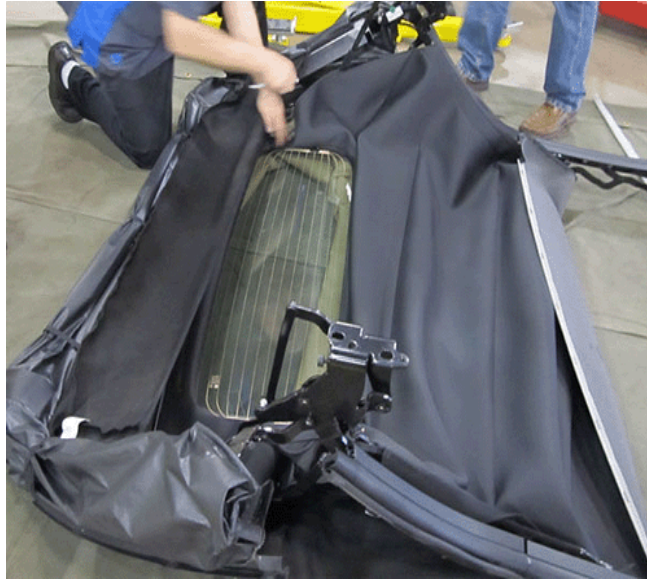
2874341

2. Place the convertible top on a clean tarp or other clean, dry, suitable surface with the top cover facing downward as shown above.

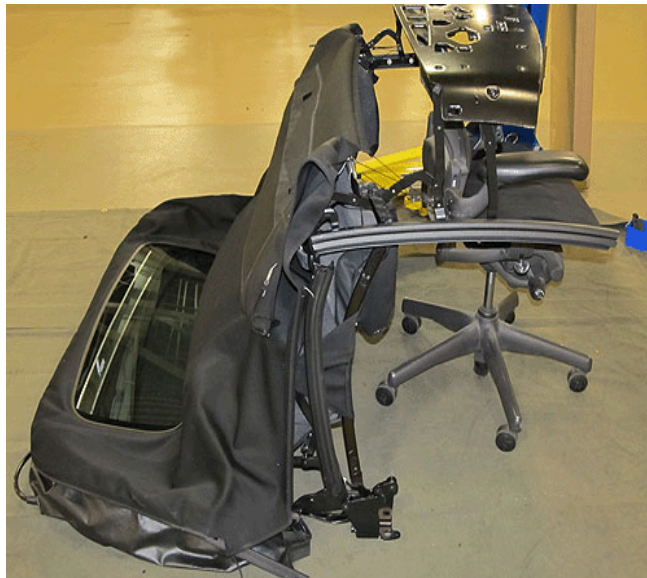
2874342

5. Position the folding top on the floor, sitting upright in the mid-open position with the 1 bow supported by a suitable support as shown above.

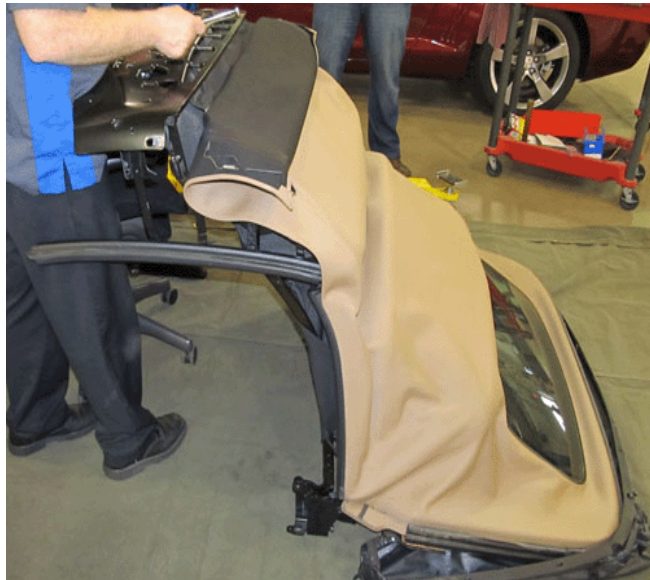
2874343

Note: The fore/aft control cords were removed on the new top cover design. During reassembly, attachment to the #1 bow does not occur as in the previous design.

6. Start removing the top cover from the #1 bow exposing the entire top side of the #1 bow casting. Remove the large header garnish molding by accessing the fasteners from the top side of the #1 bow. Disassemble the headliner from the #1 bow and disconnect the top cover fore/aft control cords from the #1 bow. Drill out the top cover side strap rivets attached to the rear #1 bow link and control links. Refer to Folding Top Cover Replacement in SI.

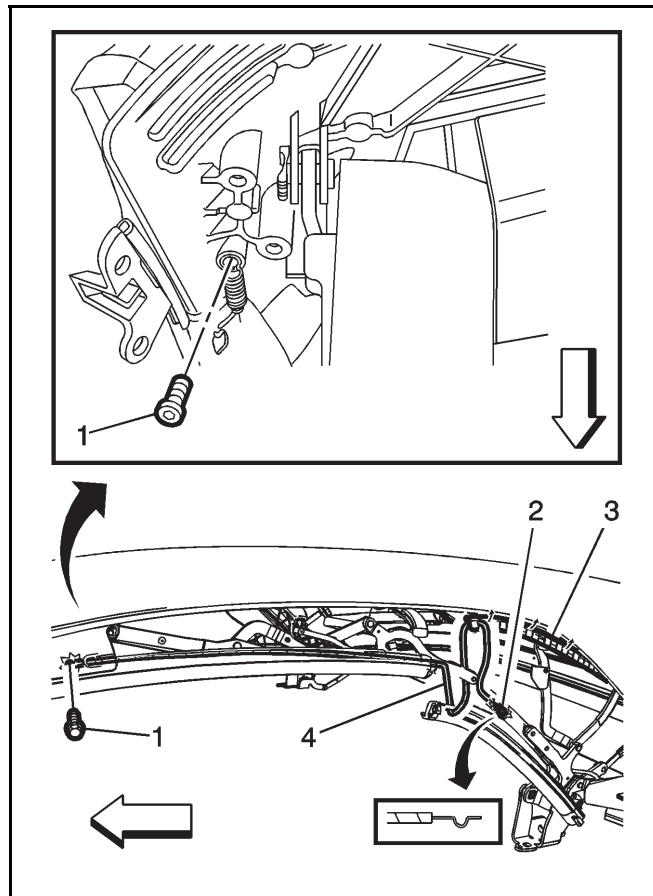
2905470

7. Remove the left and right side tension cables from the top cover and the rear side rail weatherstrips following the steps below. If additional detail is needed, refer to Folding Top Cover Side Tension Cable Replacement in SI.

- 7.1. Remove the left front side tension cable spring retaining screw from the #1 bow.
 - 7.2. Feed the side tension cable and spring out of the top cover material.

- 7.3. Pull the top cover edge plastic retainer out of the channel on the left rear side weatherstrip rail. Start at the bottom and work your way upward.

- 7.4. Peel the left rear side weatherstrip out of the rail so there is access to the side tension cable.
 - 7.5. Remove the piece of tape holding the tension cable end into the side rail link hole.

- 7.6. Remove the side tension cable anchor from the rear side rail.
 - 7.7. Pull the cable back through the weatherstrip so it is free and clear of everything.

- 7.8. Repeat the same operation on the opposite side.

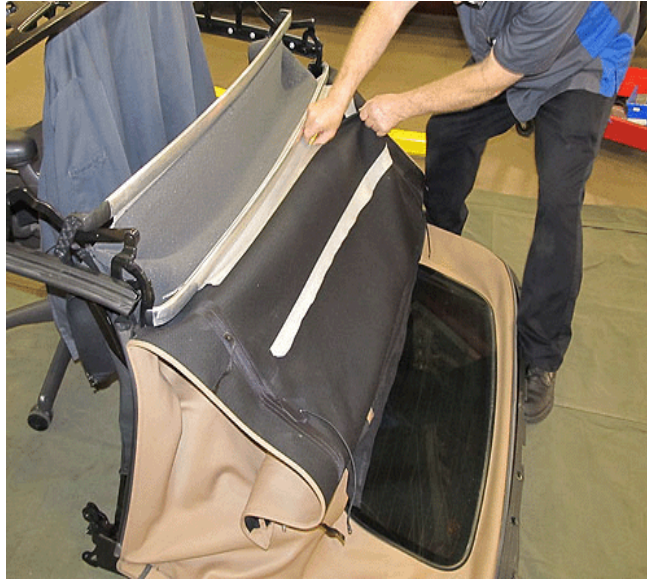
2874345

Note: Due to top cover replacement, the fabric connecting the top cover beads to the cover can be cut for quicker removal. DO NOT cut any of the headliner beads.

Important: Mark the #2 bow to show that the top cover bead is installed in the front slot and the headliner bead is installed in the rear slot. Note that the beads alternate front and rear position on each bow going rearward.

8. Starting at the #2 bow working rearward, remove the top cover from the bows by cutting the fabric connecting the top cover retaining beads to the cover. After cutting the fabric, slide the beads out of the bows.

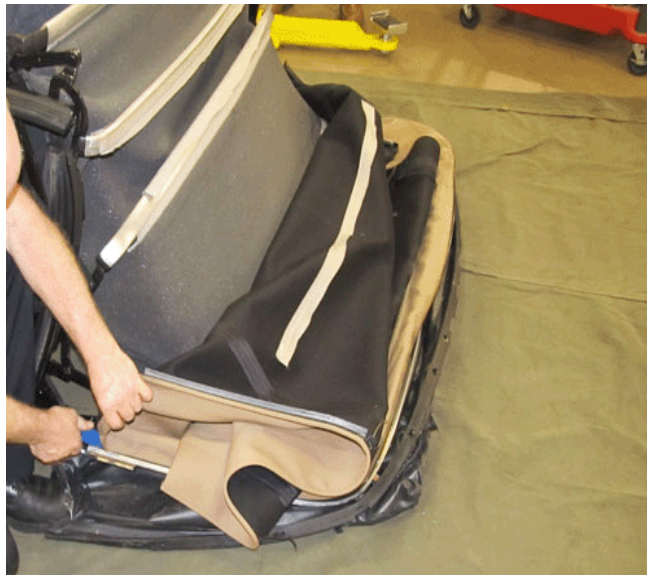
2874347

9. Remove the 5 bow seal and release the top cover retainer from the 5 bow. The old top cover can now be lifted away from the top frame.

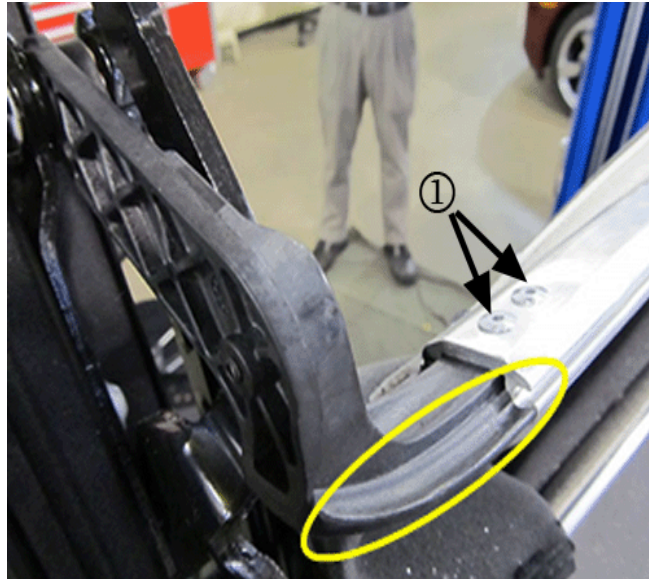
Early Design #2 Bow Bracket

Important: The #2 bow end brackets are made of plastic and will likely break/snap during removal. Two new brackets are included with the top cover replacement kit. Regardless of breakage, all early design #2 bow brackets should be replaced.

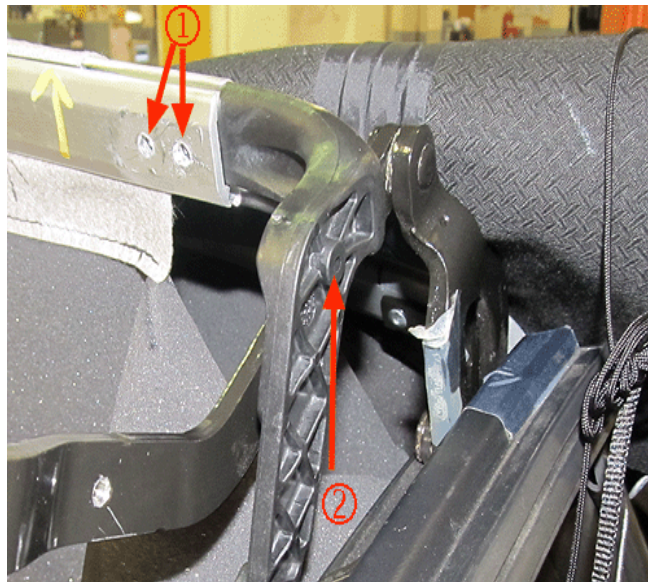
3217410

- 10.1. Drill out the rivets (1) that hold the #2 bow brackets to each end of the #2 bow (two rivets per side), and remove the D-link from the headliner cord on each side.
- 10.2. If still attached, slide the headliner retaining bead out of the #2 bow and drill out the rivet (2) retaining the side headliner straps to each side #2 bow bracket.

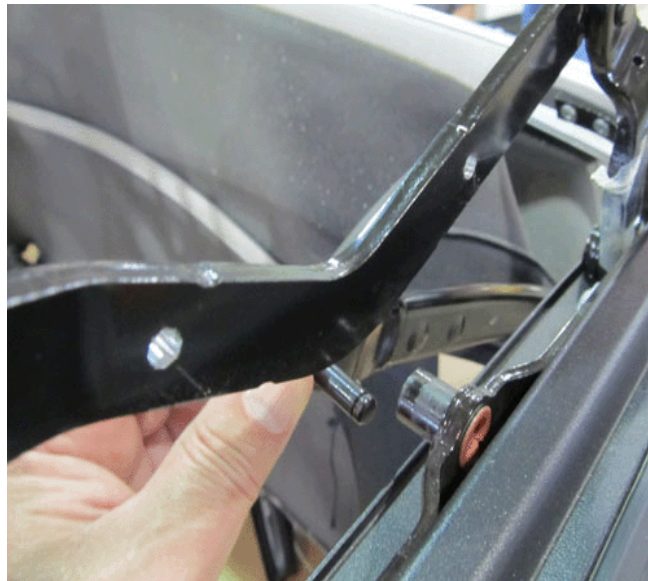
2874351

- 10.5. Remove the retaining clips holding the #2 bow brackets to the balance link pins, and work the bushing and bracket out of the linkage on each side. Pull inboard at the top of the balance link to disengage the pin and leave it disengaged until later in the retrofit procedure.

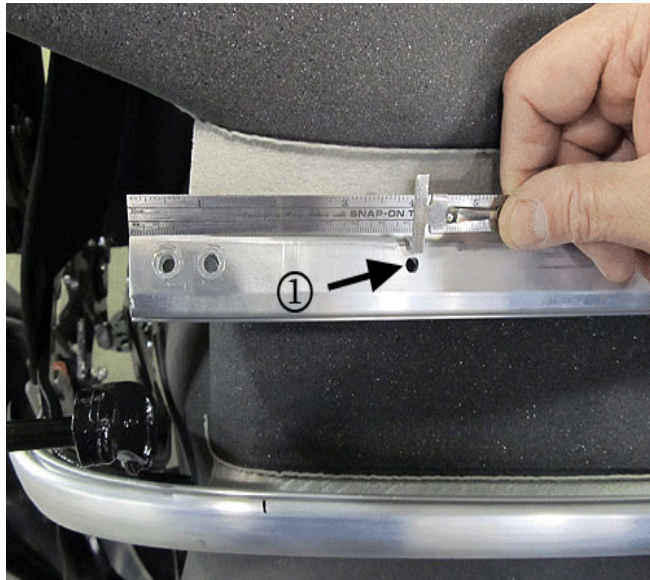
2874353

Important: The two holes added to the #2 bow should be centered on the bow and ARE NOT through holes. DO NOT drill through to the topside of the #2 bow.

11. While the #2 bow is removed, drill two 5 mm (0.197 in) holes (1) in the underside of the #2 bow. Position the holes 102 mm (4.0 in) from each end of the bow.

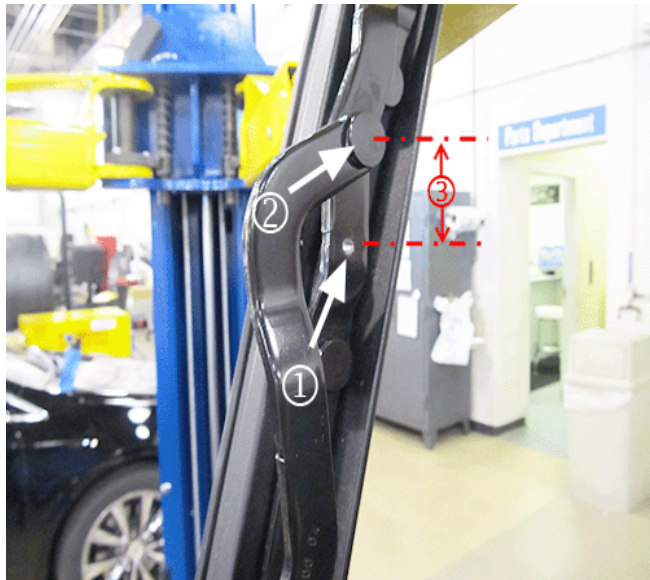
2874355

12. Centered on the left rear #1 bow link, drill a 5 mm (0.197 in) hole (1) into the link, positioned 35 mm (1.375 in) (3) from the center of the link pivot (2). Repeat the same operation on the opposite side of the top.

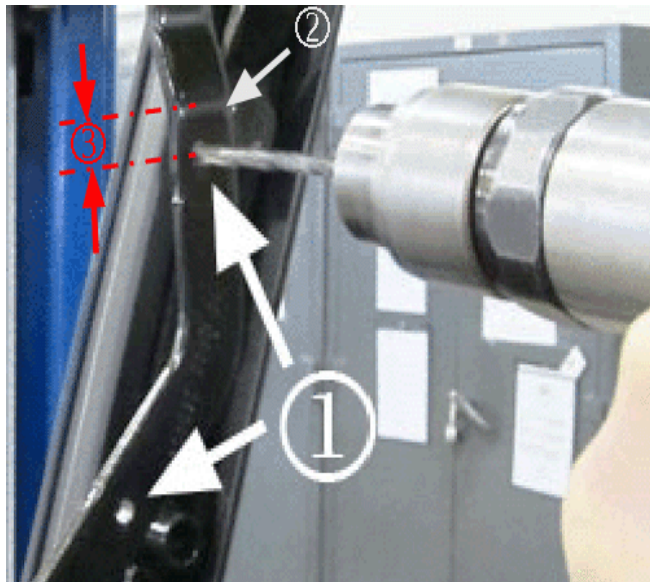
2912885

Note: Older convertible tops may be missing the upper 3.2 mm diameter hole shown in the control link above. If the hole is missing, add by drilling a new 5 mm (0.197 in) hole positioned 10 mm (0.40 in) (3) from the bend radius (2). Repeat the same operation on the opposite side of the top.

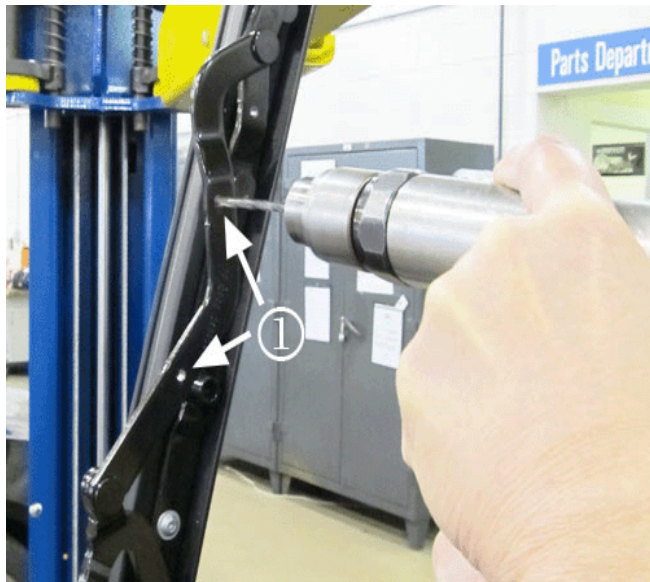
2874358

13. Re-drill the two existing 3.2 mm (0.125 in) holes (1) in the left control link to open the diameter up to 5 mm (0.197 in). Repeat the same operation on the opposite side.

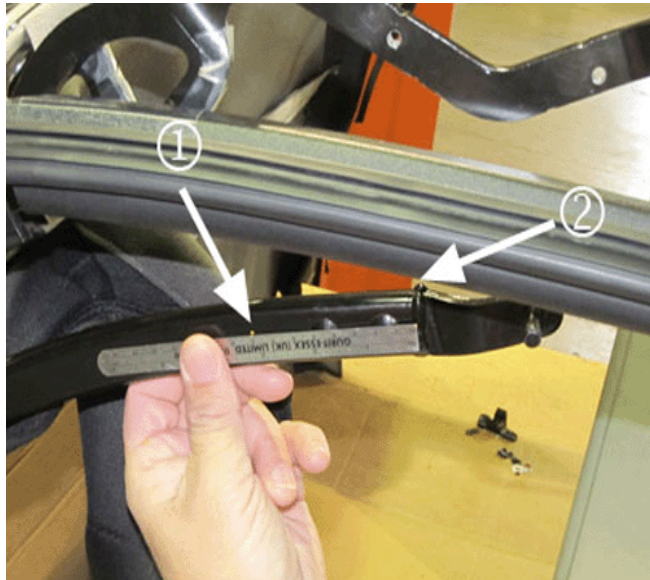
2874360

Important: The holes added to the each balance link are on the outboard side of the link and ARE NOT through holes. DO NOT drill through to the inboard side of the balance link. The right side balance link is shown in the graphic above.

14. Centered on the outboard side of the right balance link (1), drill a new 3.2 mm (0.125 in) hole, positioned 80 mm (3.15 in) from the center of weld bead (2). Repeat the same operation on the opposite side.

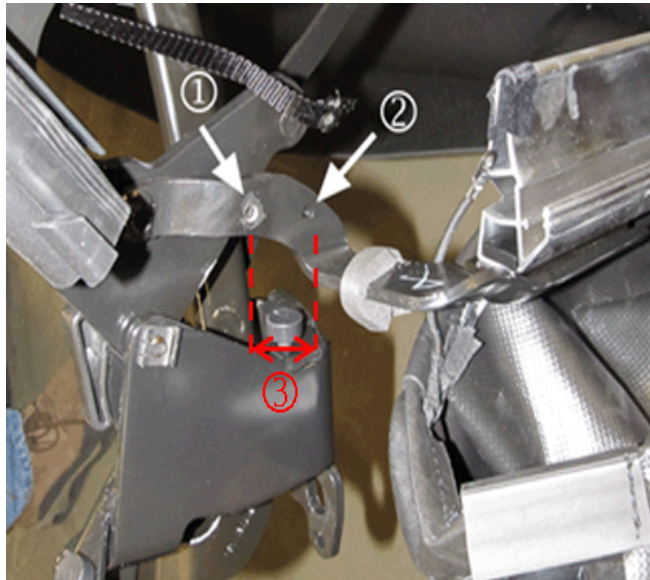
2874361

15. The graphic above shows the left #5 bow bracket with the strap and cords removed, and also the orientation of the new hole (1) and existing hole (2) for illustration purposes only.
 - 15.1. Drill a 5 mm (0.197 in) hole into the left and right #5 bow brackets, positioned 30 mm (1.12 in) (3) from the hole where the rear headliner strap and water management bag cord are attached.
 - 15.2. Drill out the original rivet retaining the strap and cord for repositioning those to the new hole.

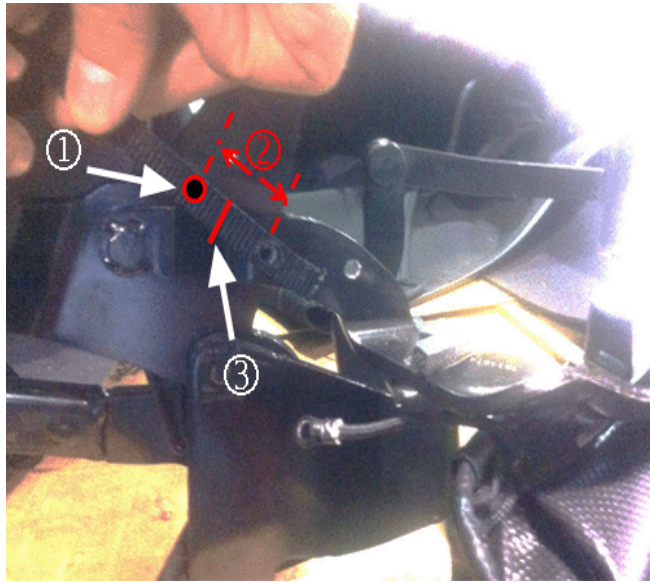
2913650

15.3. The graphic above shows the headliner strap, which is attached to the 5 bow bracket. If the top being retrofitted does not have a new 5 bow bracket equipped with the new hole, then using a hot mandrel, or equivalent tool, burn a new hole (1) into the headliner strap. As shown above, locate the new hole 30 mm (1.20 in) (2) from the current location, then cut the reworked headliner strap at call out #3.

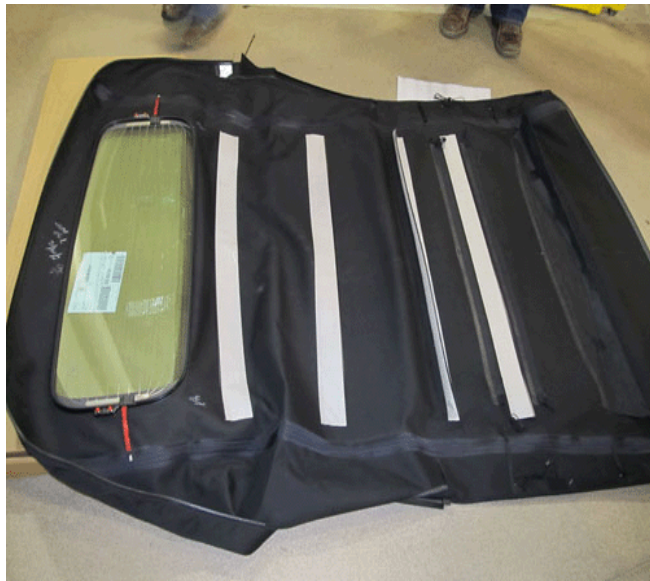
2874363

16. Lay out the new corded top cover on a clean, protected surface.

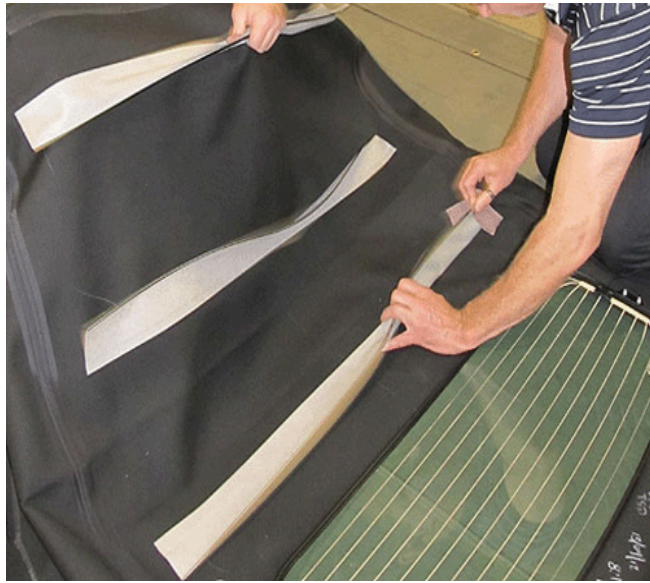
2874365

Important: Trial fit the top cover retaining beads into their corresponding roof bows. If installation is extremely difficult, it may be necessary to remove material from all of the beads, prior to their full installation. Use sand paper, or equivalent, to remove material from the tops of the beads to reduce/eliminate interference.

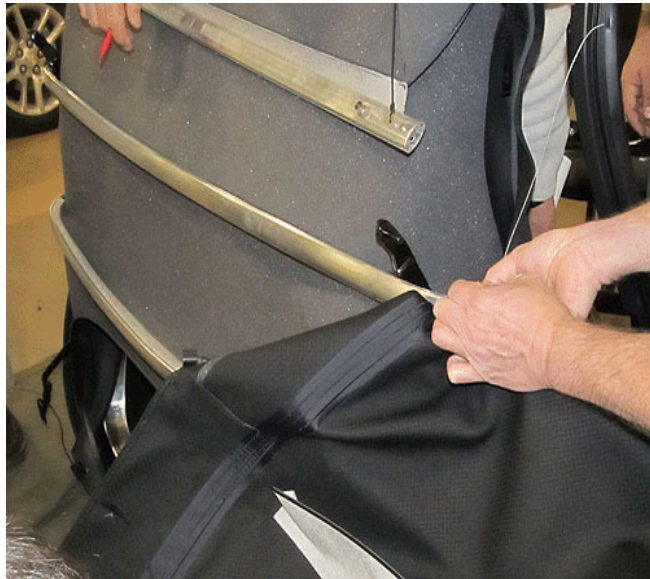
2874366

17. Starting from the passenger side, position the top cover beads to the beveled edge at the end of each bow.
18. With the aid of an assistant, alternately feed the beads into the slots on roof bows #3, #3.5 and #4. Continue to work the beads across to the opposite side until the all the top cover beads are centered on the roof bows.

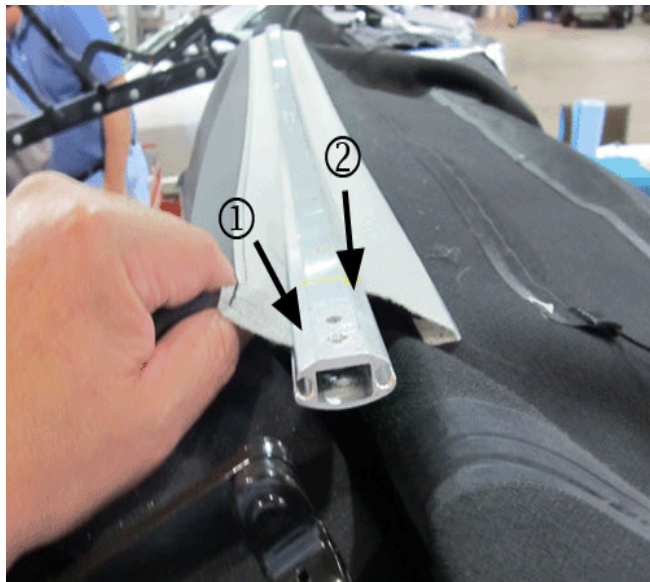
2874367

Note: As marked during the removal earlier, the headliner bead goes in the rear #2 bow slot (1) and the top cover bead goes in the front #2 bow slot (2).

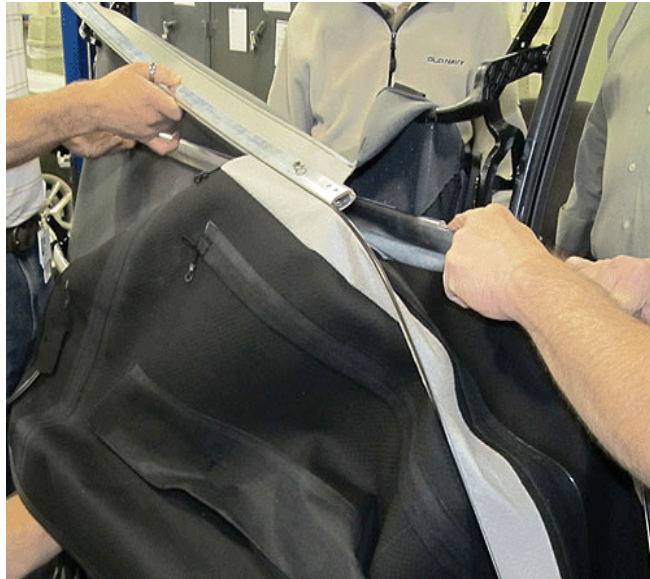
2874368

19. Slide the reworked #2 bow onto the headliner and new top cover beads **at the same time** as shown above.

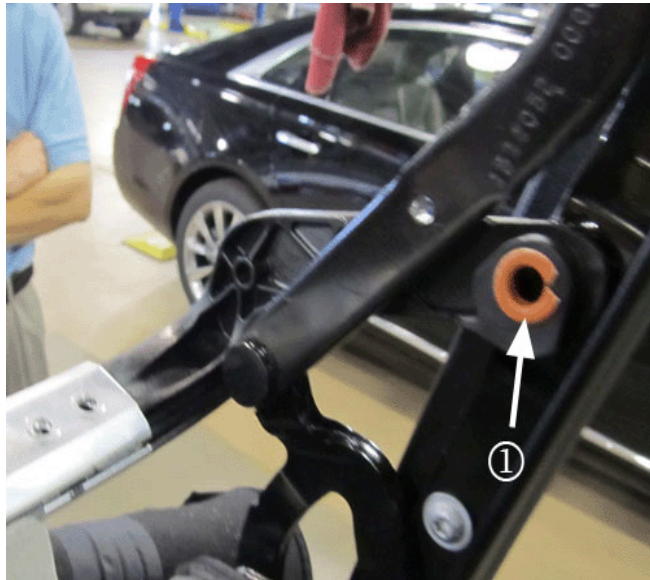
2874369

20. Reassemble the #2 bow bracket bushings (1), new plastic thrust washers, then the retaining clips. With the aid of an assistant, install the #2 bow brackets to the #2 bow, while simultaneously angling the brackets into position on the linkage on each side.

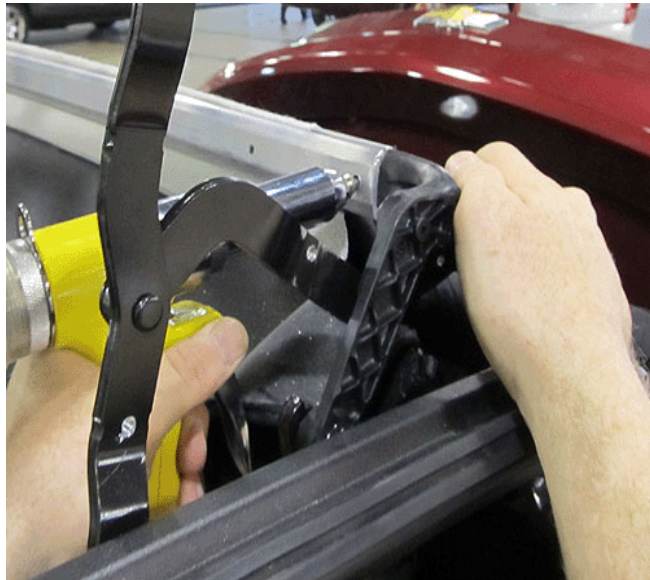
2874370

21. Ensure the brackets are fully seated on the #2 bow and install only the outboard rivets on the left and right side at this time.

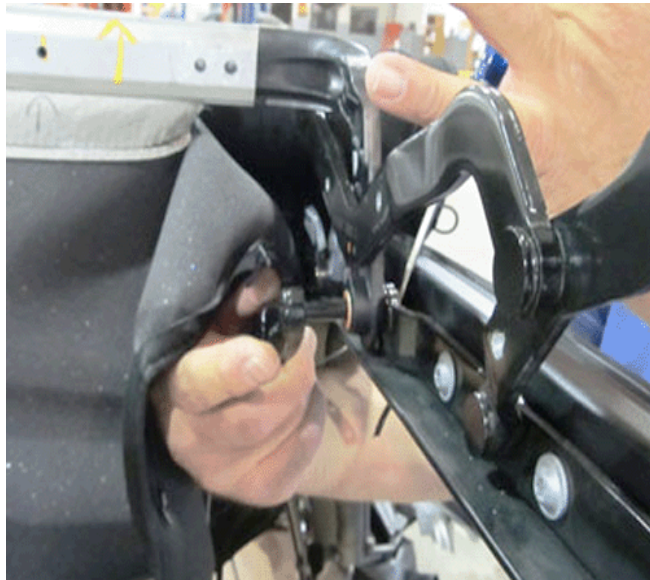
2874371

22. Reinstall the balance link pins, install the plastic thrust washers, then the retaining clips on each side.

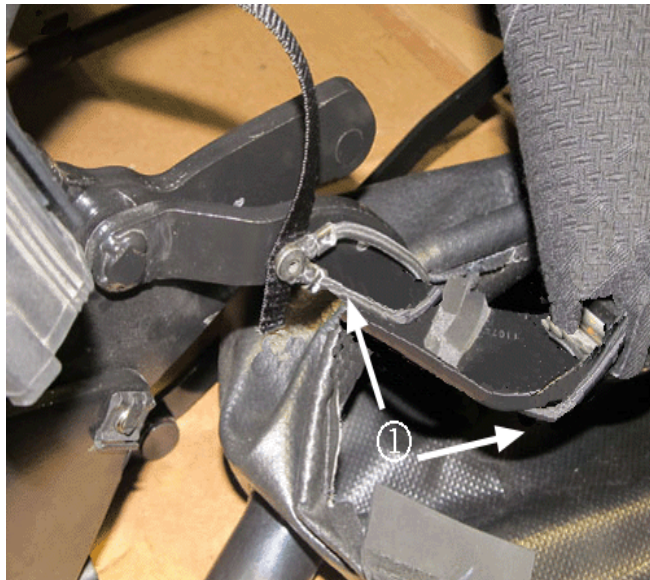
3217415

Important: Ensure that the top cover #5 bow bracket cord (1) is routed underneath the bracket.

23. Rivet the new top cover #5 bow bracket cord (1) to the new holes on the left and right #5 bow brackets, along with the water bag cord and the headliner control strap as shown above.
24. Install the rear window pivot bracket nuts, connect the defogger connectors, reinstall the headliner bead around the rear window, and secure the top cover to the #5 bow. Refer to Folding Top Cover Replacement in SI.
25. Reroute the side tension cables through the rear side rail, rear weatherstrip and top cover on each side following the steps below. If additional detail is needed, refer to Folding Top Cover Side Tension Cable Replacement in SI.

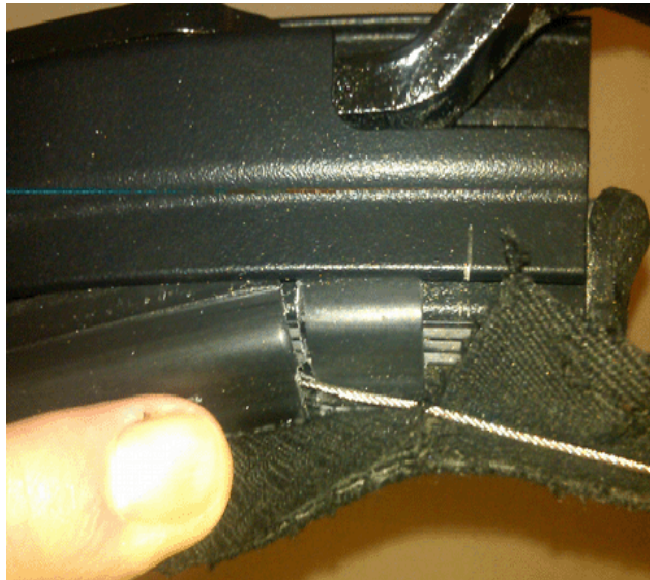
2915759

Note: The design of the top cover plastic retainer has changed slightly on the new corded top covers. The plastic retainer on the previous top covers had a slit near the end that allowed the side tension cable to pass through it as shown above.

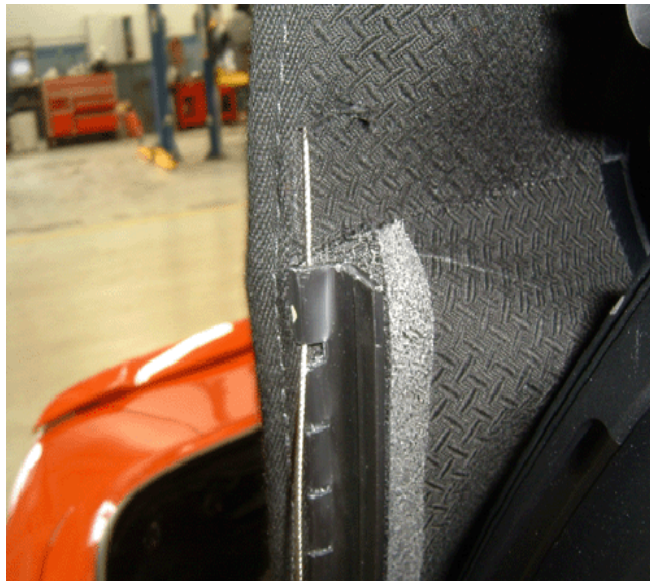
2915760

Instead of a slit in the plastic, the retainer now has a large square hole at the very end, which is large enough to allow the cable anchor to pass through it. The retainer and square hole can be seen in the graphic below.

25.1. Starting on the left side, route the side tension cable through the backside of top cover edge plastic retainer as shown above.

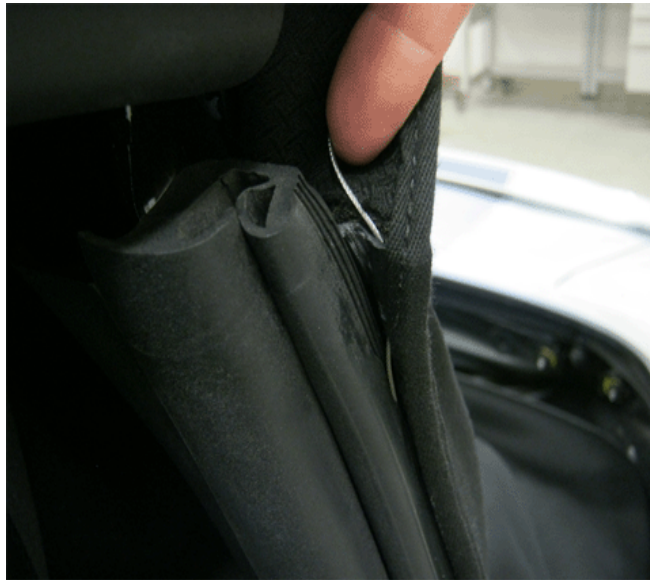
2900643

Note: The graphic above shows the correct routing of the side tension cable once everything is reinstalled.

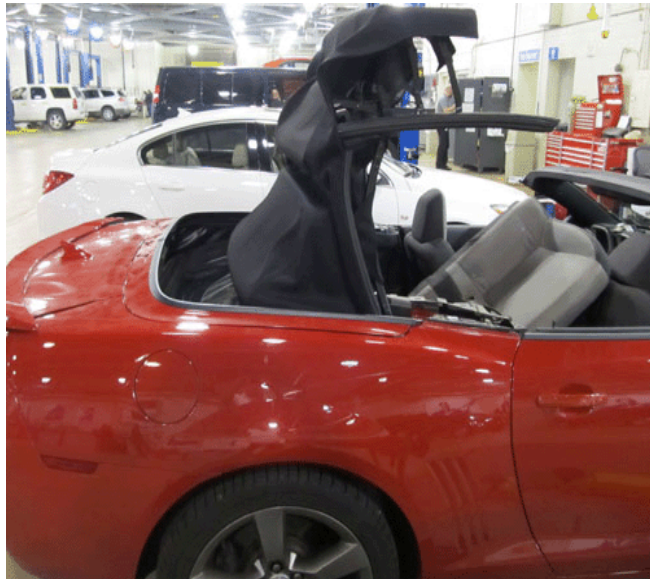
2874374

27. Position the folding top in the mid-open position. Clear any contents out of the rear seat and move the front seats forward. The technician will need to stand in the back seat to route and rivet the control cords and straps to the top frame.

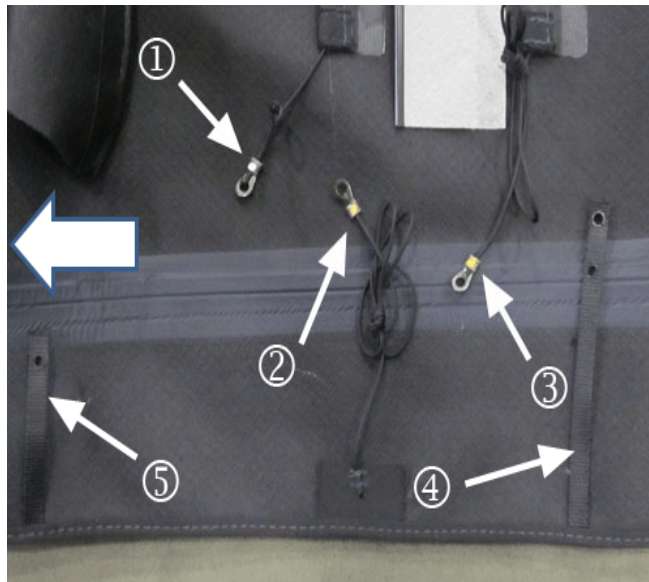
2884722

Note: The three cords added to each side of the top cover are color-keyed with paint dots on the cord eyelets. The orientation of the three colors white (1), yellow (2) and orange (3), along with the rear (4) and front (5) control straps, are shown above. The following steps will reference them as the white, yellow or orange control cords.

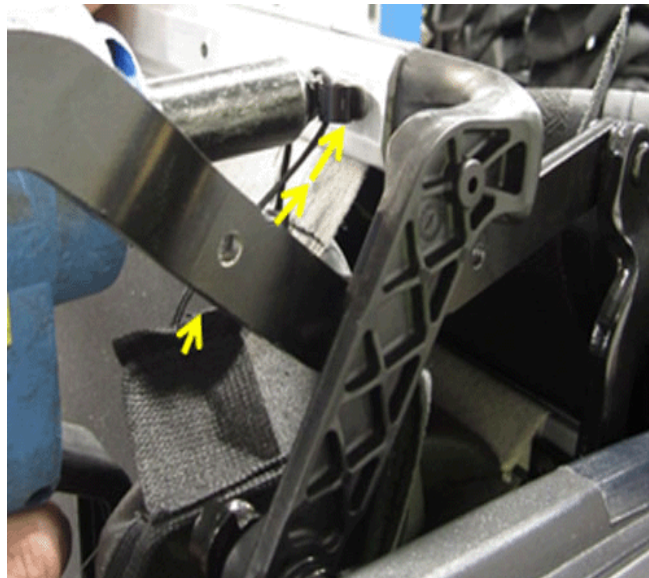
2874377

28.1. Route the cord (no color dot) coming off the **headliner tab** upward through the bottom of the P-clip. Position the clip to the #2 bow so that the P-clip is facing outboard.

Note: The headliner control cord must be routed through the P-clip before installing the rivet.

28.2. Install the rivet. (The headliner cord end eyelets can hang off the top side of the P-clip for now. They will be riveted to the control link later in step #31.)

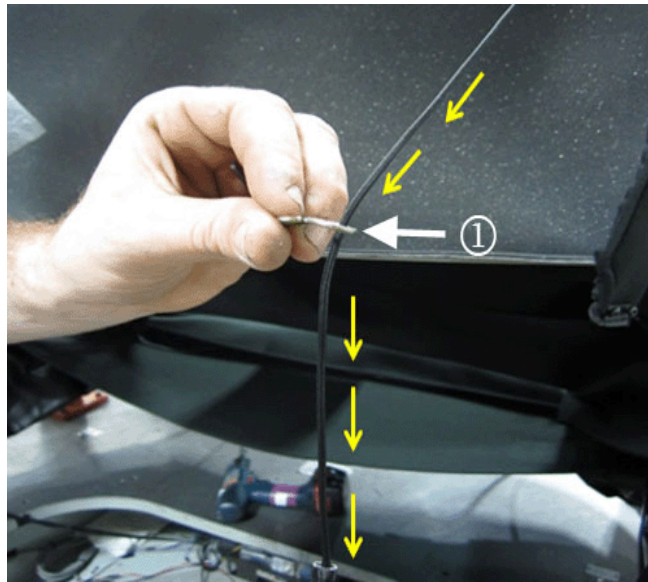
2874382

29.2. Route the cord downward through the large eye loop (1) with the eye loop angled downward as shown above.

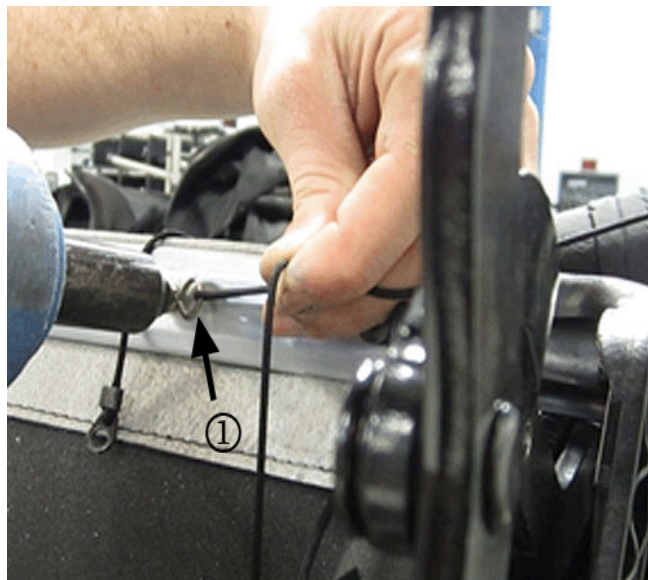
2874384

29.3. Install the rivet on the #2 bow through the small eye loop hole with the large eye loop hole (1) aimed outboard as shown above.

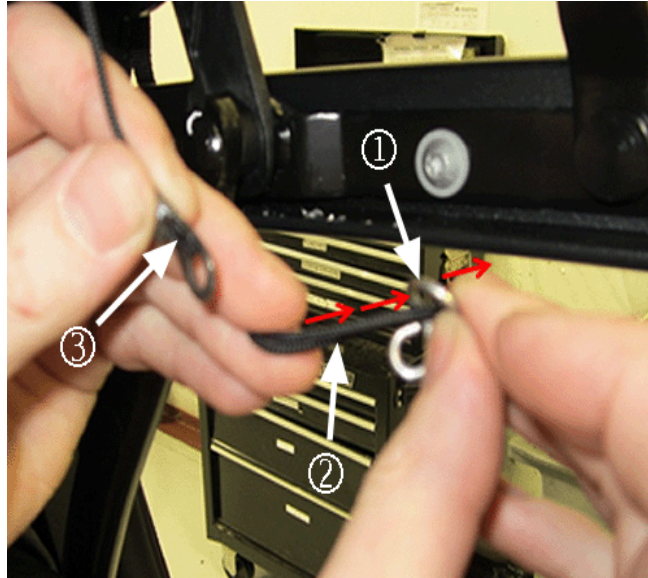
2920243

30.1. Holding the eye loop (1) with the 75° bend angled upward, route the yellow (2) and orange (3) top cover control cords down through the large eye loop opening.

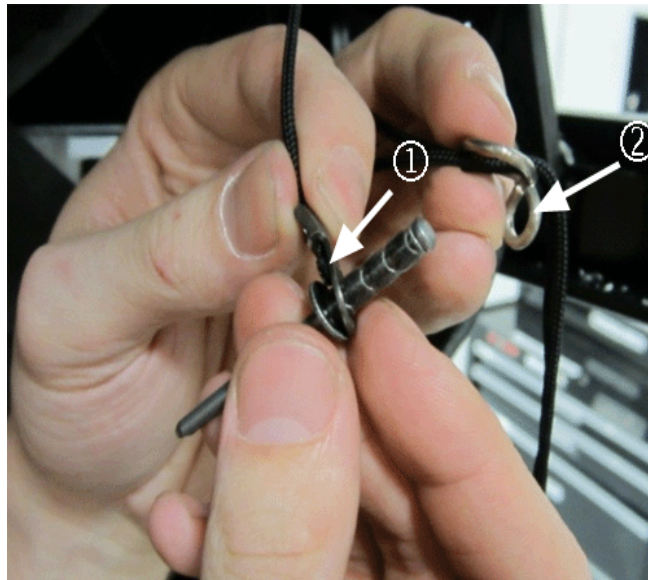
2920246

30.2. Grab the eyelet on the end of the white top cover control cord. Put the eyelet (1) on the new rivet, then add the eye loop (2) through the small hole of the 75° bend eye loop.

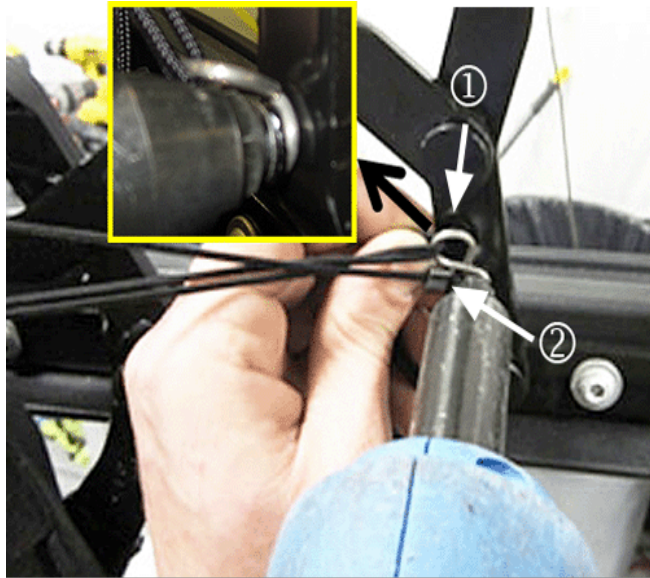
2920250

Note: The large eye loop should already have the yellow and orange control cords routed through it, prior to attaching the rivet.

- 30.3. Install the rivet to the rear #1 bow link with the 75° bend of the large eye loop angled inboard (as shown in the inset above) and the orientation of the eye loop (1) and the cord eyelet (2) as shown.
- 30.4. Repeat the same operation on the opposite side.
31. Rivet the end eyelets of the **headliner** cord (no color dot), along with a new P-clip, to the forward hole previously drilled in the left and right control links following the steps below:

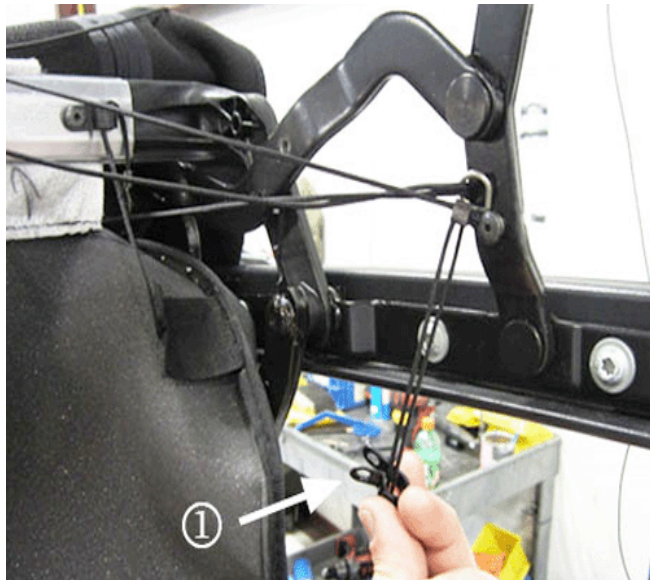
2874390

- 31.1. Grab a new P-clip (1) and route the yellow and orange control cords through the P-clip as shown above.

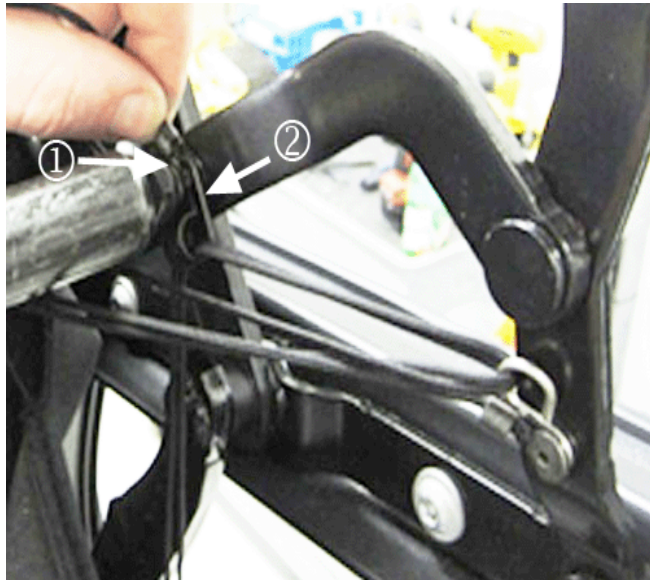
2874391

- 31.2. Insert a new rivet in the **headliner** eyelet, then through the P-clip (with the yellow and orange cords already running through it) and position them to the forward hole previously drilled in the control links.
- 31.3. Install the rivet to the control link with the orientation of the cord eyelet (1) and the P-clip (2) as shown above.
- 31.4. Repeat the same operation on the opposite side.
32. Rivet a new eyelet, along with the rear strap that is attached to the top cover binding, to the rearward hole previously drilled in the left and right control links following the steps below:

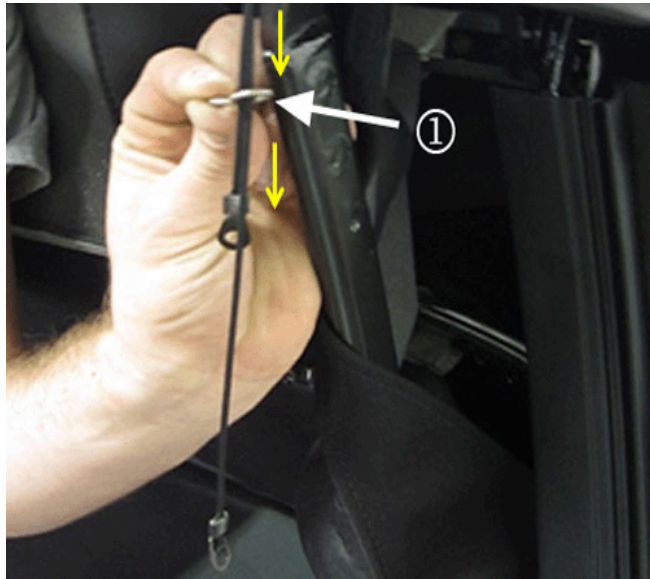
2874392

- 32.1. Route the yellow and orange control cords down through the large hole in a new eye loop (1) with the eye loop angled upward as shown above.

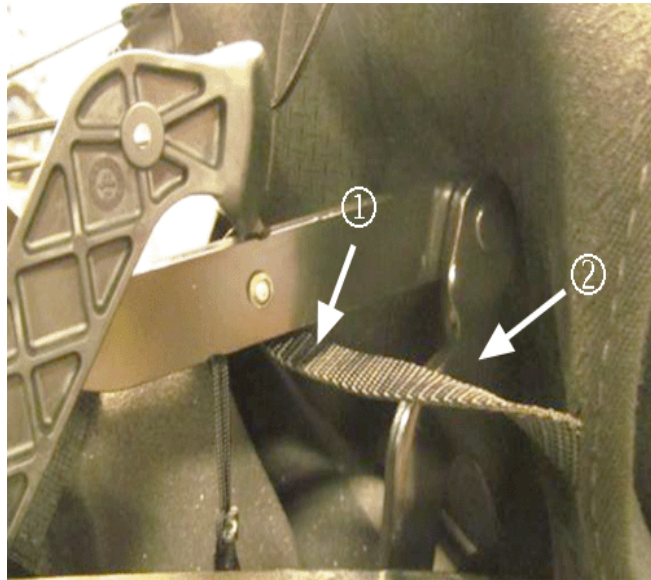
2915765

Important: Verify that the rear strap (1) of the top cover is routed under the side link and is not hung up behind, but is clear of, the wishbone link (2) as shown above.

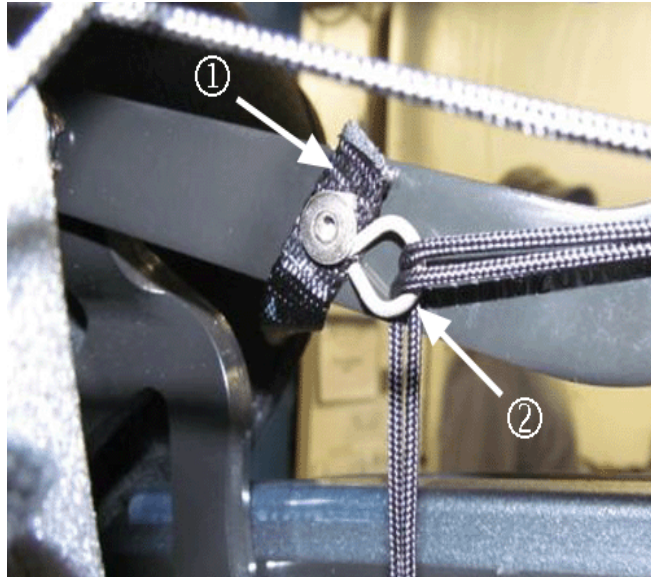
2915766

32.2. Insert a new rivet through the small opening in the eye loop (2), then through the strap (1) with the orientation of the eyelet and the strap as shown in the graphic above.

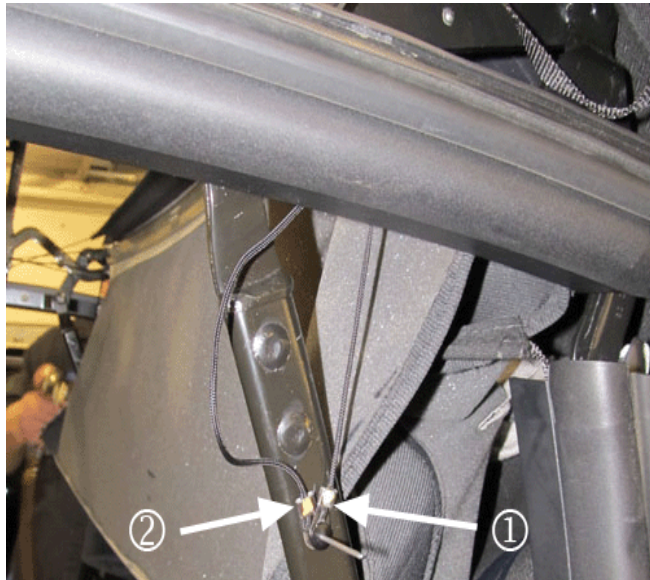
2874398

33. Rivet both end eyelets of the yellow and orange control cords to the hole previously drilled in the left and right balance links following the steps below:
 - 33.1. Insert a new 3.2 mm (0.125 in) rivet through the end eyelets on first the yellow (1), and then the orange (2), control cords.
 - 33.2. Attach the rivet to the hole in the balance link as shown above.
 - 33.3. Repeat the same operation on the opposite side.

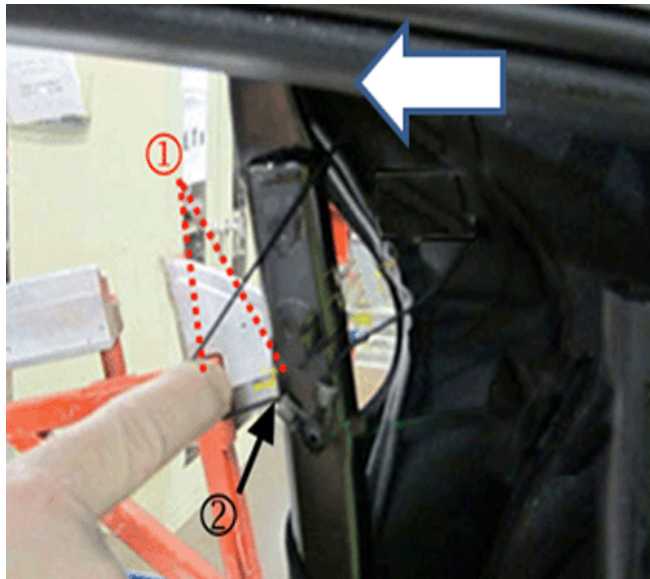
2884727

34. Balance the new cross-car control cord in the top cover's second pocket by completing the following steps:
 - 34.1. Cycle the top to the half open position.

- 34.3. With your index finger, pull the cord forward, taking out the slack.
 - 34.4. When the cords are even from side to side, there will be a gap of about 25 mm (1.0 in) (1) between your finger and the balance link as shown above. If the gap is less than an inch, reach into the top cover and gently pull the cord towards you, then recheck the gap. Noting the gap on one side, go to the other side of the top and repeat the process. Repeat this process from side to side until the gaps are equal.

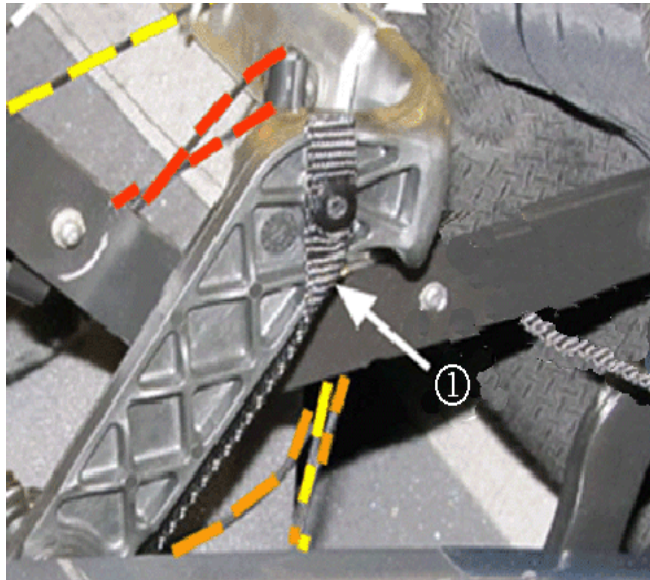
3217412

Important: Ensure the headliner strap is routed under, and towards the backside of, the #2 bow bracket.
35.1. Install the side headliner strap (1) to the left and right #2 bow brackets.

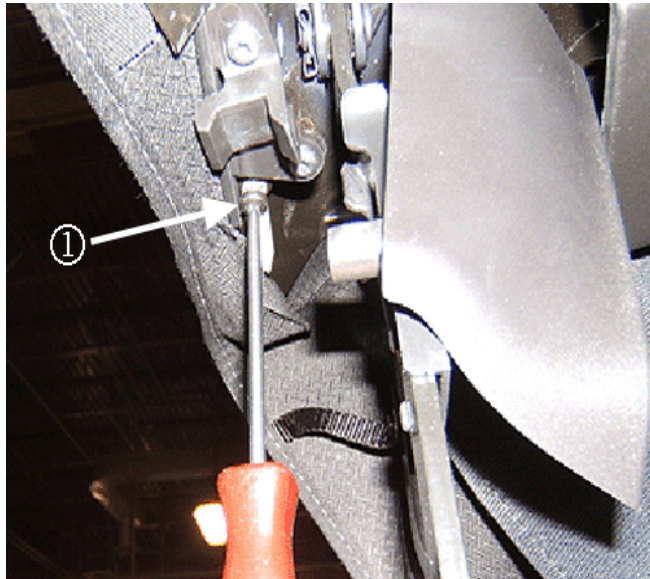
3217416

35.2. Install the tension cable spring and retaining screw (1) to both sides of the #1 bow.

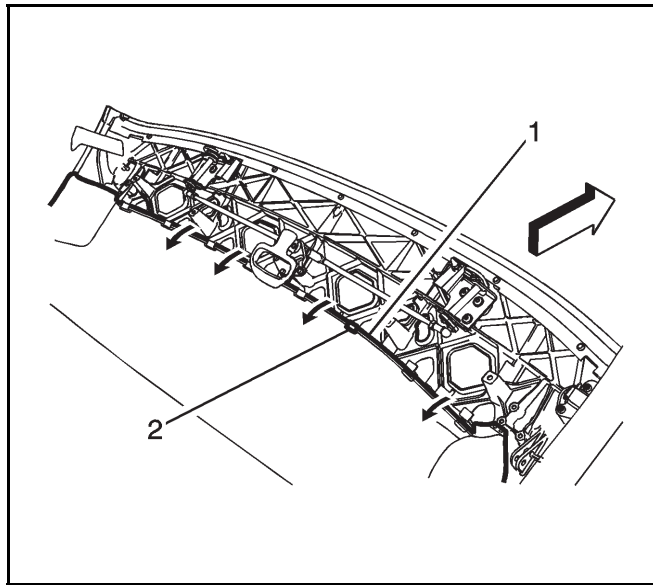
2529633

35.3. Install the headliner (1) to the #1 bow retainers (2) across the inner lower edge of the bow.
