Service Bulletin

Bulletin No.: PI0756B

Subject: Retrofit Procedure for New Corded Folding Top Cover Installation to Original Design Frame

Models: 2011-2012 Chevrolet Camaro Convertible

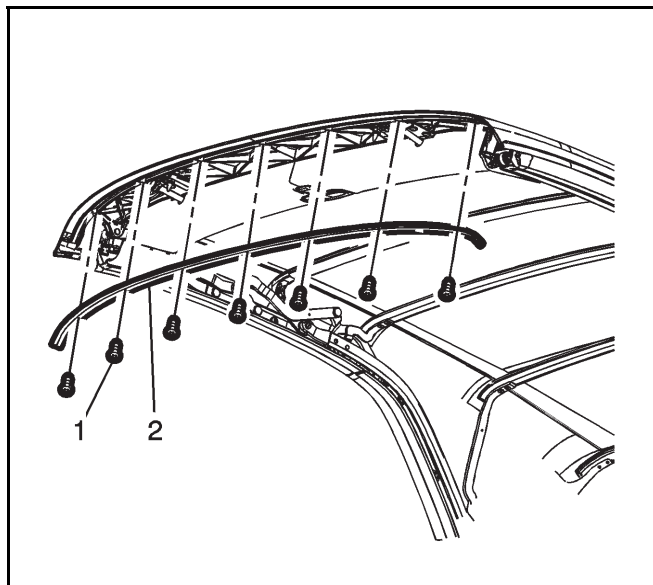
2524648

35.6. Install the top cover front edge retainer and screws.

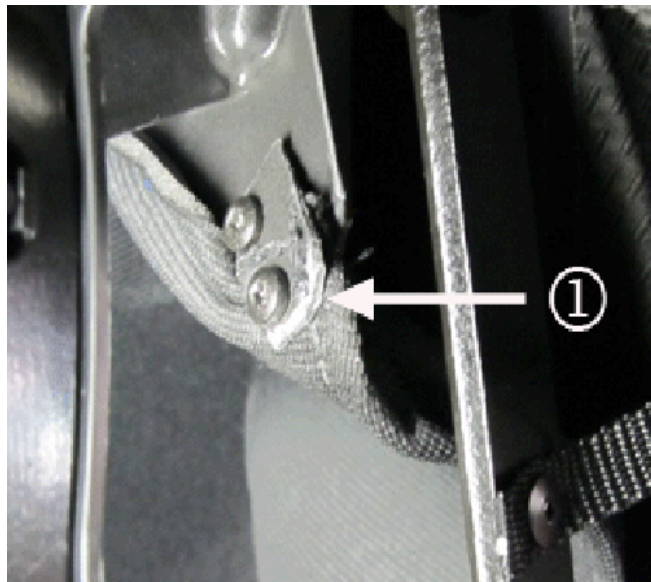
3217417

- 35.7. Position the headliner front corner supports to the left and right flipper doors, and install the retaining screws.
- 36. After balancing the cross car cord and completing the top cover installation, cycle the top to the fully stowed position before cycling the top closed.
- 37. Verify proper operation of the folding top.
- 38. Water test the folding top to verify there are no water leaks.
