Service Bulletin

Bulletin No.: PI0807A

Subject: Exhaust Rattle Noise

Models: 2011-2012 Chevrolet Camaro Convertible
Equipped with V8 L99 Engine

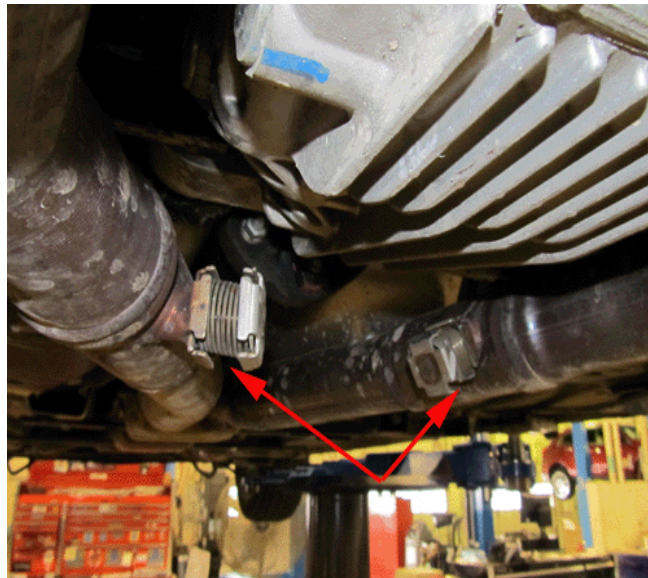
2898702

The spring in the exhaust valve may be causing the exhaust to rattle or make noise.

1. Raise the vehicle.
2. Install two O-rings onto the left exhaust valve spring.
3. Install two O-rings onto the right exhaust valve spring.
4. Lower the vehicle.
