Service Bulletin

Bulletin No.: PI0875

Subject: Load Floor Hook and Loop Fastener(s) Separate from Spare Tire Support Assembly

Models: 2012-2013 Chevrolet Equinox
2012-2013 GMC Terrain

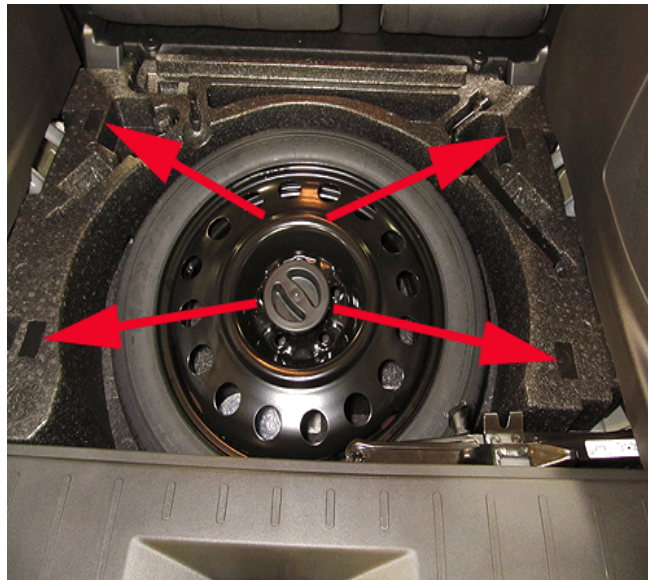
3226078

Some customers may comment the hook and loop type fasteners that secure the rear compartment load floor have separated from the molded plastic spare tire support assembly. This condition may be caused by poor retention between the spare tire support assembly and the attachment pin on the hook and loop fasteners.

Use the following steps to reattach the hook and loop fastener(s) using hot melt glue.
