Ignition Coil Housing Cracked (58/12)

Vehicle Type: **Boxster (986) model line**
Boxster/Cayman (987) model line
Carrera (996) model line
Carrera (997) model line

Concerns: **Ignition coil with Part Nos. 997.602.104.00 and 997.602.107.00**

Information: **Procedure for replacing faulty ignition coils.**

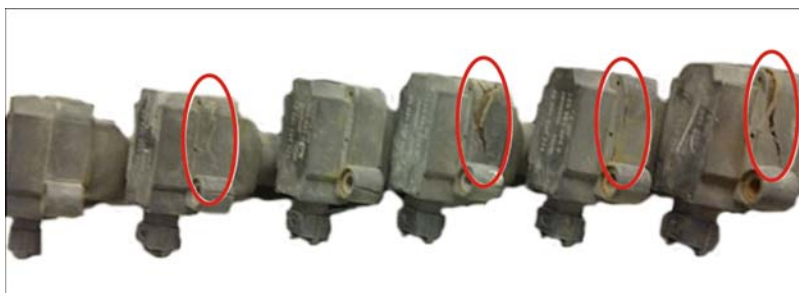
Figure 1

Cracks in the ignition coil housing (⇒ *Figure 1*) can cause corrosion, which can result in a rough-running engine and misfiring.

Work Procedure:	Part No.	Designation	Procedure
	997.602.104.00	without “EM 10”	Replace all ignition coils with new ignition coils with the designation “EM 10”.
	997.602.104.00	with “EM 10”	Only replace the ignition coil that was diagnosed as faulty.
	997.602.107.00	without “EM 10”	Replace all ignition coils with new ignition coils with the designation “EM 10”.
	997.602.107.00	with “EM 10”	Only replace the ignition coil that was diagnosed as faulty.

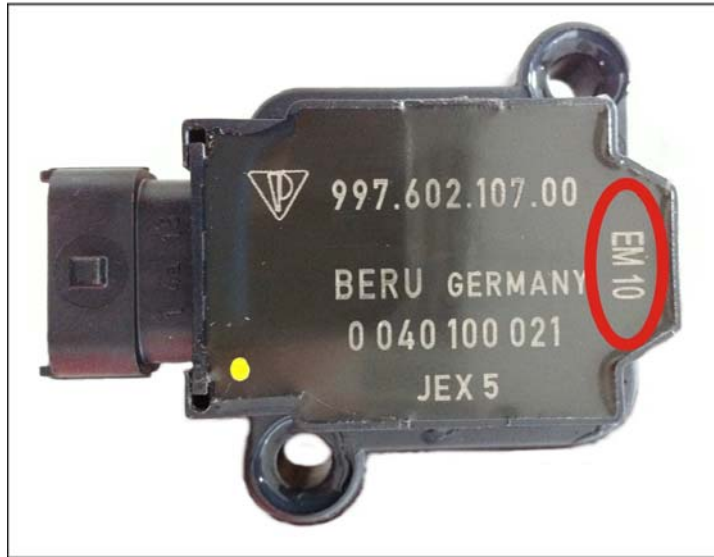
Figure 2

Action Required: If at least one ignition coil is diagnosed as faulty, the designation (with or without "EM 10", ⇒ *Figure 2*) must be read off all ignition coils.

Depending on the designation (“EM 10”) on the faulty ignition coil, either all ignition coils or a single ignition coil must be replaced, ⇒ see “Procedure”.
