INSTRUCTION TO SERVICE

ITS: 5158	
SECTION:	219 Engine & Transmission
WRITTEN BY:	Mike Pearson
SUBJECT:	Remove & replace exhaust flex connector.

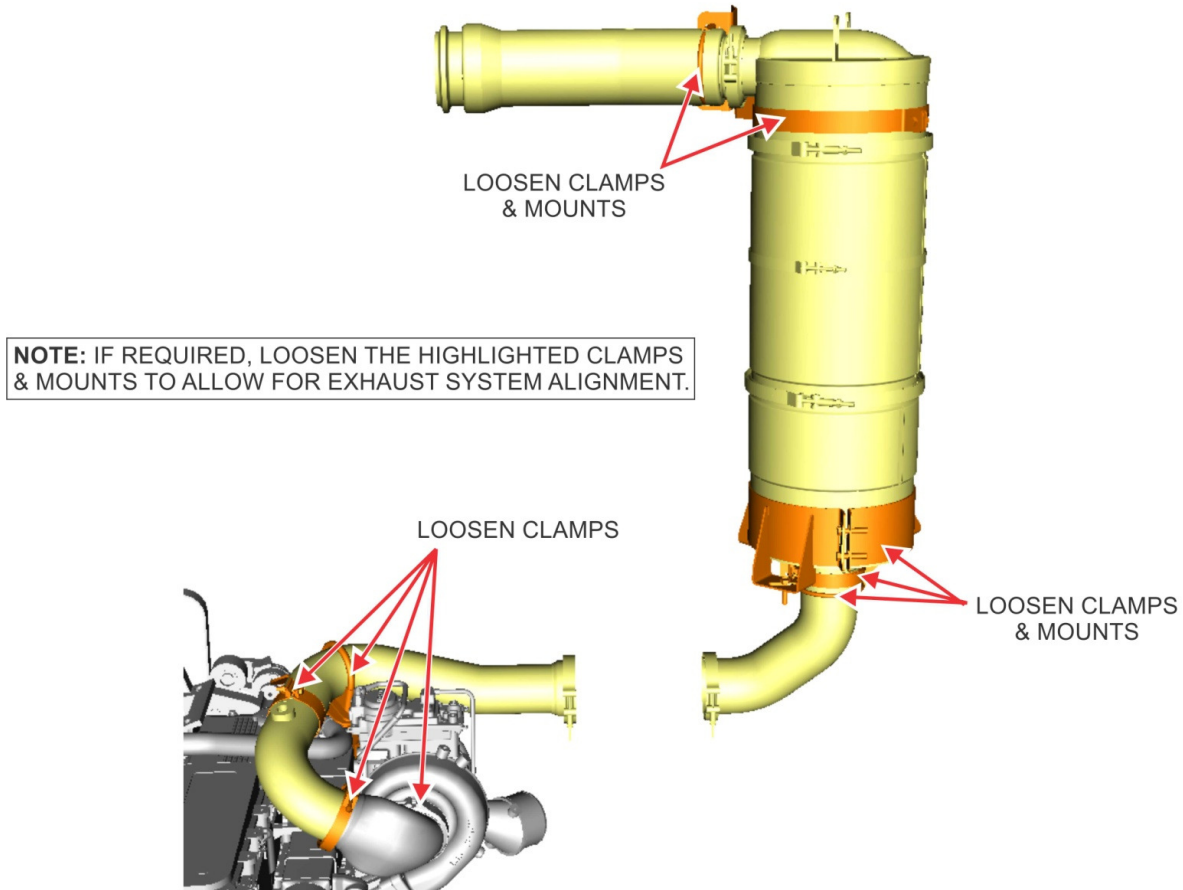
Figure 3: Exhaust Tube and Muffler Installation

- ☞ **NOTE:** Adjustment of muffler and/or exhaust tubes might be necessary to achieve proper alignment. If the tool does not align or does not fit between the exhaust tube ends, loosen the following: upper muffler clamp and 3 lower muffler base bolts, muffler elbow V-band clamp, turbo to flex connector tube band clamp, exhaust tube U-bolt and turbo elbow V-band clamp (Figure 3). Install the tool to exhaust tubes. Adjust and tighten the clamps to achieve proper alignment.

7. Follow Appendix A to ensure that the exhaust tubes and exhaust flex connector alignment tool are all aligned.
8. After verifying that the tubes and tool are all aligned tighten the clamps to the following torque specifications:
 - a. Tighten the V-band clamp at the 90° outlet to turbo connection, torque to 124 in*lb (10 ft*lbs).
 - b. Tighten the V-band clamp at the exhaust tube to 90° turbo outlet connection, torque to 75 in*lb (6 ft*lbs).
 - c. If applicable, tighten the band clamp on the turbo to flex connector tube, torque to 45*60 ft-lb.
 - d. Tighten the U-clamp.
 - e. Tighten the V-band clamp on the muffler connection, torque to 75 in*lb (6 ft*lbs).
 - f. Tighten bolts on the muffler base if these were loosened.

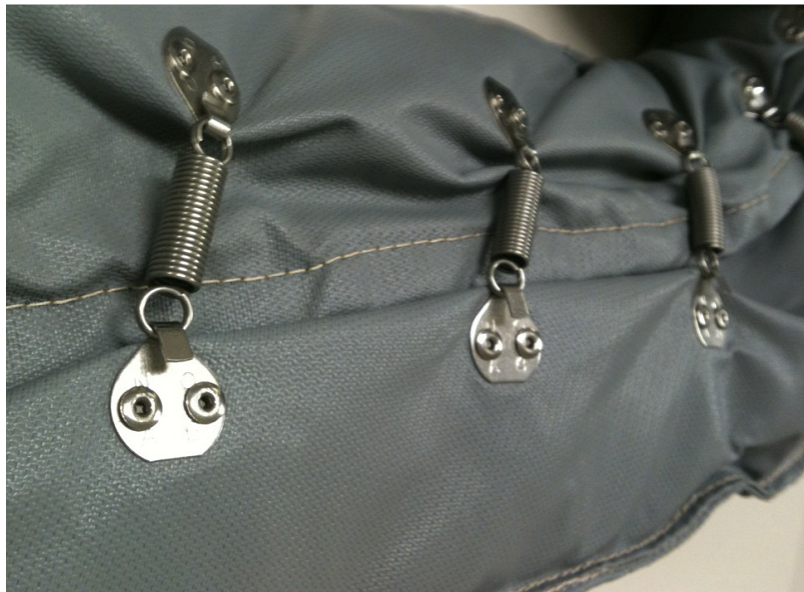
Figure 4: Insulated Blanket Installation

- Tighten the exhaust flex connector V-band clamps, torque to 75 in*lb.
- Turn the main battery disconnect switch to the “ON” position.
- Start the bus and check for exhaust leaks, adjust as needed.
- After the flex connector installation has been completed cover the new connector with the new insulation blanket p/n 6407715 and fasten using attached clasps, seam should be parallel and facing the rear of the bus, See Figure 4.

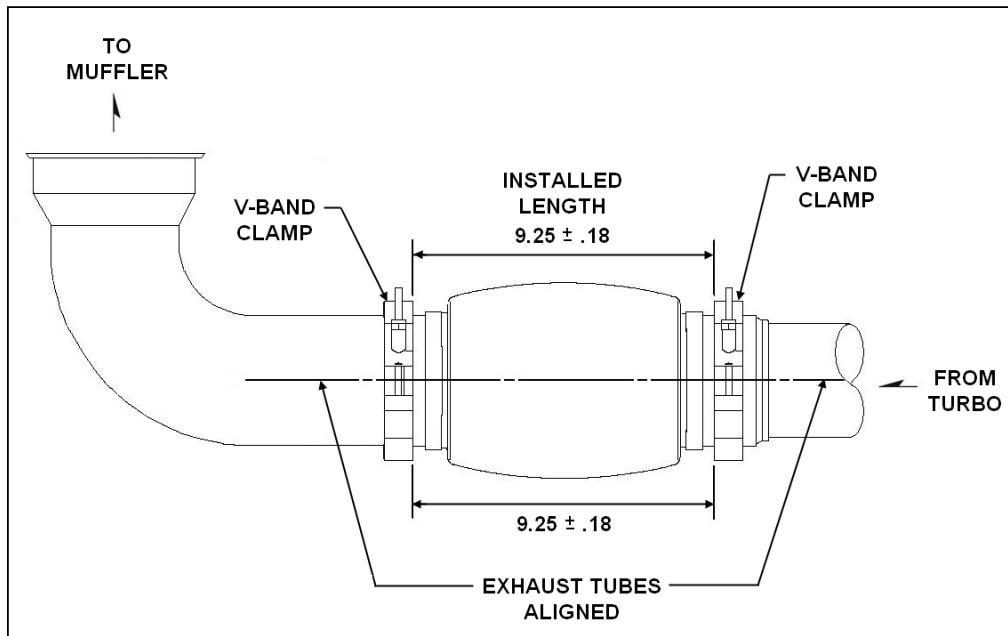
A correct installation will be straight. The exhaust flex connector will not be installed with torsion.

NOTE: Distance between torque clamp edges must be 9.25" +/- .18. Adjust exhaust tubes to achieve this distance (Free Length).

⚠ WARNING: The exhaust flex connector is extremely sensitive to installation. A slight misalignment will result in premature failure. Careful inspection of the alignment is necessary.
