## New Jersey Transit: Fan Support Bracket Repair

**Property and Top Bus Number:** New Jersey Transit 416.15, 164200, 164400, 279000, 279500, 289000

**Issue:** Cracks at the fan support bracket area.

**Solution:** Repair cracks and add reinforcement parts per this work instruction (SOI).

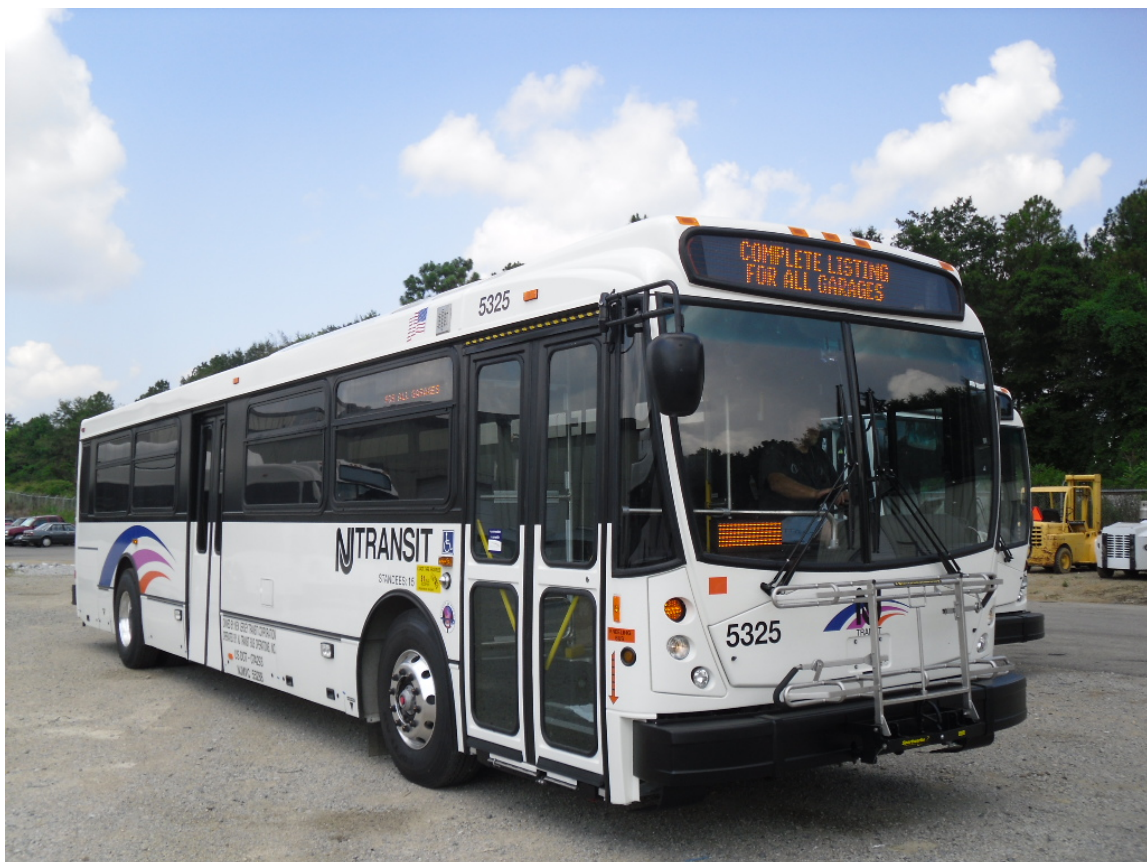
**Reason/ cause:** NABI updated the structure to enhance the durability.

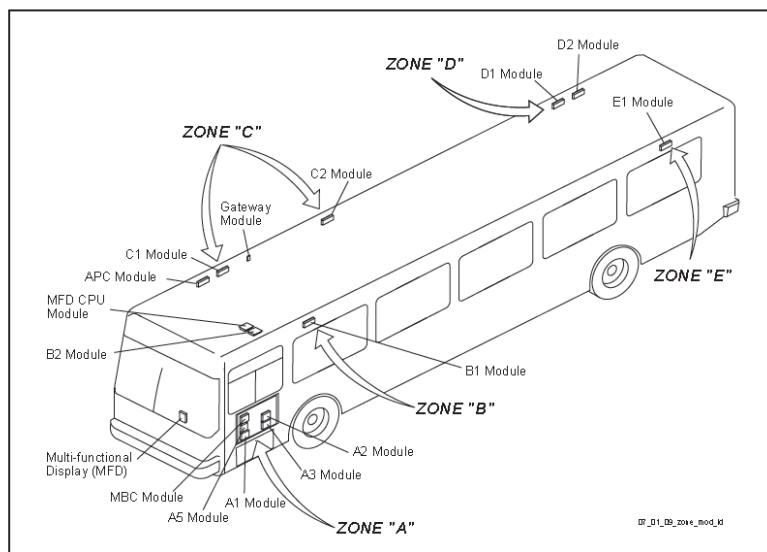
Figure 1- Zone and Module Identification

2. Park the bus and apply the parking brake.
3. Turn off main battery disconnect switch(es).
4. Tag and disconnect batteries cables.
5. Disconnect the ECU of engine, transmission and ABS. Disconnect the destination signs. Turn off and disconnect the PA system. Open the light panels and disconnect all the IO modules.  
**Disconnect the 2 way weather pack connector at the fire suppression bottle, located at the street side (SS) in front of the rear axle.** See some example pictures on the next page.

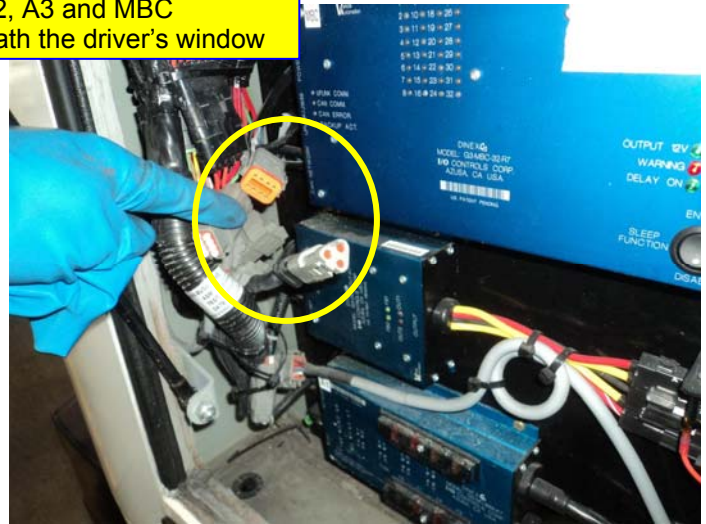
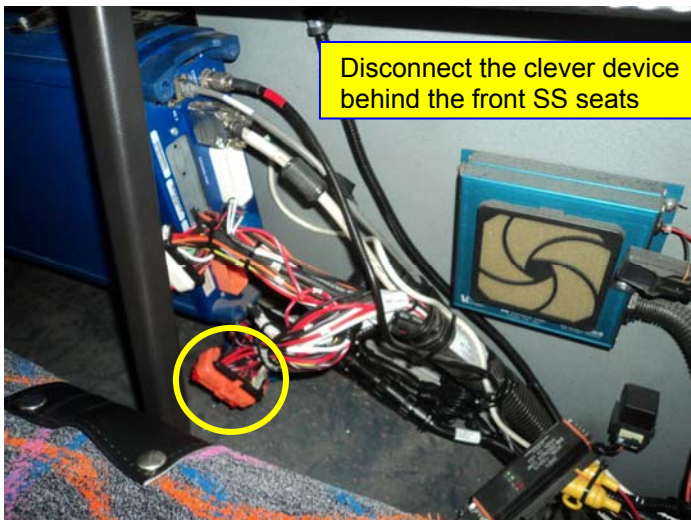
Disconnect the clever device behind the front SS seats

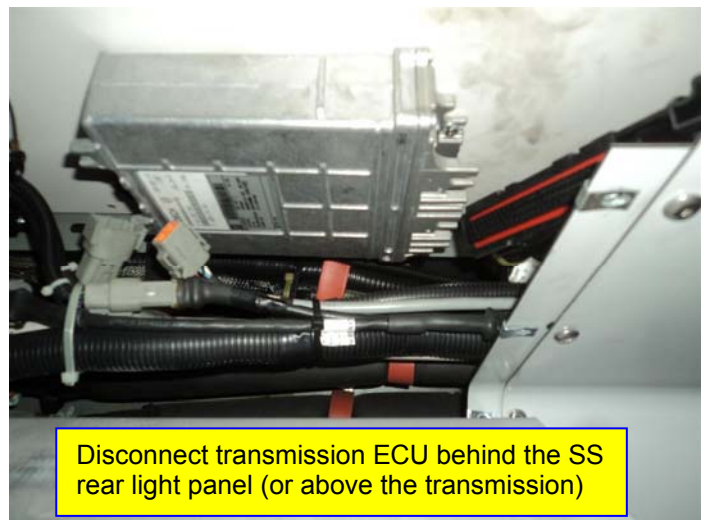
Disconnect transmission ECU behind the SS rear light panel (or above the transmission)

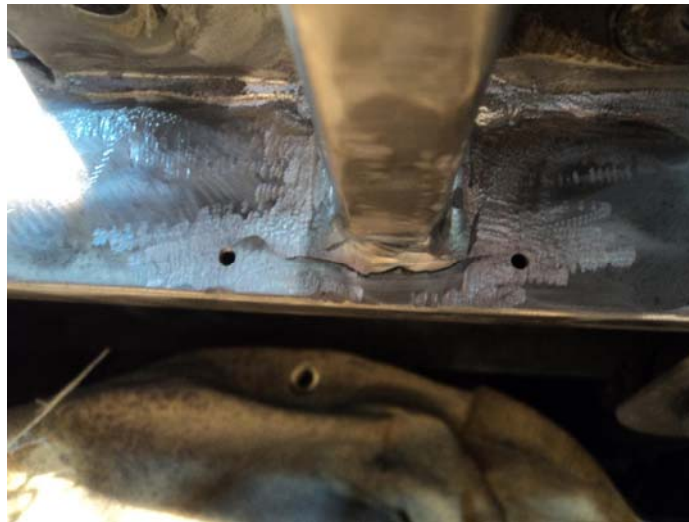
17. Check for cracks around the fan support bracket. Use magnifying glass and/or penetrant test to identify cracks.

- Find the end of the crack,
- Drill a 1/8" size hole at the end of the crack,

- Bevel the crack profile 2x30° for single V-groove weld,
- Clean the surface in the welding area (mechanical cleaning).

- Degrease surfaces.
- Fix the tube the right position, use hydraulic ram (or mechanical clamp). This step will reduce the residual stress after welding, which means higher service life.
- Weld the crack according to WPS No. **WPS 35/40LFW-R03**.
- Check the welds by Visual Test and/or Penetrate Test.

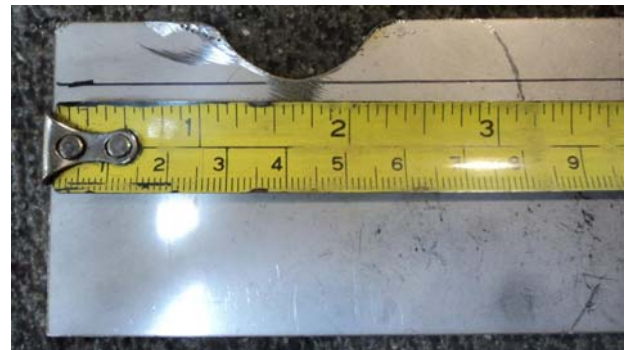
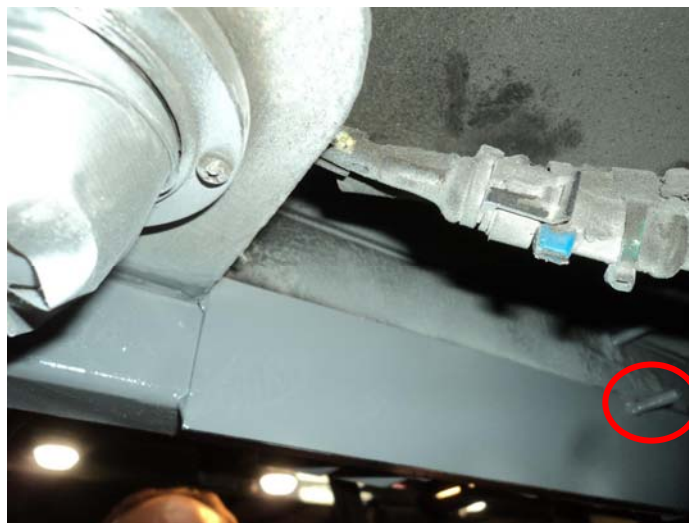
Notch the CS backing plate (PN **10C-1301-223**) as picture shows below. It is necessary to provide clearance around the threaded stud of the temperature sensor (see picture below)

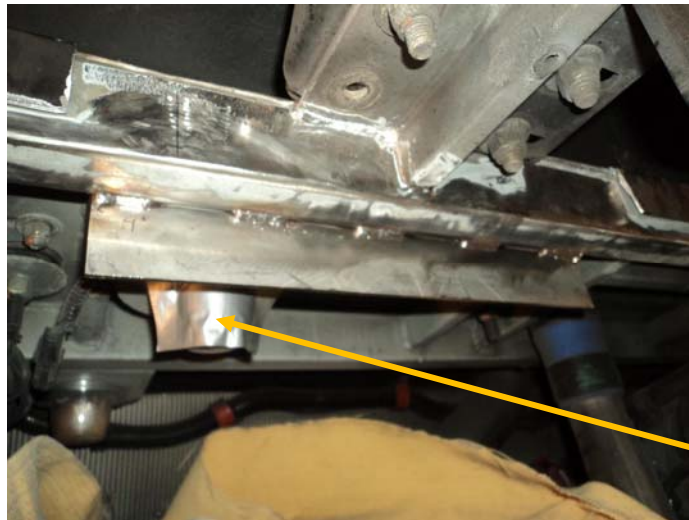
- Weld at interface between back corner of tube and backing plate. Weld is stitch weld, 1-3 (1" long weld and 3" between the centers of the welds) per **WPS 35/40LFW-R01**.

- Grind weld smooth so the next part will fit correctly.

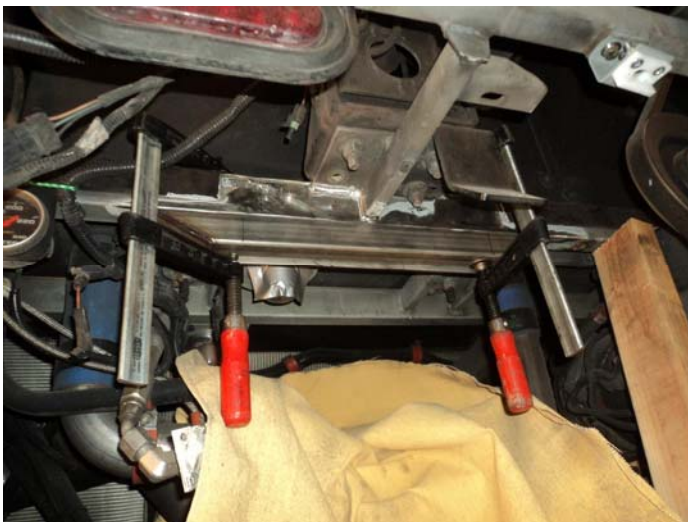
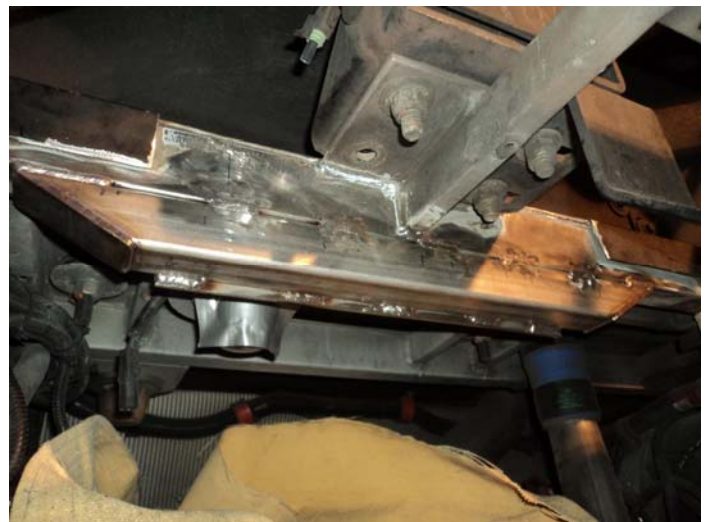
- Weld the corner between the cross-member and the support tube and also weld between the support tube and the backing plate. Weld is 1-3. **WPS 35/40LFW-R01**.

- Grind weld smooth so the next part will fit correctly.

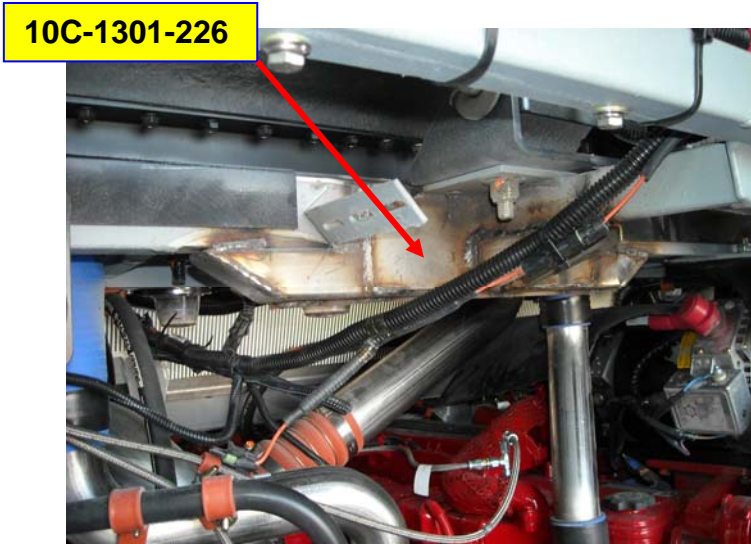
- Weld along bottom edge with 1-3 stitch, weld sides solid and weld top with 1-3 stitch welds. Weld solid at cutout around brace. Weld 3 plug welds at the holes. Welds per **WPS 35/40LFW-R02**.
- Grind welds as required.

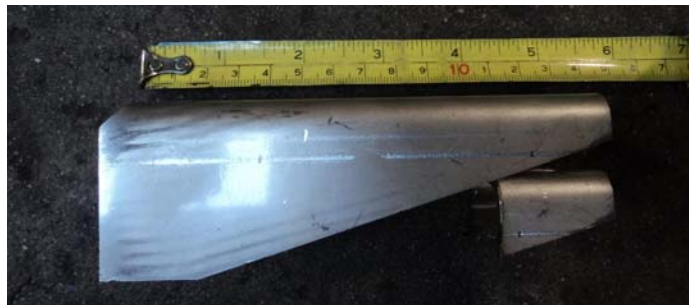
- **Note:** buses equipped with CAT and 2007 Cummins engines, the brace is not removable. Cut 1.5" off from the end of support bracket (see below) to provide clearance for the snuber bracket then weld the support gusset underneath the original brace (see next paragraph about welding instructions).

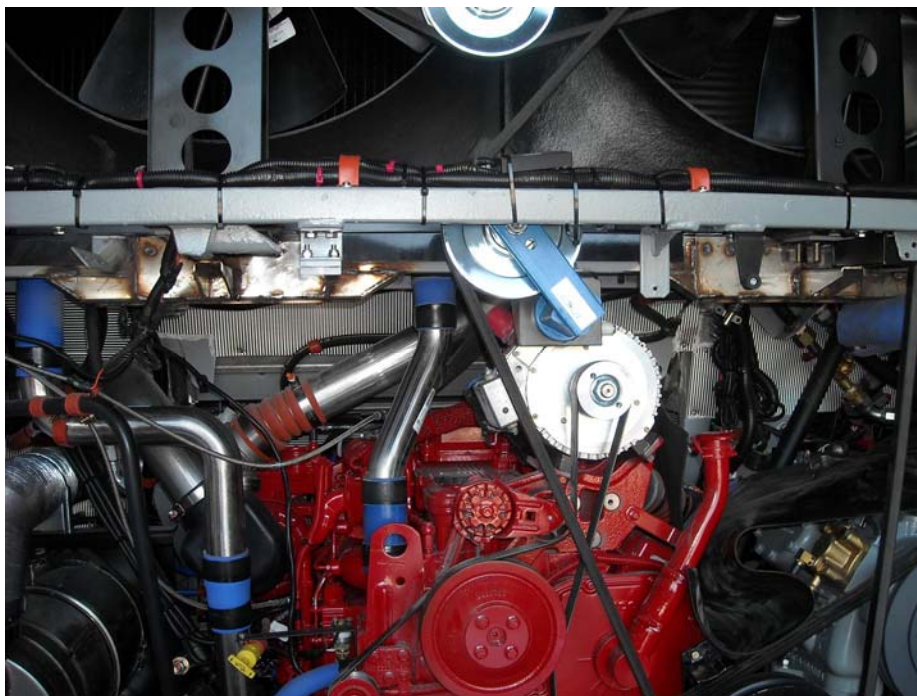
23. Install CS and SS support gussets P/N 10C-1301-207:

- Position support gussets as picture shows below.

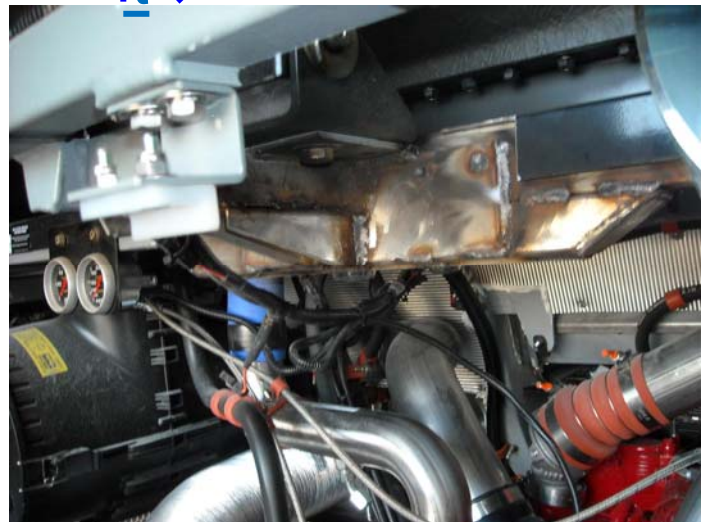
**On buses equipped with the 2010 Cummins engine the CS support brace is removable in order to replace fan drive belt. Do not weld the support bracket to the brace! The slots on the support bracket are for the 1/4-20 bolts!**

- Weld CS support gusset solid at interface with cross-member. On buses equipped with CAT and 2007 Cummins engines weld the CS support gusset same as the SS bracket.
- Welds per **WPS 35/40LFW-R02**.

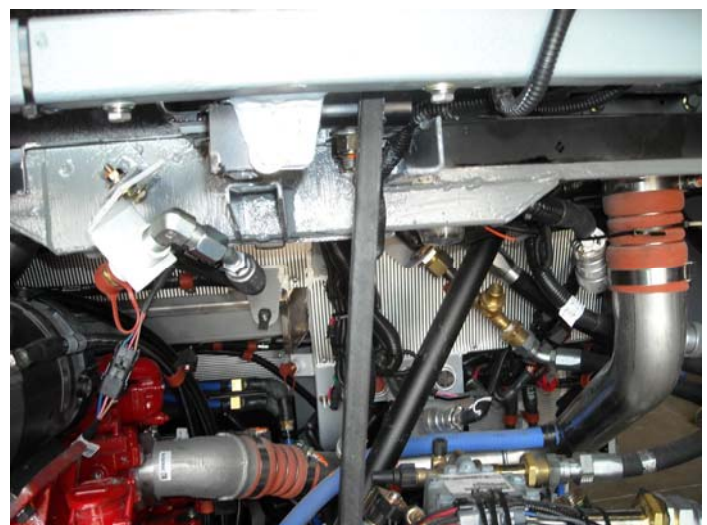
26. Clean welded area with wire brush.

27. Degrease surfaces.

28. Apply primer onto the new parts.

29. Apply gray color paint to the primed surfaces.
