Nashville: Roof Closeout Panel Rework

Property name and top bus number: Nashville, 60BRT-09, 227000 and 275000

Issue: Roof leak.

Reason/ cause: The closeout panel around the coolant line of the roof mounted battery cooler unit may separate from the roof panel.

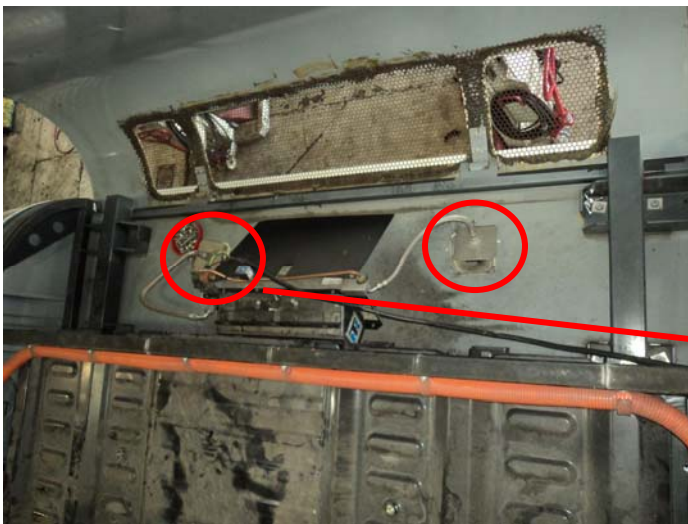
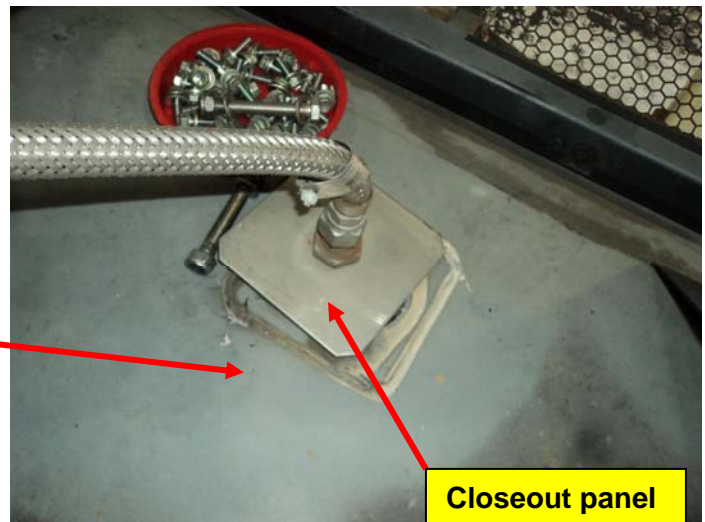
1. Park the bus and apply parking brake.
2. Turn off main battery disconnect switch(es).
3. Place sign on the steering wheel that says “do not start bus”.
4. Open the forward roof compartment access doors and locate the closeout panels around the AC coolant lines on the street side (there are two closeout panels, see pictures below).

5. Inspect the attachment of the closeout panel. Ensure that the panel is sealed all the way around. No separation or cracks allowed on the sealer in order to provide watertight seal.
6. Drill 1/8” size holes at the four corners of the panel.
7. Install #10x3/4 SS screws into the four holes.
8. Wipe the panel of with clean rag soaked with Sika Cleaner. Clean the panel all around the edges and around the screws. Allow 10 minutes to evaporate the cleaner.
9. Apply Sikaflex around the edges of the closeout panel and onto the screws to prevent leaks.
10. Inspect and perform the work on the other closeout panel as well.

11. Remove old adhesive from the panel and from the roof by using utility knife or scraper.
12. Reposition the closeout panel to the roof and drill 1/8” size holes at the four corners of the panel.
13. Mark the perimeter of the closeout panel on the roof with a pencil.
14. Wipe surfaces with clean rag soaked with Sika Cleaner. Let it dry for 10 minutes.

15. Apply a continuous bead of Sika 252 adhesive to the roof panel, 1/2" inwards from the markings, all around.
16. Install #10x3/4 SS screws into the four holes.
17. Smooth the Sikaflex around the edges of the closeout panel.
18. Apply Sikaflex 252 onto the screws to prevent leaks.
19. Inspect and perform the work as required on the other closeout panel as well.
20. Remove all the tools from work area.
21. Check for completeness of work.
22. Record bus number, mileage and the date of repair.
