Service Bulletin

Subject: Grease Leak From Front Hub Bearings

Models: 2004-2013 Cadillac Escalade Models
2004-2013 Chevrolet Avalanche, Silverado, Silverado Classic, Suburban, Tahoe
2004-2013 GMC Sierra, Sierra Classic, Yukon and Yukon Denali Models
2004-2010 Hummer H2

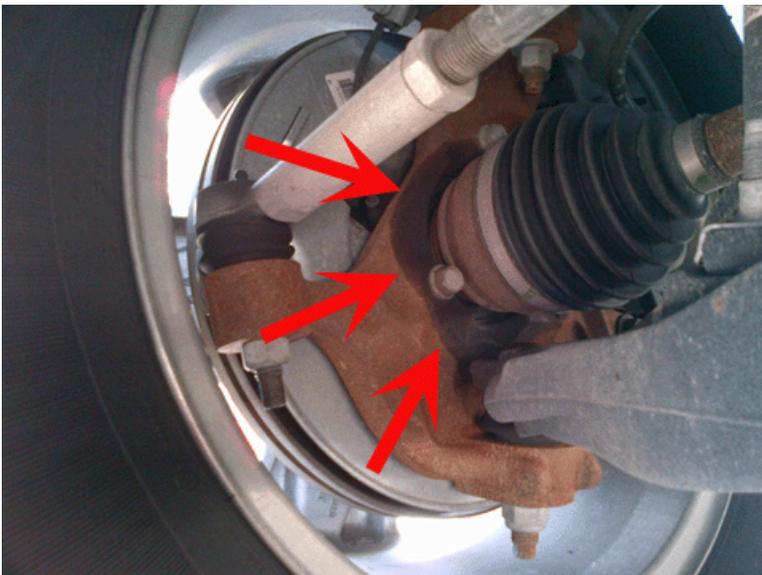
The factory grease fill of the front bearing/hub assembly exceeds the amount of grease that is required for adequate bearing lubrication throughout the life of the vehicle. A portion of the grease will purge through the self-venting bearing seals for the initial drive period (a few thousand miles/kilometers) and helps to form an additional barrier to block contamination of the bearing. This additional barrier is called a "grease dam". This grease dam will form in the area near the bearing seal and will mix with outside dirt. In addition, grease may move radially outward from this area onto adjoining components, see example picture below.

Do not replace the bearing for grease purge. Furthermore, do not clean the purged grease from the area immediately on or adjacent to the seals because this grease provides additional protection. If desired, any grease that has migrated away from the immediate seal area can be wiped off.

The bearing should be replaced only if:

- The seals show visible damage
- The bearing endplay is greater than 0.005" or 0.13mm
- The bearing exhibits rough rotation

- The bearing exhibits abnormal noise
