Bulletin No.: PIT4225F

Subject: Service Stability Lamp DTC C0710

Models: 2007-2013 Cadillac Escalade Models

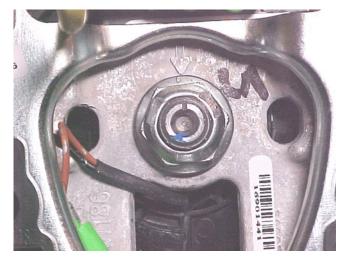
If the vehicle is not repaired after normal diagnosis, check to make sure the steering wheel is properly installed to the steering shaft. There is an alignment arrow on the steering wheel and a mark on the shaft, which should be aligned as shown in the picture below. IF BOTH MARKS ARE ALIGNED THEN DISREGARD THIS PLAS IT IS NOT THE CAUSE OF THE FAULT.

Note: The steering wheel and shaft have a master spline and when the alignment marks are in-line the master splines will be aligned.

If the steering wheel and shaft marks are not properly aligned, remove the steering wheel and align the steering wheel to the shaft. Inspect to make sure the splines are properly engaged and install the steering wheel nut and torque to factory spec per SI. Perform a toe adjustment.
