# Service Bulletin

## PRELIMINARY INFORMATION

**Subject:** Flutter Or Rattle Type Noise From Front Of Vehicle While Driving

**Models:** 2012 Chevrolet Sonic

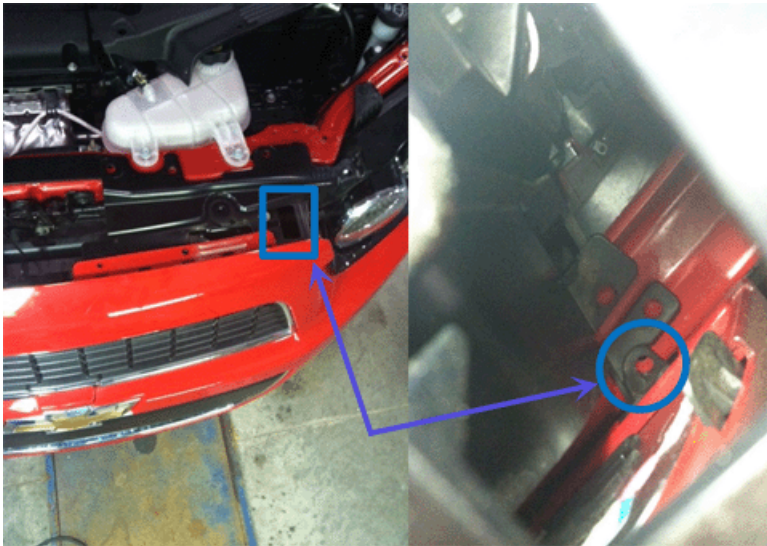
Inspect the upper radiator baffle for a loose or missing clip, See picture below for area of concern:

If no concerns are found with the baffle, proceed with using chassis ears on various components and locations of the vehicle to help isolate the area of the concern.
