Service Bulletin

Subject: ABS Service Traction Lamp / Service Stability Message

Models: 2013 Chevrolet Equinox
2013 GMC Terrain
with DTC C0035 and/or C0040 Symptom 18 or 0F

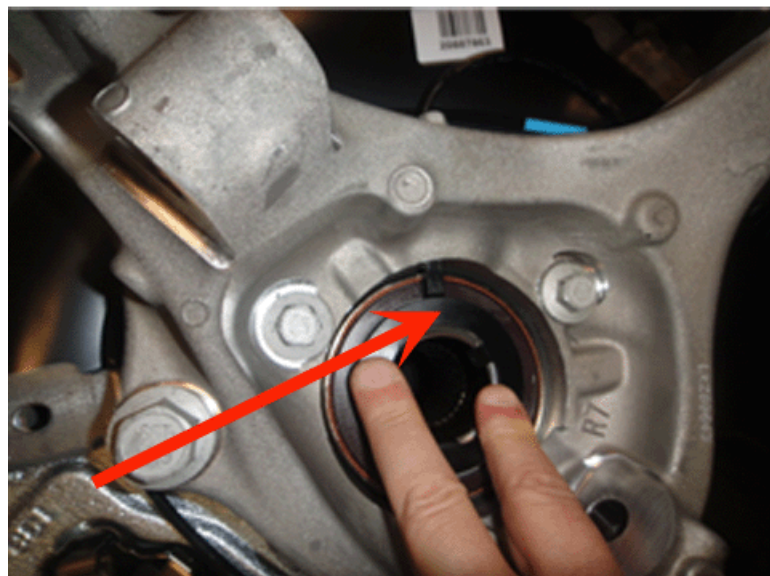
Original washer has a larger diameter and, if off-center, may contact the WSS.

Remove the hub bearing and discard the washer and install Service Washer (GM P/N 11611232). Install the replacement washer, verify the repair with a test drive, and follow published diagnostics for any remaining DTC that may set.

Note: The replacement washer has a smaller outside diameter - diminishing the chance of contacting the WSS.

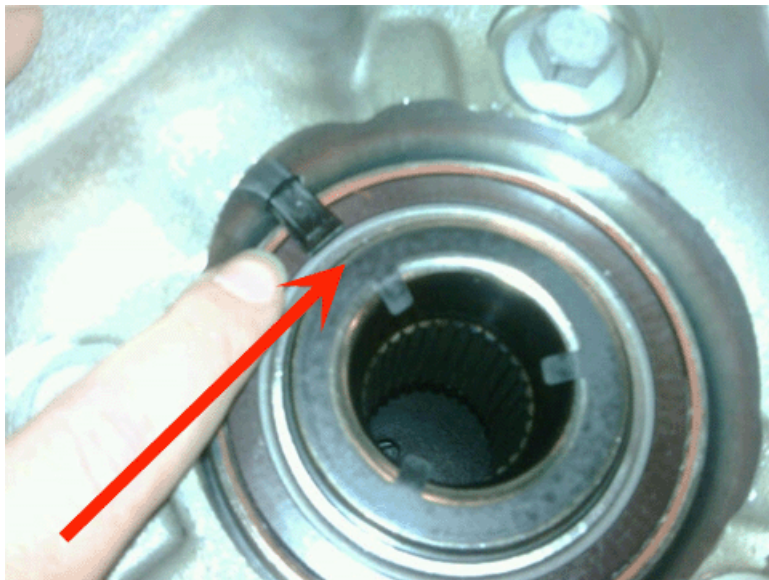
Replacement washer has a smaller diameter.
