Service Bulletin

Subject: Retrofit Procedure for New Corded Folding Top Cover Installation to Original Design Frame

Models: 2011-2012 Chevrolet Camaro Convertible

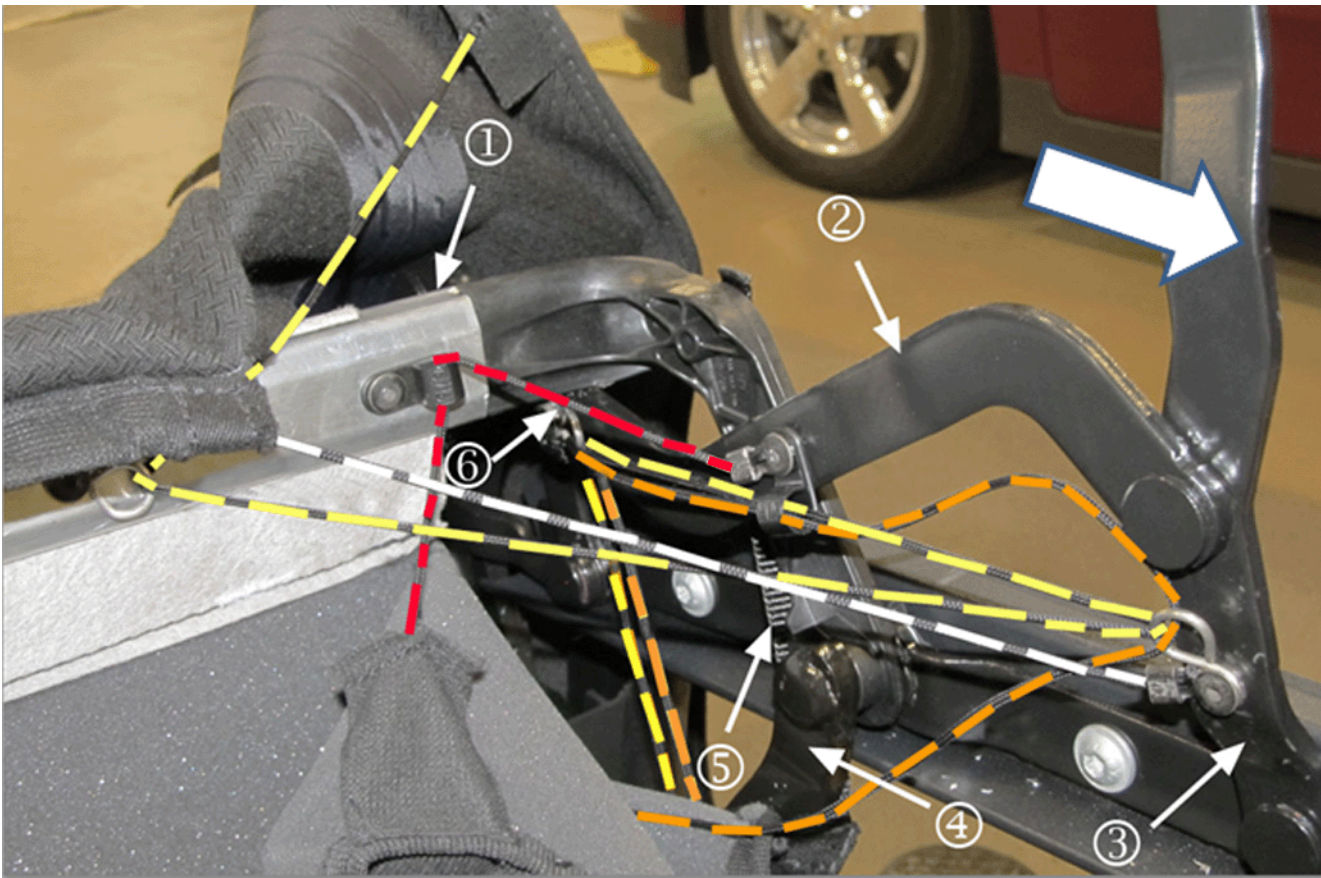
Inboard/Left Side View of Cord Routing and P-Clip, Eyelet and Straps Orientation

Note: The graphics above are views with the top in mid-open position and the right side views would mirror the left. The top frame links and strap callouts referenced later in the instructions are noted in the key below.

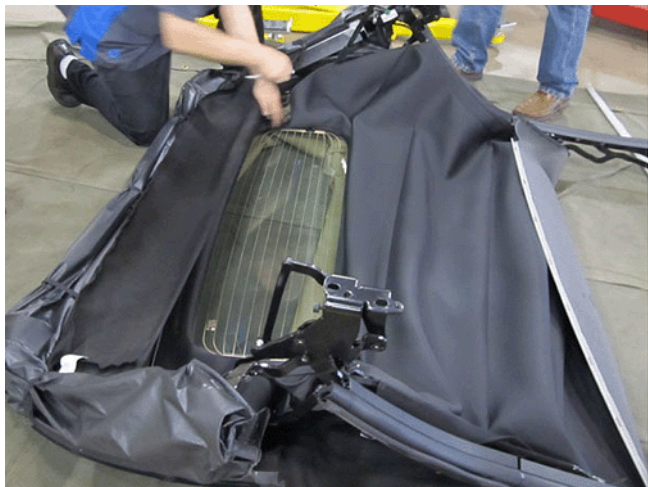
2. Place the convertible top on a clean tarp or other clean, dry, suitable surface with the top cover facing downward as shown above.

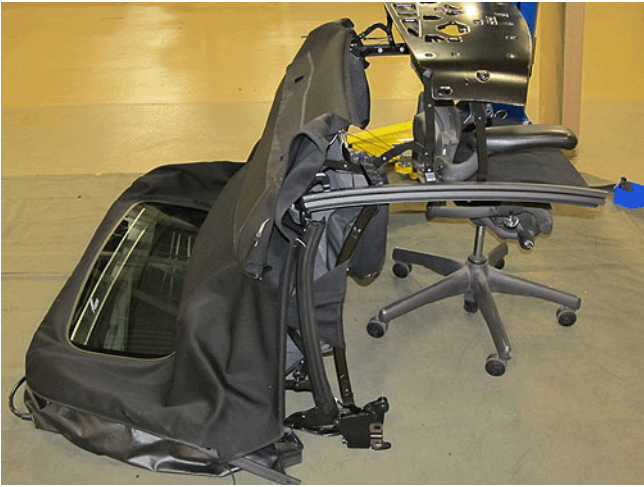
5. Position the folding top on the floor, sitting upright in the mid-open position with the 1 bow supported by a suitable support as shown above.

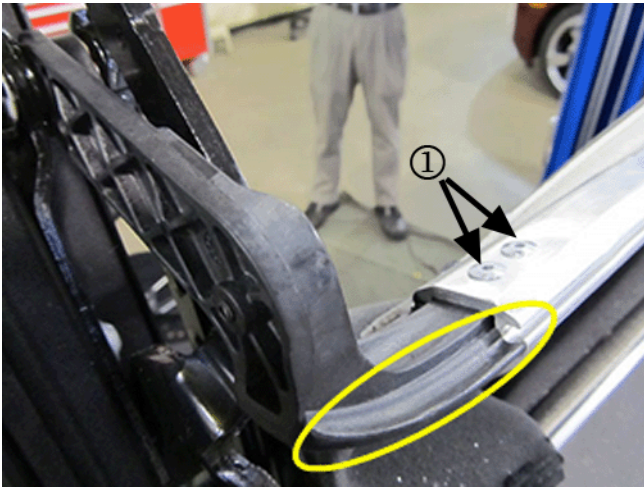
Early Design #2 Bow Bracket

Important: The #2 bow end brackets are made of plastic and will likely break/snap during removal. Two new brackets are included with the top cover replacement kit. Regardless of breakage, all early design #2 bow brackets should be replaced.

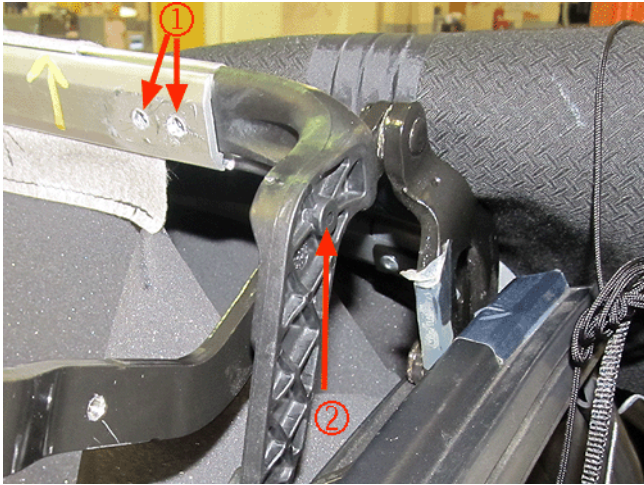
- 10.1. Drill out the rivets (1) that hold the #2 bow brackets to each end of the #2 bow (two rivets per side), and remove the D-link from the headliner cord on each side.

- 10.2. If still attached, slide the headliner retaining bead out of the #2 bow and drill out the rivet (2) retaining the side headliner straps to each side #2 bow bracket.

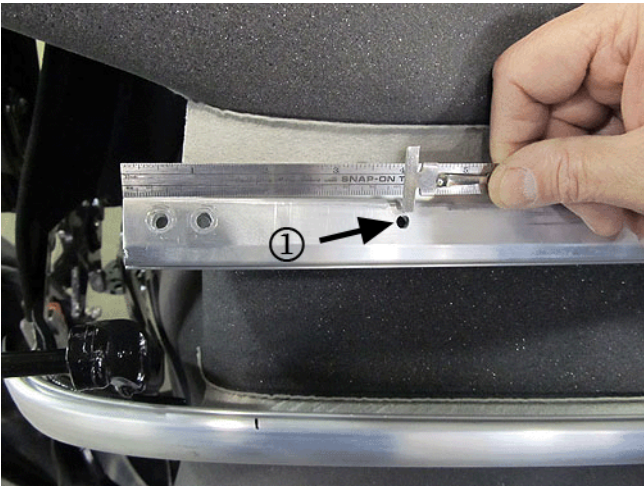
Important: The two holes added to the #2 bow should be centered on the bow and ARE NOT through holes. DO NOT drill through to the topside of the #2 bow.

11. While the #2 bow is removed, drill two 5 mm (0.197 in) holes (1) in the underside of the #2 bow. Position the holes 102 mm (4.0 in) from each end of the bow.

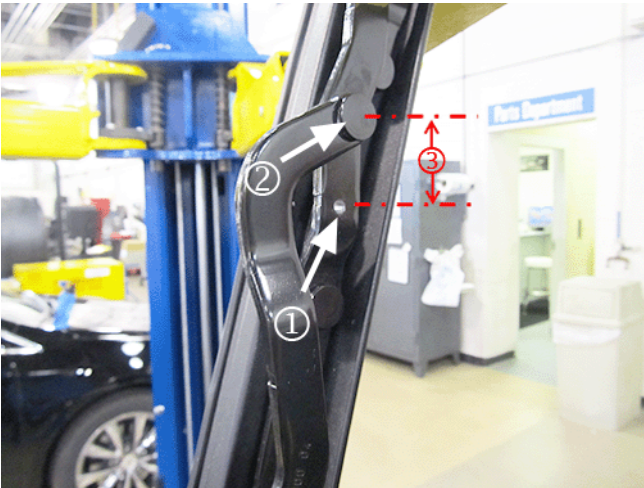
12. Centered on the left rear #1 bow link, drill a 5 mm (0.197 in) hole (1) into the link, positioned 35 mm (1.375 in) (3) from the center of the link pivot (2). Repeat the same operation on the opposite side of the top.

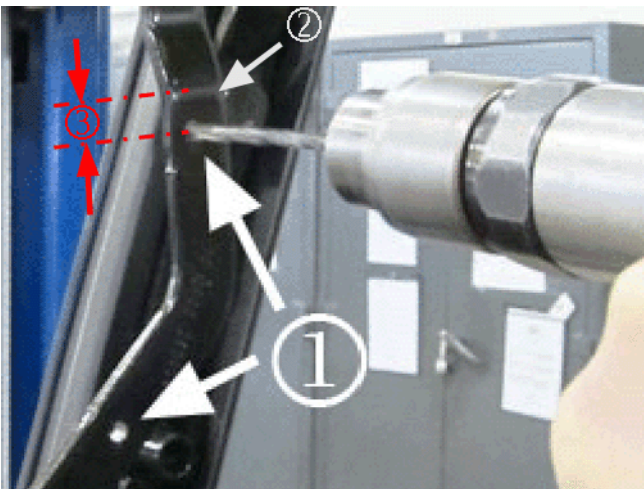
Note: Older convertible tops may be missing the upper 3.2 mm diameter hole shown in the control link above. If the hole is missing, add by drilling a new 5 mm (0.197 in) hole positioned 10 mm (0.40 in) (3) from the bend radius (2). Repeat the same operation on the opposite side of the top.

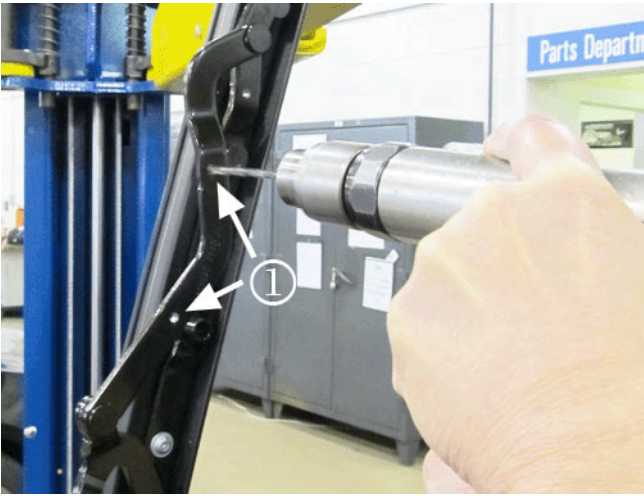
13. Re-drill the two existing 3.2 mm (0.125 in) holes (1) in the left control link to open the diameter up to 5 mm (0.197 in). Repeat the same operation on the opposite side.

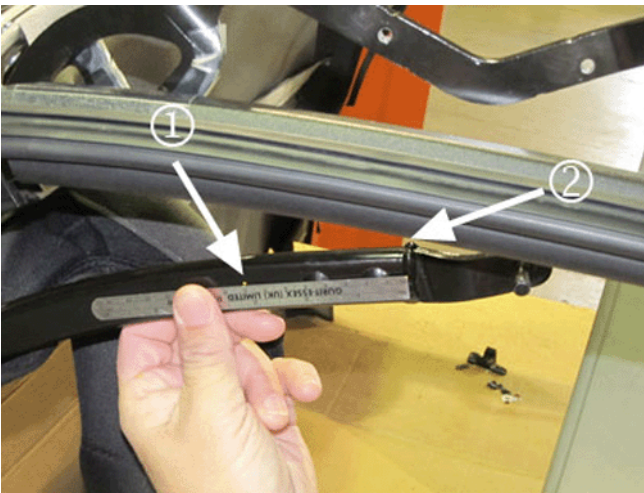
Important: The holes added to the each balance link are on the outboard side of the link and ARE NOT through holes. DO NOT drill through to the inboard side of the balance link. The right side balance link is shown in the graphic above.

14. Centered on the outboard side of the right balance link (1), drill a new 3.2 mm (0.125 in) hole, positioned 80 mm (3.15 in) from the center of weld bead (2). Repeat the same operation on the opposite side.

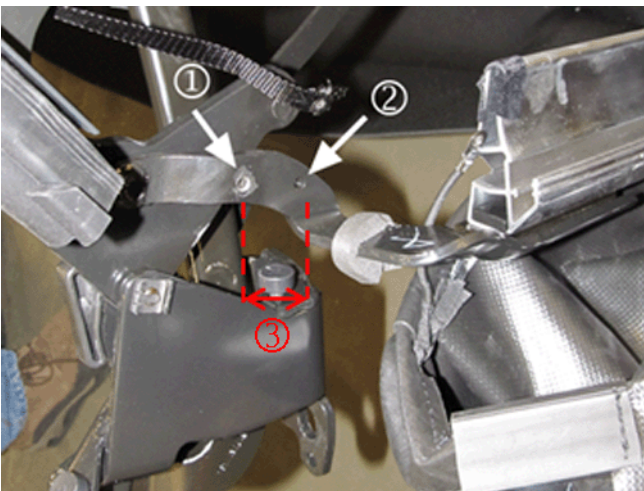
15. The graphic above shows the left #5 bow bracket with the strap and cords removed, and also the orientation of the new hole (1) and existing hole (2) for illustration purposes only.

15.1. Drill a 5 mm (0.197 in) hole into the left and right #5 bow brackets, positioned 30 mm (1.12 in) (3) from the hole where the rear headliner strap and water management bag cord are attached.

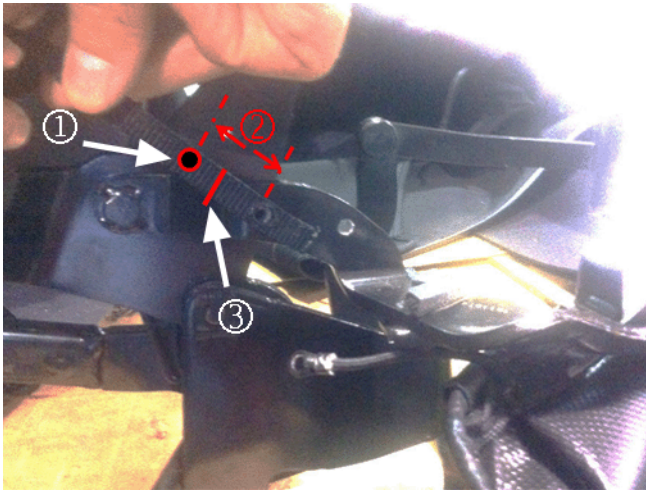
15.3. The graphic above shows the headliner strap, which is attached to the 5 bow bracket. If the top being retrofitted does not have a new 5 bow bracket equipped with the new hole, then using a hot mandrel, or equivalent tool, burn a new hole (1) into the headliner strap. As shown above, locate the new hole 30 mm (1.20 in) (2) from the current location, then cut the reworked headliner strap at call out #3.

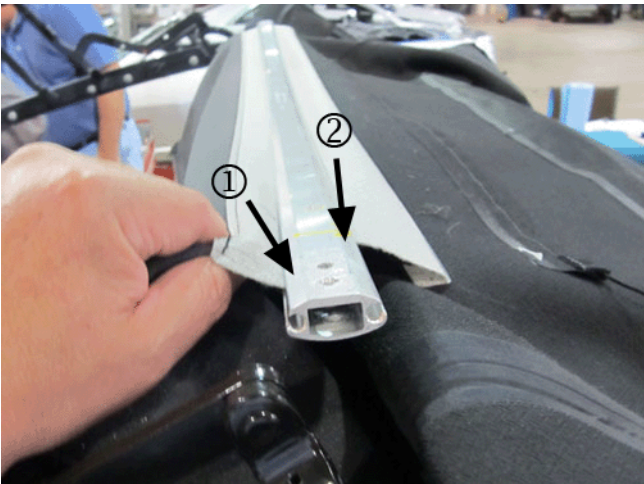
Note: As marked during the removal earlier, the headliner bead goes in the rear #2 bow slot (1) and the top cover bead goes in the front #2 bow slot (2).

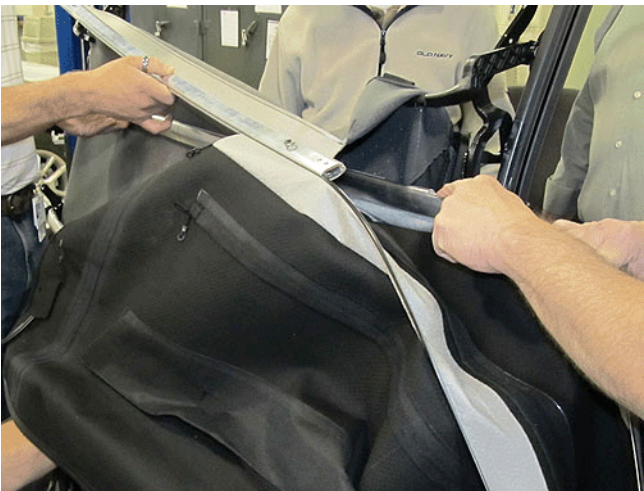
19. Slide the reworked #2 bow onto the headliner and new top cover beads **at the same time** as shown above.

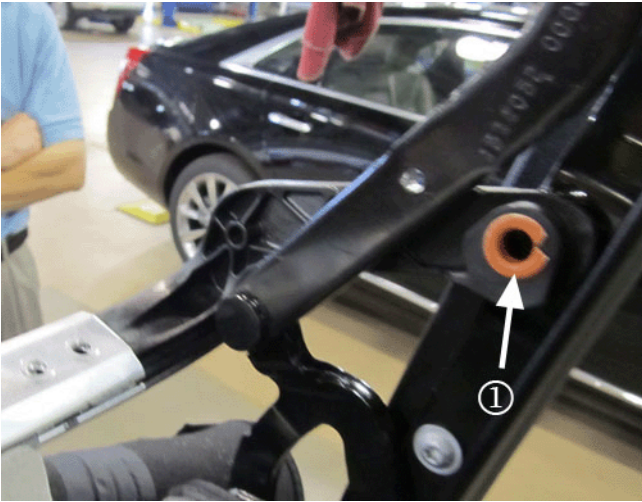
20. Reassemble the #2 bow bracket bushings (1), new plastic thrust washers, then the retaining clips. With the aid of an assistant, install the #2 bow brackets to the #2 bow, while simultaneously angling the brackets into position on the linkage on each side.

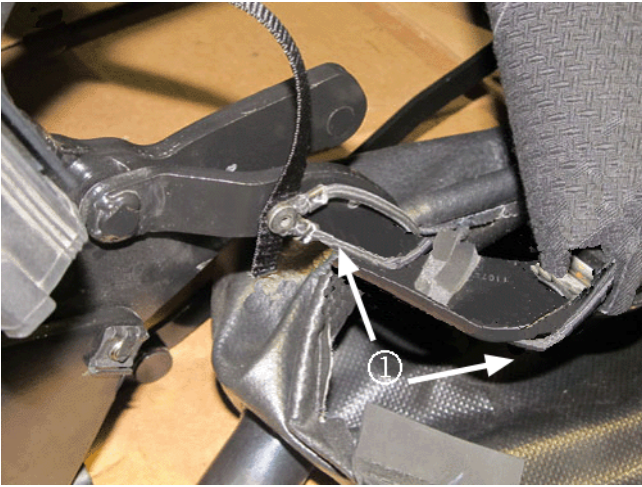
Important: Ensure that the top cover #5 bow bracket cord (1) is routed underneath the bracket.

23. Rivet the new top cover #5 bow bracket cord (1) to the new holes on the left and right #5 bow brackets, along with the water bag cord and the headliner control strap as shown above.
24. Install the rear window pivot bracket nuts, connect the defogger connectors, reinstall the headliner bead around the rear window, and secure the top cover to the #5 bow. Refer to Folding Top Cover Replacement in SI.
25. Reroute the side tension cables through the rear side rail, rear weatherstrip and top cover on each side following the steps below. If additional detail is needed, refer to Folding Top Cover Side Tension Cable Replacement in SI.

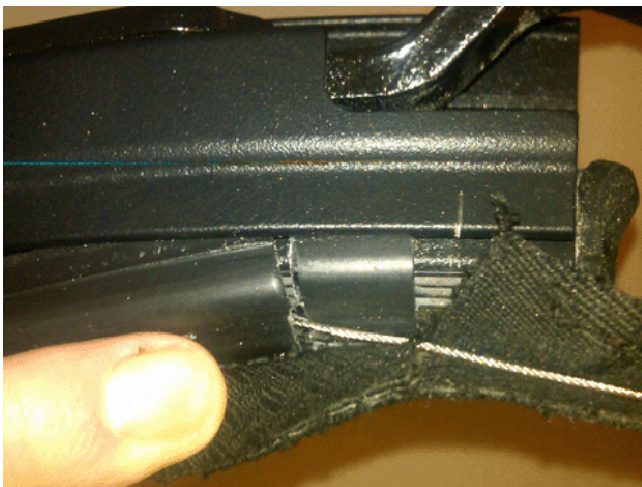
Note: The design of the top cover plastic retainer has changed slightly on the new corded top covers. The plastic retainer on the previous top covers had a slit near the end that allowed the side tension cable to pass through it as shown above.

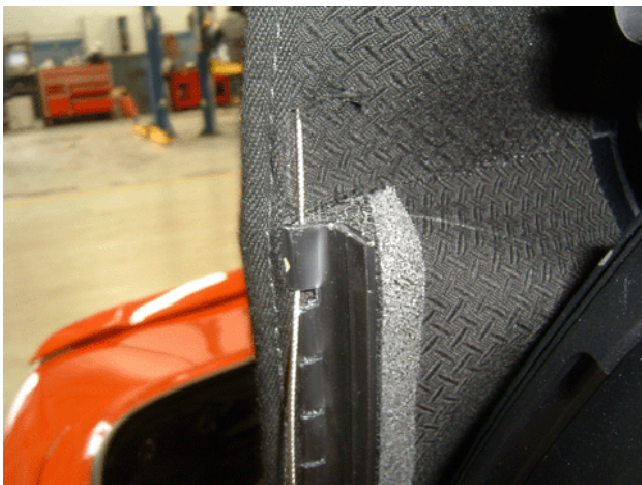
Instead of a slit in the plastic, the retainer now has a large square hole at the very end, which is large enough to allow the cable anchor to pass through it. The retainer and square hole can be seen in the graphic below.

- 25.1. Starting on the left side, route the side tension cable through the backside of top cover edge plastic retainer as shown above.
- 25.2. Next, route the cable through the small hole in the left side rail weatherstrip. It should run from the outside of the weatherstrip to the inside so that the cable is hidden, and it runs alongside the metal side rail itself.

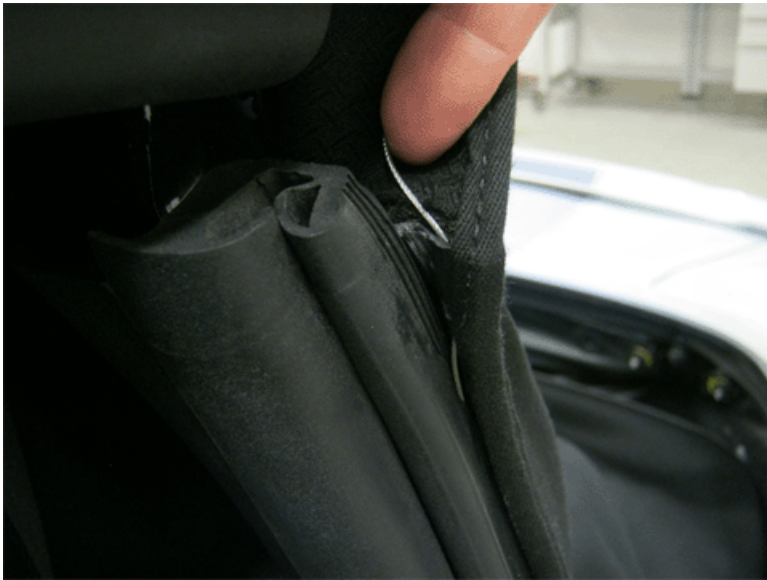
Note: The graphic above shows the correct routing of the side tension cable once everything is reinstalled.

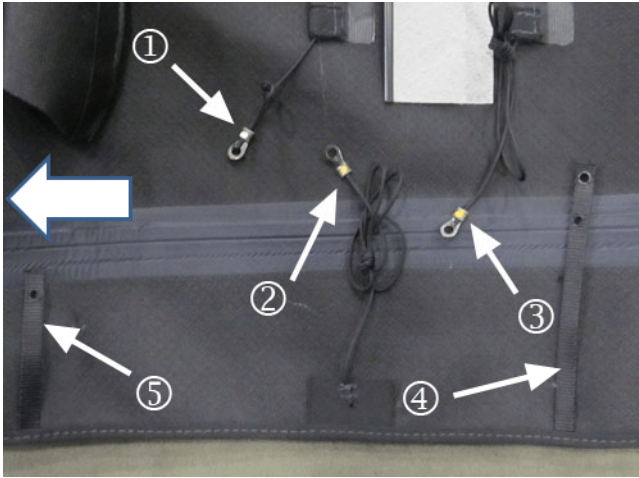
Note: The three cords added to each side of the top cover are color-keyed with paint dots on the cord eyelets. The orientation of the three colors white (1), yellow (2) and orange (3), along with the rear (4) and front (5) control straps, are shown above. The following steps will reference them as the white, yellow or orange control cords.

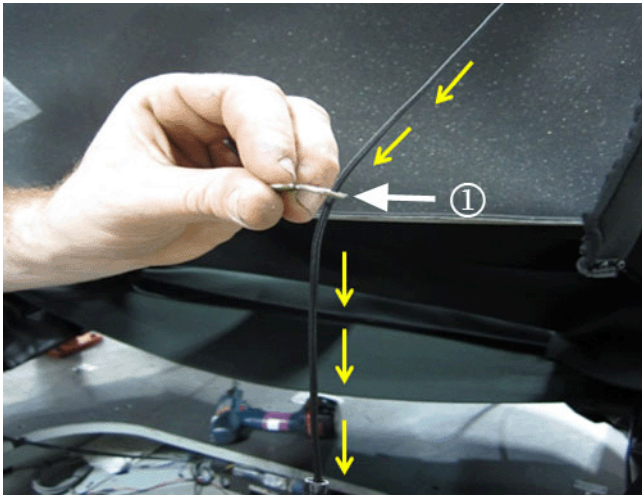
29.2. Route the cord downward through the large eye loop (1) with the eye loop angled downward as shown above.

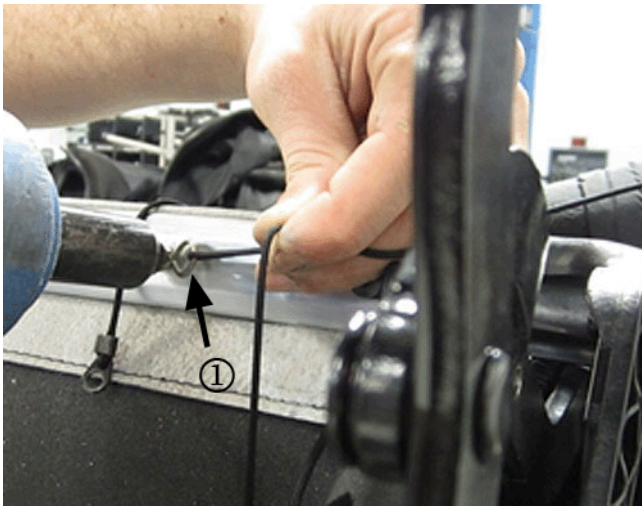
29.3. Install the rivet on the #2 bow through the small eye loop hole with the large eye loop hole (1) aimed outboard as shown above.

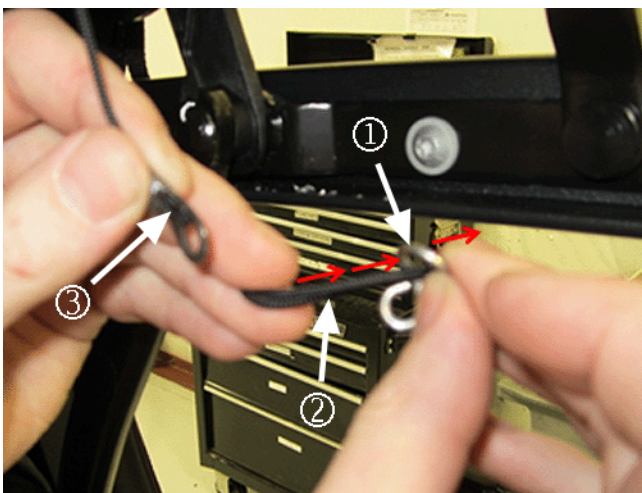
30.1. Holding the eye loop (1) with the 75° bend angled upward, route the yellow (2) and orange (3) top cover control cords down through the large eye loop opening.

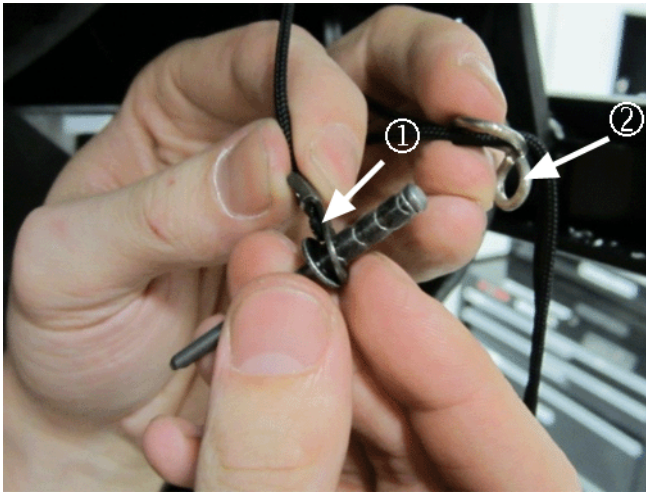
30.2. Grab the eyelet on the end of the white top cover control cord. Put the eyelet (1) on the new rivet, then add the eye loop (2) through the small hole of the 75° bend eye loop.

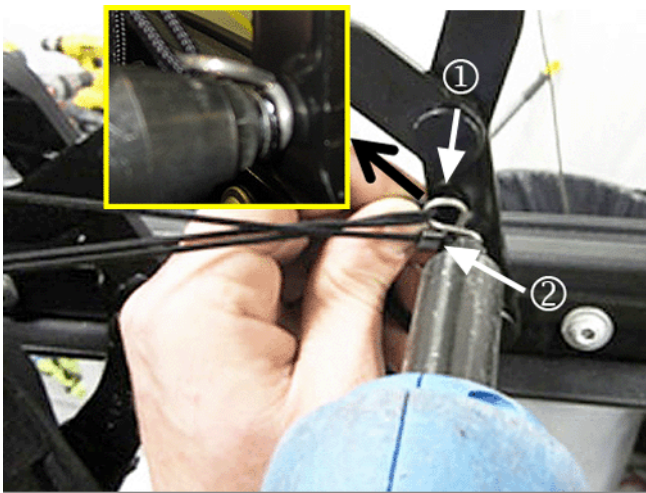
30.3. Install the rivet to the rear #1 bow link with the 75° bend of the large eye loop angled inboard (as shown in the inset above) and the orientation of the eye loop (1) and the cord eyelet (2) as shown.

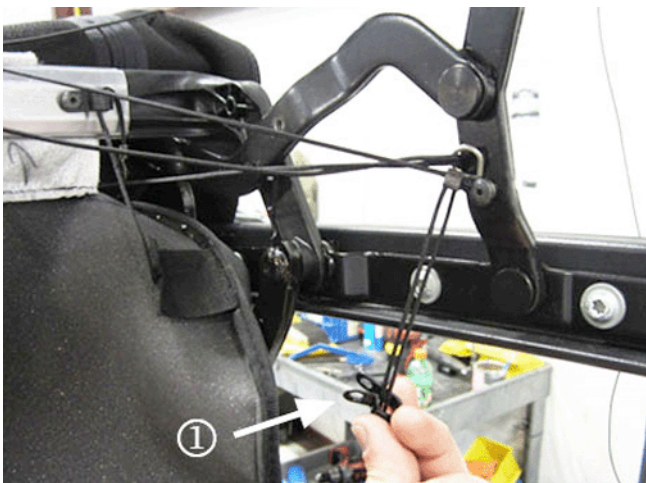
31.1. Grab a new P-clip (1) and route the yellow and orange control cords through the P-clip as shown above.

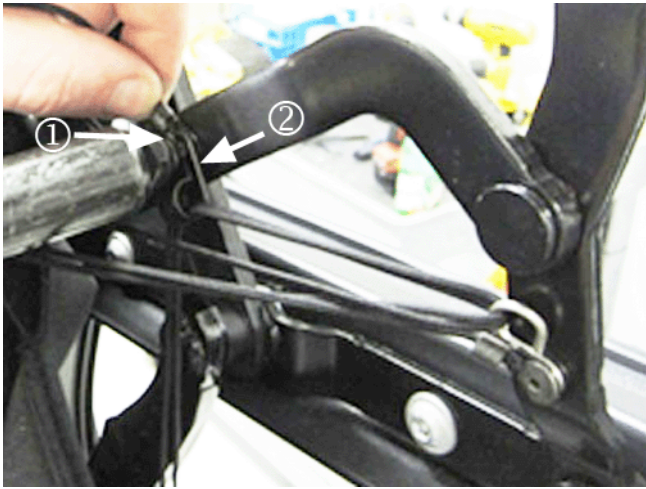
31.3. Install the rivet to the control link with the orientation of the cord eyelet (1) and the P-clip (2) as shown above.

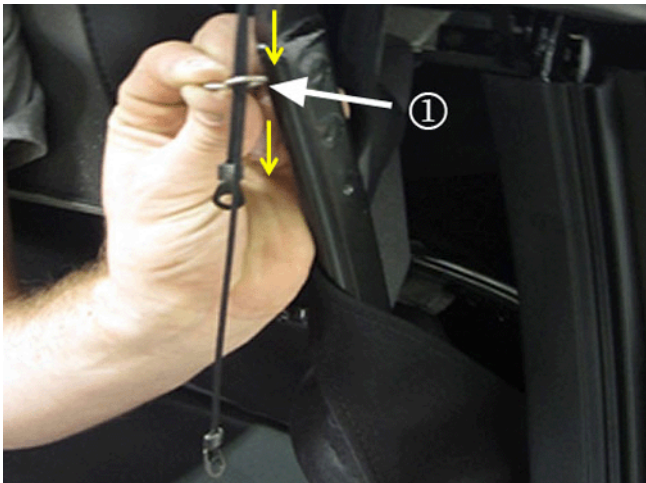
32.1. Route the yellow and orange control cords down through the large hole in a new eye loop (1) with the eye loop angled upward as shown above.

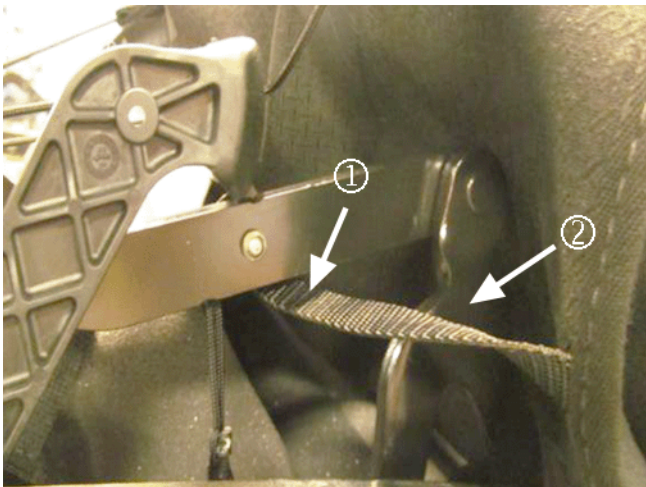
Important: Verify that the rear strap (1) of the top cover is routed under the side link and is not hung up behind, but is clear of, the wishbone link (2) as shown above.

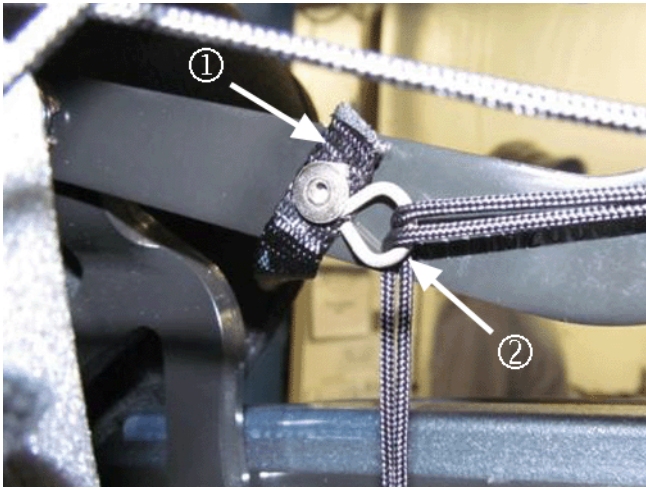
32.2. Insert a new rivet through the small opening in the eye loop (2), then through the strap (1) with the orientation of the eyelet and the strap as shown in the graphic above.

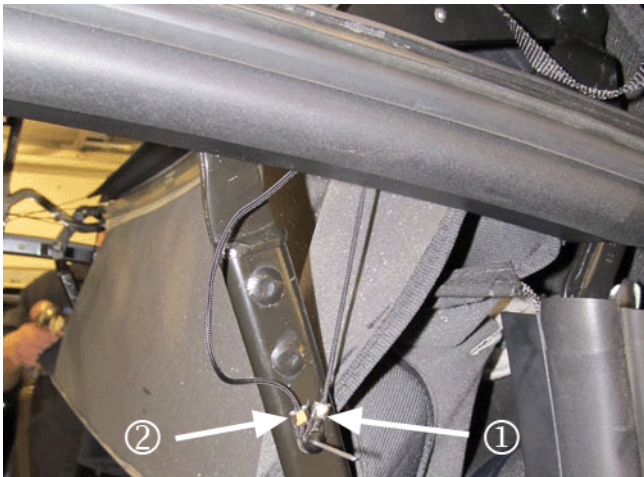
33.1. Insert a new 3.2 mm (0.125 in) rivet through the end eyelets on first the yellow (1), and then the orange (2), control cords.

33.2. Attach the rivet to the hole in the balance link as shown above.

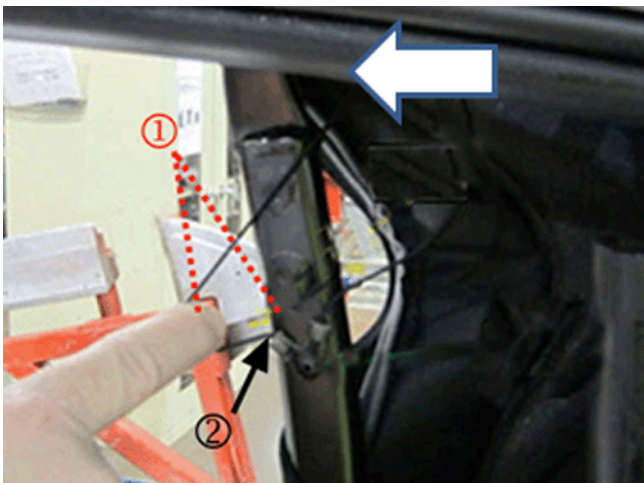
- 34.1. Cycle the top to the half open position.
 - 34.2. Locate the second pocket control cord with the orange paint dot on the eyelet (2), which is the longer of the two cords riveted to the balance link.

- 34.3. With your index finger, pull the cord forward, taking out the slack.
 - 34.4. When the cords are even from side to side, there will be a gap of about 25 mm (1.0 in) (1) between your finger and the balance link as shown above. If the gap is less than an inch, reach into the top cover and gently pull the cord towards you, then recheck the gap. Noting the gap on one side, go to the other side of the top and repeat the process. Repeat this process from side to side until the gaps are equal.

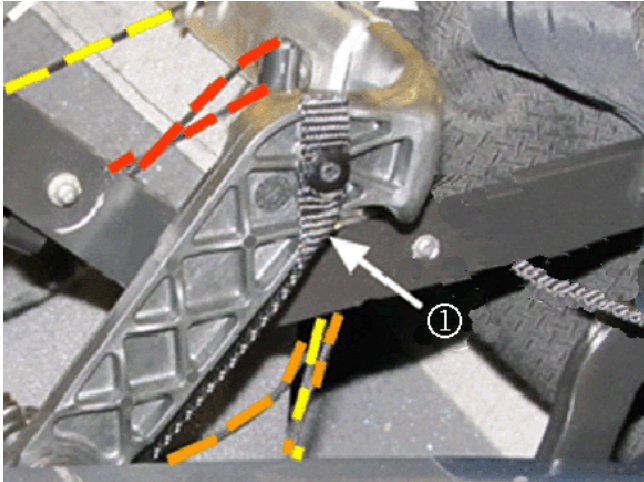
Important: Ensure the headliner strap is routed under, and towards the backside of, the #2 bow bracket.

- 35.1. Install the side headliner strap (1) to the left and right #2 bow brackets.

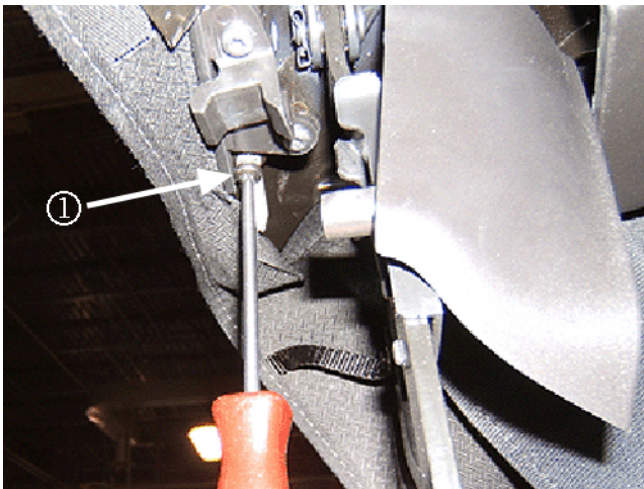
- 35.2. Install the tension cable spring and retaining screw (1) to both sides of the #1 bow.

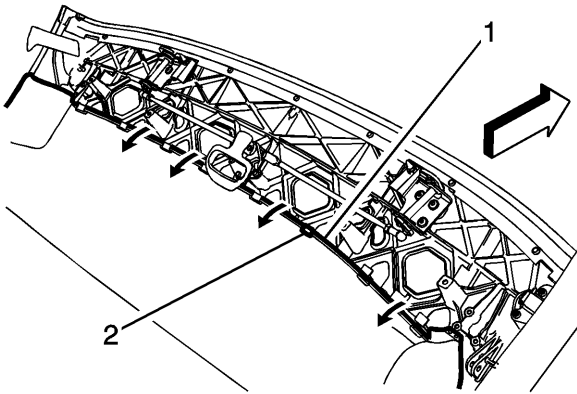
35.3. Install the headliner (1) to the #1 bow retainers (2) across the inner lower edge of the bow.
