Service Bulletin

Subject: Heated Seat Indicator Lights Momentarily When Activated / Heated Seats Inoperative / DTC U1524 Stored

Models: 2013 Cadillac SRX

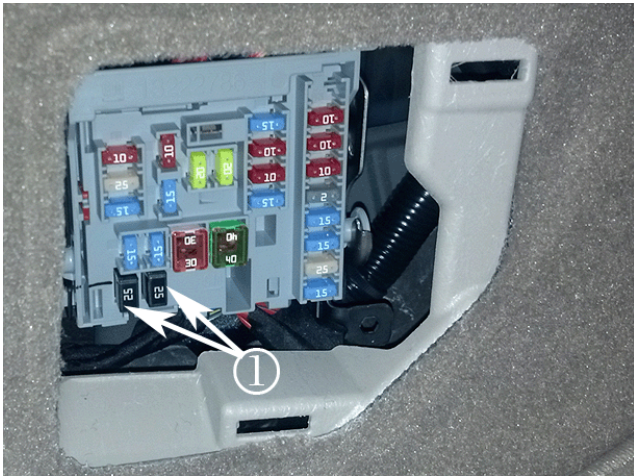
To resolve the condition, remove both 25 amp heated seat circuit breakers (1) from the instrument panel fuse panel as shown in the graphic below. The I/P fuse panel is located on the right side of the center console. Wait at least 30 seconds before reinstalling the circuit breakers.

This action will remove power from the heated seat control module and reset the heated seat control module correcting the condition. While the initial cause of this concern is under review, the condition does not appear to return after the module is reset.
