# Technical Service Bulletin

## 58B9 UPDATE – Door Seal (NVLW)

58 12 04 2031094/1 October 2, 2012.

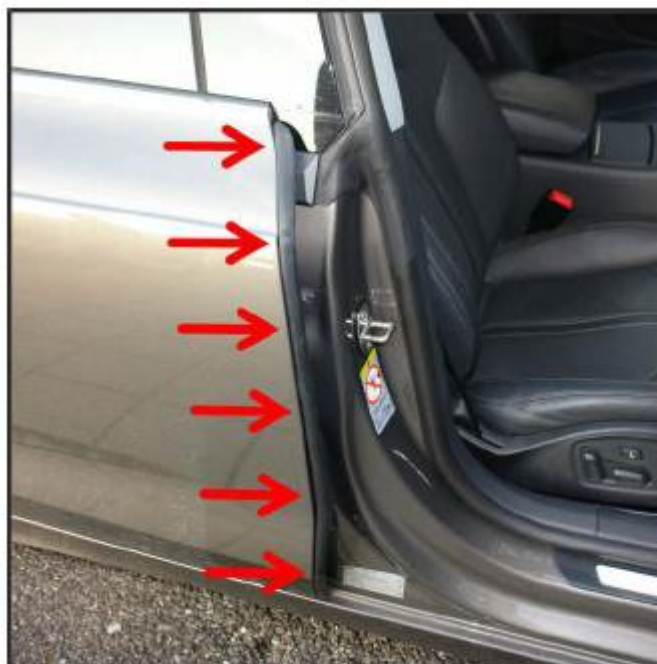
The door seals between the front and rear doors were omitted on Audi A7 vehicles manufactured within a specific period.

*Figure 1. Fit door seal along this edge, on both sides.*

1. Clean edge of door (e.g. with cleaning solution D 009 401 04).

2. Fit door seal along edge of rear door, on both sides of vehicle, as shown in Figure 1.
