Technical Service Bulletin

55 Rear Trunk Lid is Difficult to Close

55 12 25 2030373/2 October 10, 2012. Supersedes Technical Service Bulletin Group 55 number 12 – 22 dated July 27, 2012 for reasons listed below.

Model(s)	Year	VIN Range	Vehicle-Specific Equipment
A6	2012, 2013	All	Not Applicable

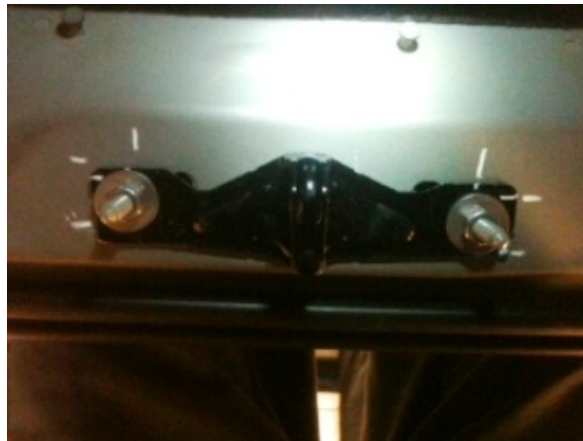
2. Mark the original position of the striker relative to the body. Use this position as a reference of the original position for adjustments (Figure 1).

Figure 1. Striker position relative to vehicle marked in white lines.

3. Reposition the Striker mechanism and check the operation of the rear lid.
4. Check for correct latching of the rear trunk lid by opening/closing the rear lid.
