Service Bulletin

Subject: Exhaust Rattle Noise

Models: 2011-2012 Chevrolet Camaro Convertible
Equipped with V8 L99 Engine

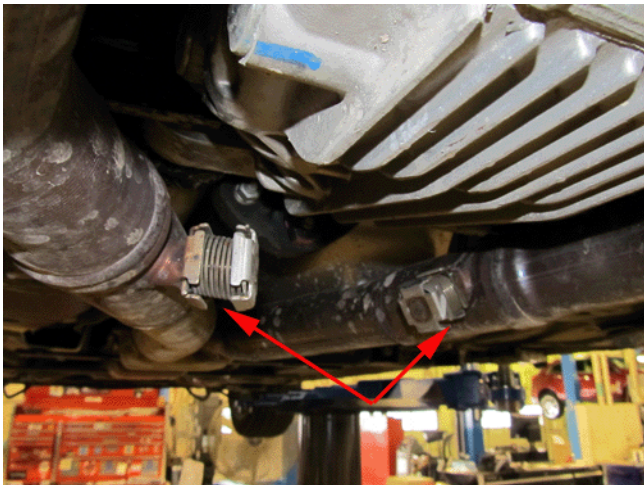
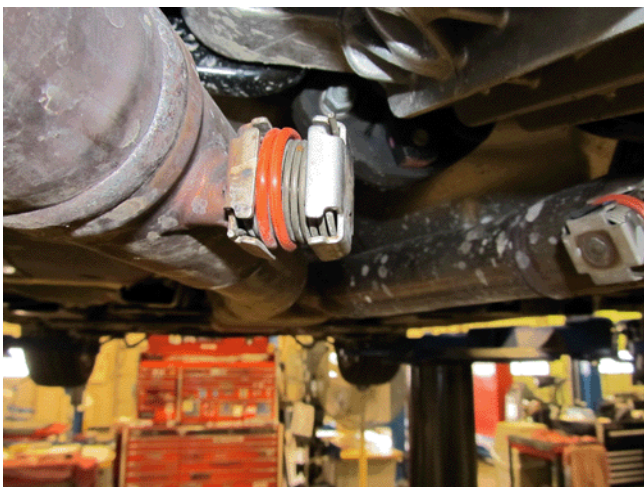
Some customers may comment on an exhaust rattle or noise when at idle or slow vehicle speeds up to 1300 engine rpm. The spring in the exhaust valve may be causing the exhaust to rattle or make noise.

Technicians should follow the procedure below and install two silicone O-rings over each of the exhaust valve springs to dampen the rattle.

1. Raise the vehicle.
2. Install two O-rings onto the left exhaust valve spring.
3. Install two O-rings onto the right exhaust valve spring.
4. Lower the vehicle.
