### Exhaust Gas Recirculation (EGR) Valve Oil Supply Line

VN, VHD, VAH  
D11H

## FSB 293-016, Exhaust Gas Recirculation (EGR) Valve, Oil Supply Line

(November 2012)

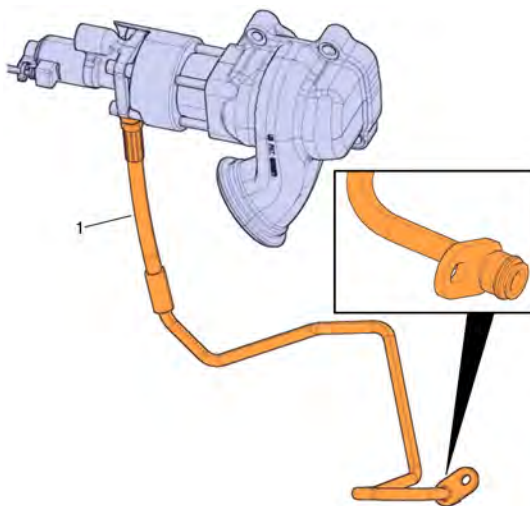
W2077816

VOLVO Truck chassis built prior to AUG 14 2012 with D11H (US10 emissions) engines built prior to engine serial number 547267 were assembled with Exhaust Gas Recirculation (EGR) valve oil supply line (part number 21183591) with the formed tube fitting. The old EGR valve oil supply line with the formed tube fitting is now replaced by the new oil supply line (part number 21544061) with the machined fitting brazed onto the end of the tube to prevent oil leaks at the oil filter housing.

**Note:** The existing supply line has the retaining plate swedged onto the tube. The new supply line has a brazed fitting and a floating retaining plate.

**Note:** Do not replace the EGR valve oil supply line unless there is an oil leak in the oil supply line fitting at the oil filter.

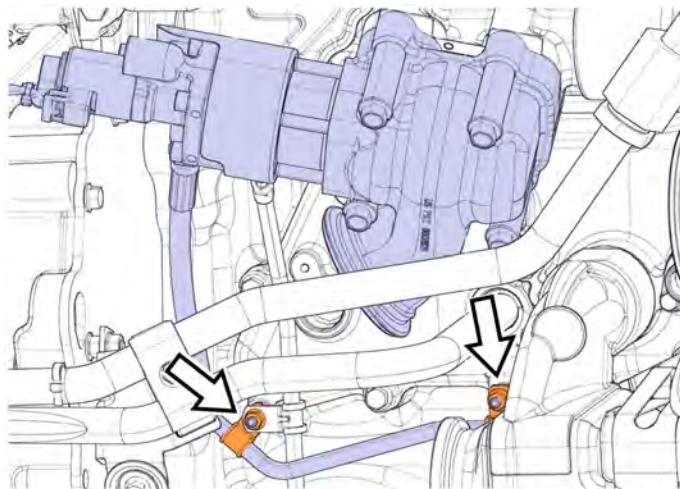
W2077822

17 Remove P-clamps from oil supply line.

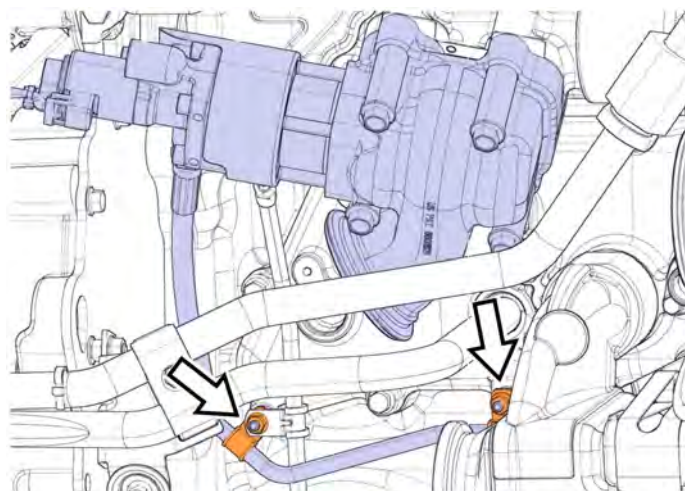
W2077822

21 Loosely install P-clamps on oil line and connect oil supply line fitting at EGR valve.
