EMISSION RECALL BULLETIN

Subject: **Emission Recall 12C3**
EPA07/EPA10 DD13 Emission Labels In Cascadia 113" Day Cab
Chassis

Emission Recall Bulletin 12C3

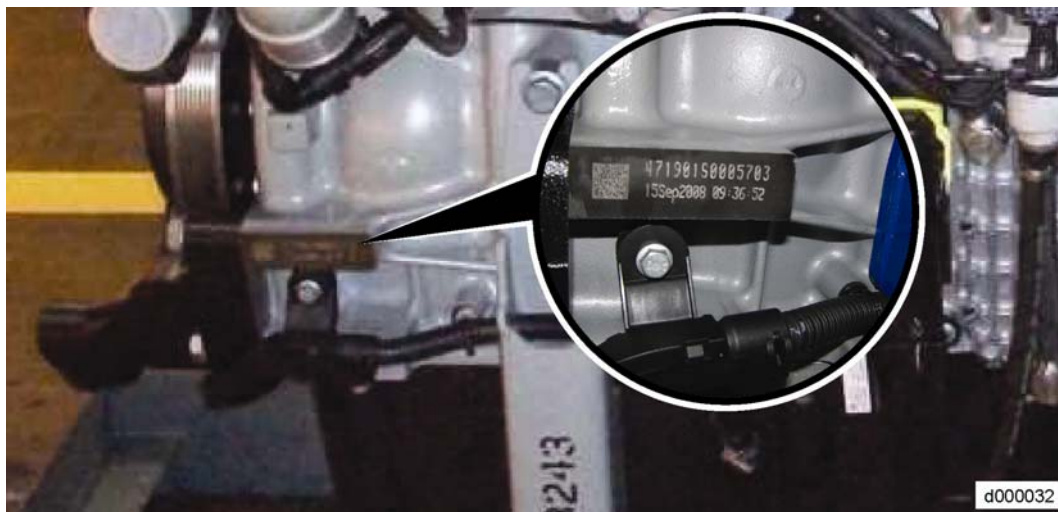
Figure 1- Engine Serial Number Location on Engine Block

1. Apply the parking brake, chock the wheels, and perform any other applicable safety steps.
2. Compare the serial number on the secondary emission label with the engine serial number stamped on the left front corner of the engine block. Refer to Figure 1 to locate the engine serial. If the engine serial number and the serial number on the label match proceed to step 3. If the engine serial on the block and the label do not match, then do not install the label. Please call the Detroit Customer Support Center at 1-800-445-1980 for further assistance.

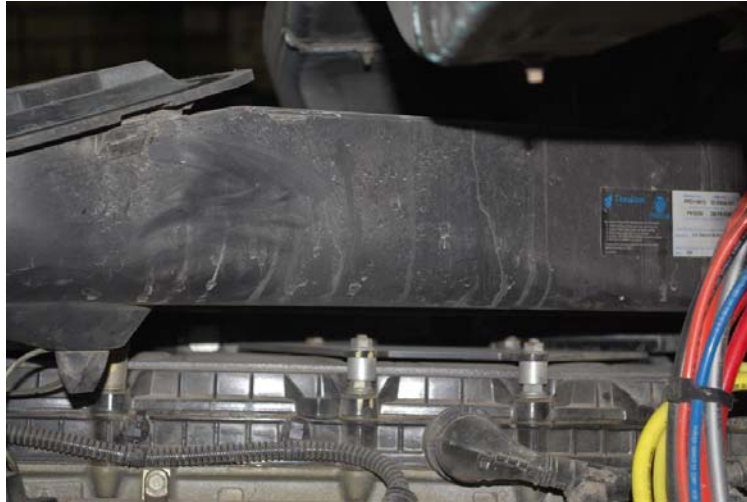
Figure 2 - Left Side Engine Air Filter Housing

3. Use a suitable cleaner to clean dust, dirt, grease or oil from an area on the side of the air filter housing large enough to accommodate the secondary emission label. Use rubbing alcohol as a final wipe to remove any residue that might inhibit the label from adhering. Do not use Brake-Kleen or a similar solvent for the final cleaning. Refer to Figure 2.

4. Allow the cleaned surface to dry completely.
5. Peel a portion of the backing from the label and stick it on the cleaned area of air filter housing oriented so the print is vertical to permit ease of reading the label. Slowly peel the backing off of the label while smoothing it onto the engine air filter housing. NOTE: do not attempt to remove the label once it has adhered to the housing. Label is intended to be destroyed if removal is attempted.
6. Installation is complete; remove the wheel chocks and return the vehicle to service.
