# A/C Inoperative and/or High Engine Temperature at a Stop

**Service Category** Engine/Hybrid System

**Section** Cooling

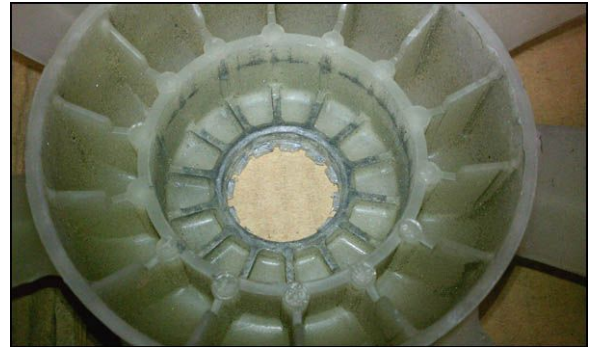
Figure 1.

1. Confirm the condition per the Introduction.
2. Inspect the radiator cooling fan blades for separation from the cooling fan motor.

Are the fan blades separated?

- **YES** — Go to step 3.
- **NO** — This bulletin does NOT apply. Continue diagnosis per the Repair Manual.

3. Replace the A/C amplifier.

4. Replace the cooling fans.
