Service Bulletin

Subject: Exhaust Rattle Noise

Models: 2011-2012 Chevrolet Camaro Convertible
Equipped with V8 L99 Engine

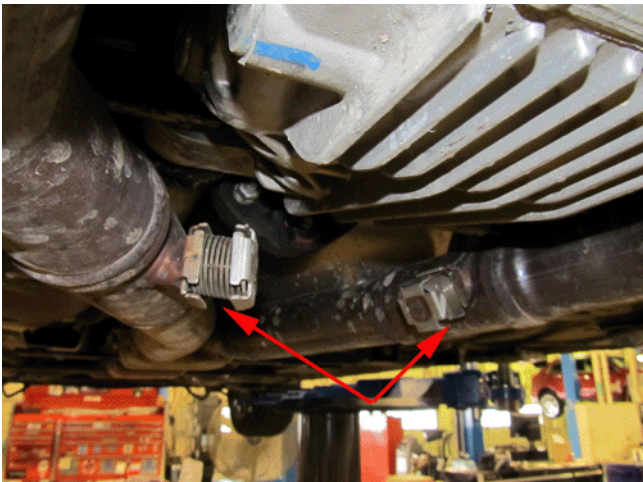
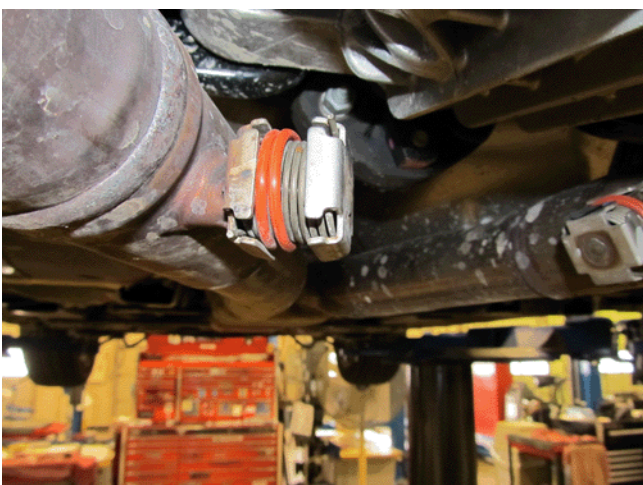
The spring in the exhaust valve may be causing the exhaust to rattle or make noise.

Technicians should follow the procedure below and install two silicone O-rings over each of the exhaust valve springs to dampen the rattle.

1. Raise the vehicle.
2. Install two O-rings onto the left exhaust valve spring.
3. Install two O-rings onto the right exhaust valve spring.
4. Lower the vehicle.
