October 2012 Technical Service

# State of Charge Not Displayed in Instrument Cluster

F30 (ActiveHybrid 3)

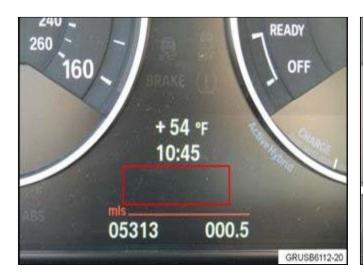
The high-voltage battery state of charge is not visible in the Instrument Cluster when called up through the Board Computer (BC). This condition may be present intermittently.

State of charge display not present.

State of charge display present.

**DO NOT** replace any parts or perform any programming. Do a PIA reset (personal profile) using Service function "AS6510\_CICCKM-Deleting Personal Profile" in ISTA/D. The path to the service function is shown below:

Service function / 03 Body / Headunit / Start search / AS6510\_CICCKM-Deleting Personal Profile
