SI M33 01 12  
Rear Axle

### Adjusting Rear Camber

R60

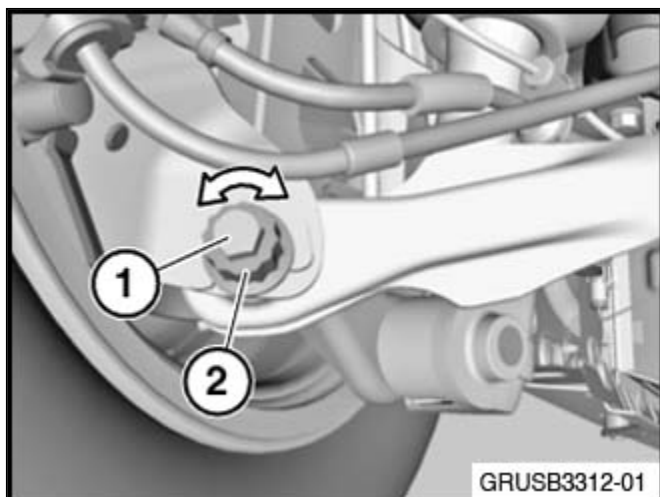
Rear camber cannot be adjusted properly.

Repair instructions not followed properly

Failure to follow these steps may result in damage to the adjustment bore in the rear trailing arm.

Follow these steps when adjusting the rear camber:

- Raise the rear axle (tire spin-free).
- Loosen the lock bolt (1).
- Turn the eccentric adjuster (2) to full positive (large portion of eccentric points down).
- Slightly tighten the lock bolt (1).
- Lower the axle and compress suspension.
- Slacken the lock bolt (1) and adjust the camber (2).
- Tighten down the lock bolt.

This procedure can be found in Repair Instruction 32 00 620, "Adjusting rear axle."
