Technical Service Bulletin

SUBJECT:			No:	TSB-12-42A-003
			DATE:	October, 2012
FENDER – SERVICE MANUAL REVISION			MODE	L: 2013 Lancer Evolution
CIRCULATE TO:	[] GENERAL MANAGER	[X] PARTS MANAGER		[X]TECHNICIAN
[X] SERVICE ADVISOR	[X] SERVICE MANAGER	[] WARRANTY PROCESS	OR	[] SALES MANAGER

The front fender removal and installation illustration is incomplete in the service manual. This TSB provides the missing information.

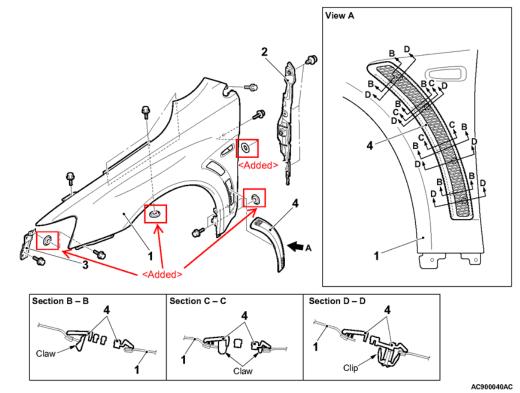
REMOVAL AND INSTALLATION

Removal steps

<<A>>> >> > > > 1. Fender

- 2. Fender protector rear
- 3. Front fender bracket
- 4. Front fender garnish

<<A>> FENDER REMOVAL

1. Remove the fender protector rear assembling clip.
