**Notice of Replacement Part  
42036, 42037  
Seat & Cover Kit**

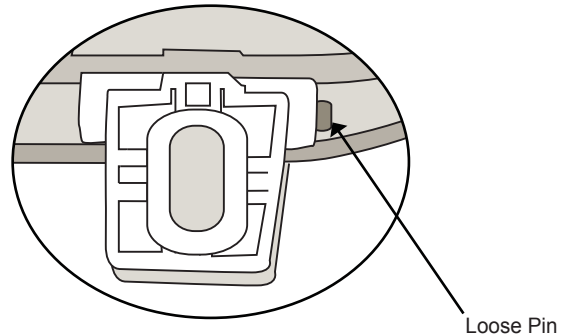
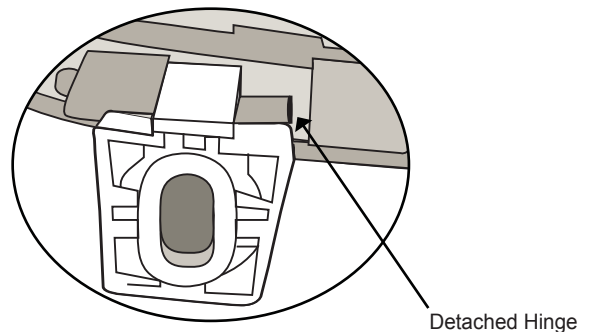
**Pin / Hinge Examples**

Between 05.01.12 and 08.08.12 improper assembly of Seat and Cover Kit 42036, 42037, 42178, 42179 occurred.

**Warning!** Problem can result in pins falling out and hinge becoming unattached to the seat and/or cover causing personal injury.

Replace the seat and cover assembly under a warranty claim using the warranty replacement part numbers listed below. **Problem should NOT be repaired-replace the part!** Order appropriate kit specified below.
