EL12-072

2011-2013 QX56; DOOR MIRROR CLICKING NOISE - OK

APPLIED VEHICLES: 2011-2013 QX56 (Z62)

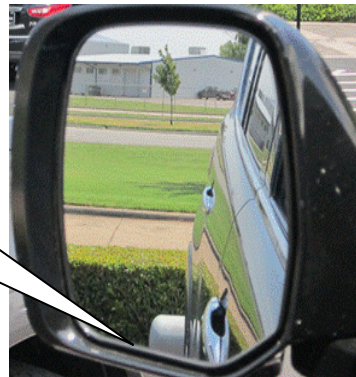
The "Reverse Tilt-Down" feature will move the glass on the outside mirrors downward when the gear selector is placed in the Reverse (R) position. As the mirror glass moves downward, it may reach the end of its travel. If the mirror glass reaches the end of its travel it will make a clicking noise. The clicking noise may occur once or multiple times.

Door mirror will make a clicking noise when it reaches the end of its travel.

- The clicking noise described above is a normal function of the mirror glass movement.
- **Do not replace the door mirror assembly in an attempt to repair this normal function.**
