Service Bulletin

Bulletin No.: PIC5252A

Subject: Diagnostic Tip - Ignition Lock Cylinder Removal Procedure

Models: 2008 - 2013 Cadillac CTS models

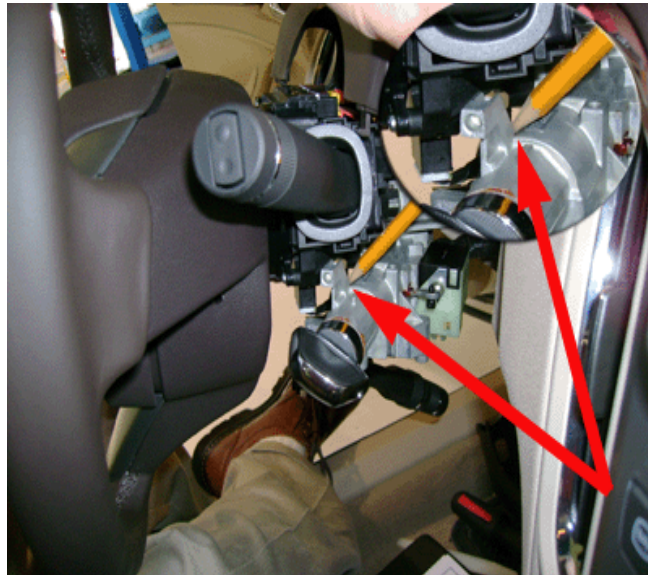
2353151

Refer to the picture below to locate the release hole. Notice that the hole is hidden behind the land on the lock cylinder housing which makes it hard to locate with the column in vehicle.

1. Turn the ignition lock cylinder to the RUN position.
2. Push a pick-type tool, or the small side of a 1mm allen wrench into the access hole on the ignition and start switch housing, and press the lock tab on the ignition and start switch housing down.
3. Pull the ignition lock cylinder out of the ignition and start switch housing.
