Technical Service Bulletin

30 Clutch pedal makes noises when pressed

30 12 16 2032224/1 December 21, 2012.

Model(s)	Year	VIN Range	Vehicle-Specific Equipment
S4	2010-12	All	0B5 S-Tronic transmission
S5 Cabriolet	2010-12

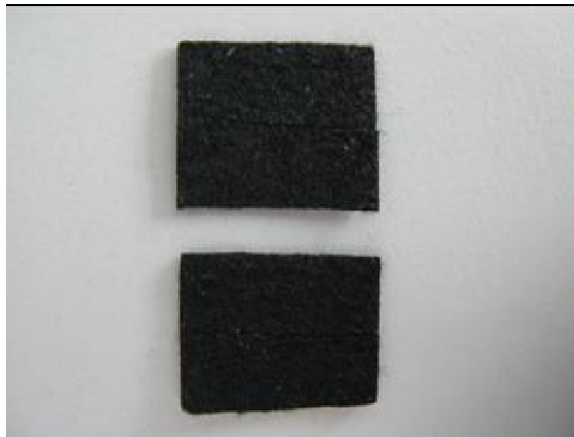
Figure 1. Felt pieces.

- From part number: **533 867 910 A** cut two felt pieces 16mm long. (Figure 1)

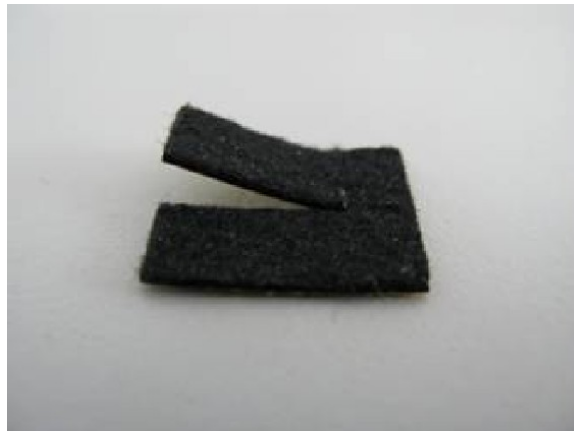
Figure 2. Cutting felt.

- On the short side cut into the felt pieces to approximately half the length (Figure 2)

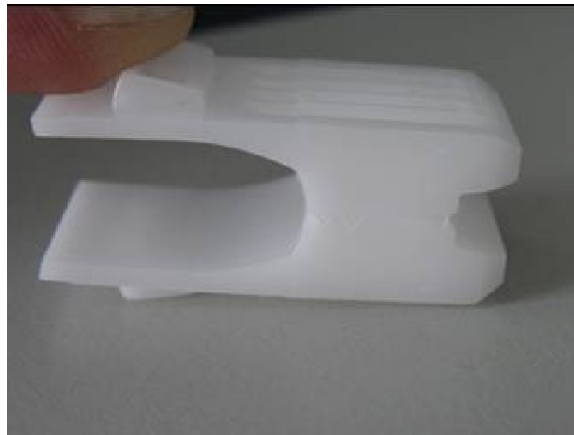
Figure 3. Mounting held together before installing felt.

4. While holding the mounting (part number: **1K0 721 357 A**) closed, as shown in Figure 3, install felt strip onto both sides of mounting.

1. Remove the mounting on the clutch pedal (Figure 3) according to the repair manual and discard.

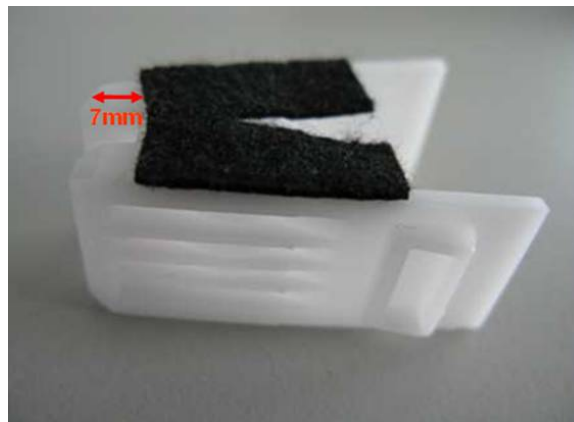
Figure 4. Distance of felt installed from end.

5. Install the felt a distance of 7 mm from tip on the depressed mounting on both sides. (Figure 4).

Tip: Figure 4 shows the relaxed condition of the mounting.
