# Service Bulletin

Bulletin No.: PI0437A

**Subject:** Appearance of Discoloration or Corrosion Near Edges/Openings on Chrome Bumpers

**Models:** 2010-2013 Chevrolet Express, Silverado  
2010-2013 GMC Savana, Sierra  
Equipped with Chrome Bumpers

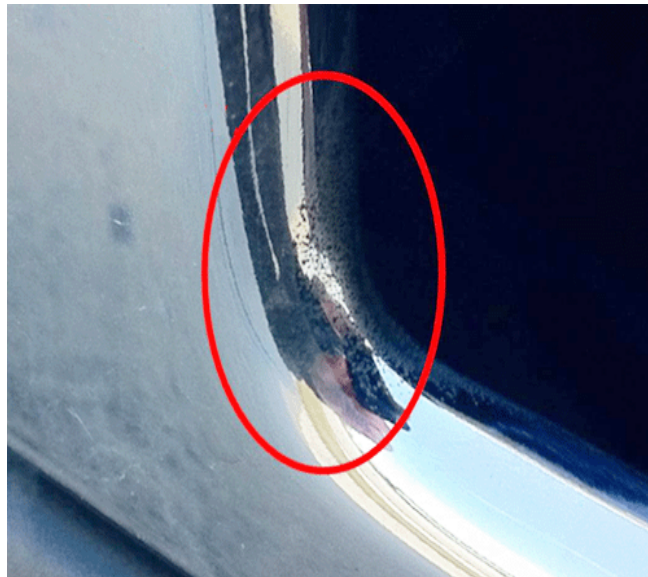
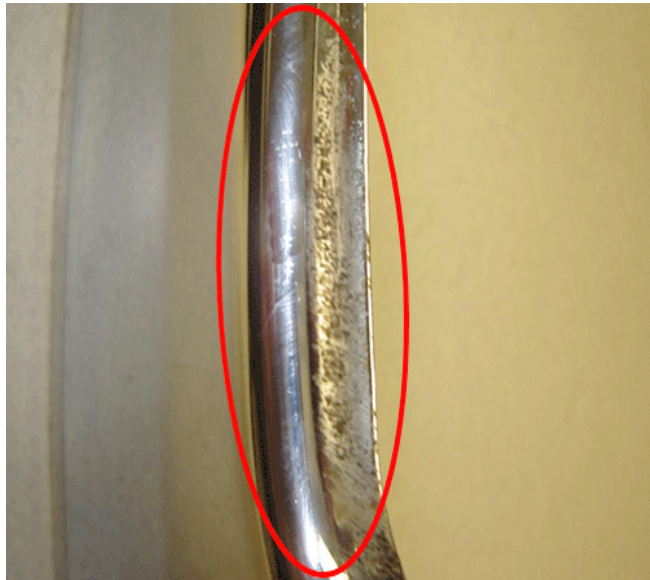
2614088

The cause of this condition may be that during processing, the supplier applies a protective paint to the backside of the bumper, and in some instances, the chrome surface was not adequately protected from paint overspray. This paint overspray may appear to be corrosion or a discoloration of the chrome.

Inspect the affected chrome surface to determine whether the chrome only appears to be corroded or discolored from paint overspray, as opposed to the surface of the chrome actually being corroded. Examples of the overspray are shown below:

Clean the affected surface to remove any residual overspray of the backside protective paint. Apply \*Kent Automotive Acrysol, P/N 20005, or \*3M General Purpose Adhesive Cleaner, P/N 08984, or equivalent, to a clean shop towel and wipe the affected chrome surface.

**Note:** Abrasives are not required to remove this overspray, so if the affected chrome surface cannot be cleaned using the referenced cleaners, the chrome may be affected by corrosion from another source.

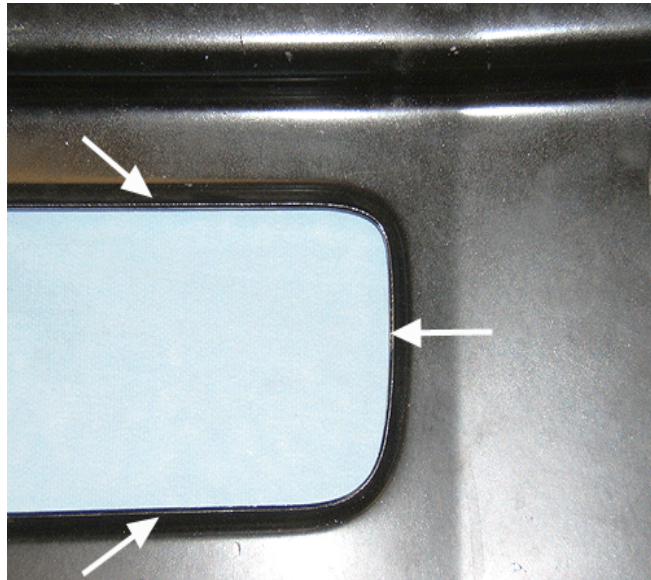
2614092

**Important::** Ensure the protective paint coating is not removed from the backside of any surfaces, including the raised edges of openings shown in the graphic below. Only remove the paint overspray from the visible surfaces.
