Service Bulletin

Bulletin No.: 08-04-19-004B

Subject: Correct Front Axle Vent Hose Routing

Models: 2007-2012 Cadillac Escalade, Escalade ESV, Escalade EXT
2007-2012 Chevrolet Avalanche, Silverado, Suburban, Tahoe
2007-2012 GMC Sierra, Yukon, Yukon XL
with Four Wheel Drive or All Wheel Drive

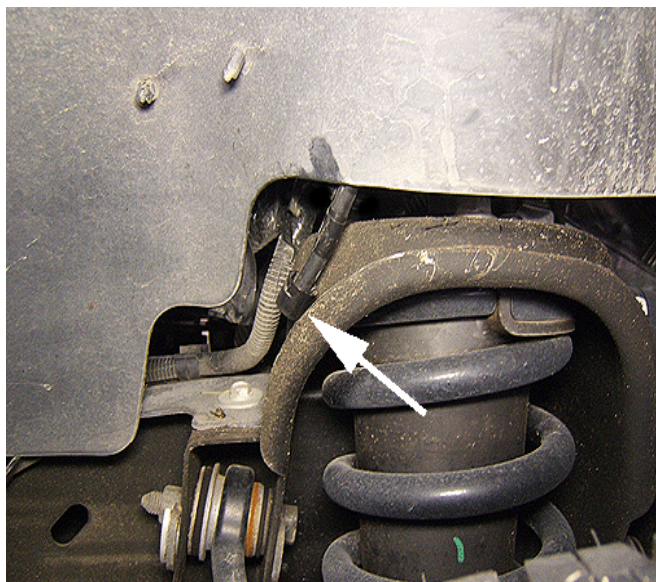
2179336

The front axle vent hose is mounted in the left side of the engine compartment, and may not be correctly routed. The vent hose can get misrouted and placed in a position that is lower than the front axle harness/engine harness in-line connector. In this position, the vent tube may ingest water. The front axle vent hose may be routed to the wheel side of the wheel well. It may be hanging through the opening of the wheel well in a vertical position, with the vent cap hanging down.
