Retailer Technical Journal 20235 Water in Tail Lamp, Bulb Socket Seal

Date 10-22-2009

Volvo Cars of North America, LLC
Technical Engineering

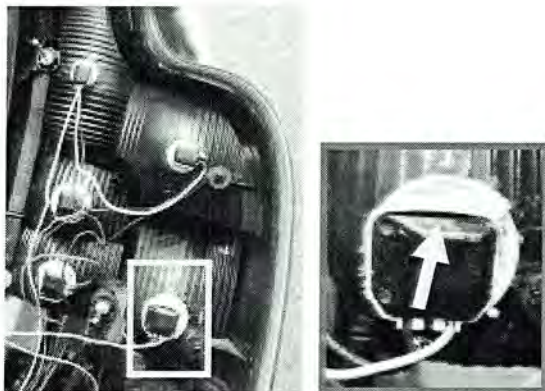
Remove the tail lamp and inspect the bulb holder to ensure the harness alone will repair.

Note the open seam of the bulb holder this is the source of the water intrusion.

If the water is **NOT** entering from the outside, replace the harness only. See the following for the harness replacement method.

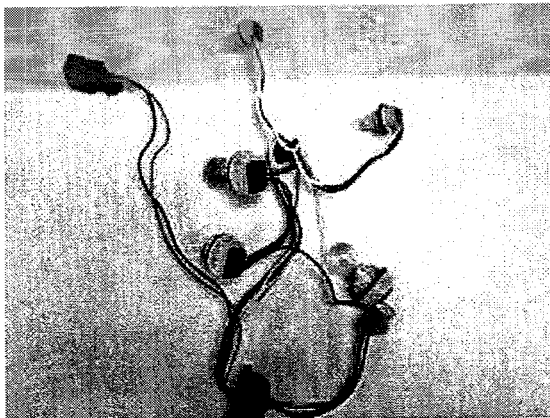
Harness only. Be sure to align the lamps to their correct position. Use the original harness and/or VIDA for reference.

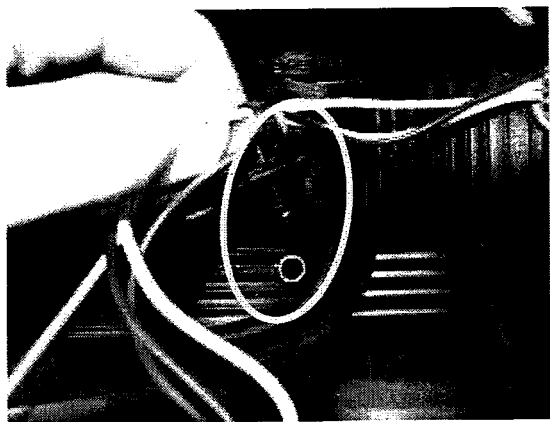
Be sure to reinstall the clip holding the harness to the lamp assembly.

After harness/tail lamp replacement, water test the lamp and verify the leak has been corrected.
