Bulletin No.: PI0339

**Subject:** Instrument Panel Cluster (IPC) Warning Lamps and/or MIL are Illuminated, Diesel Exhaust Fluid (DEF) Message Displayed, Various DTCs Set, Transmission May Not Shift or Defaults to Second Gear (Inspect Wiring Harnesses For Chafing, Connectors Not Fully Seated, and Backed Out or Damaged Terminals, Repair as Needed)

**Models:** 2011 Chevrolet Silverado 2500HD, 3500HD  
 2011 GMC Sierra 2500HD, 3500HD  
 Equipped with 6.6L Duramax™ Diesel Engine RPO LML or LGH

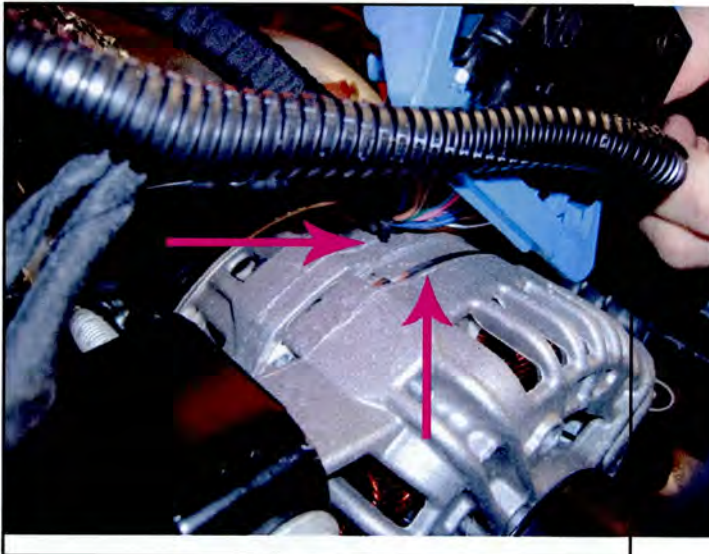
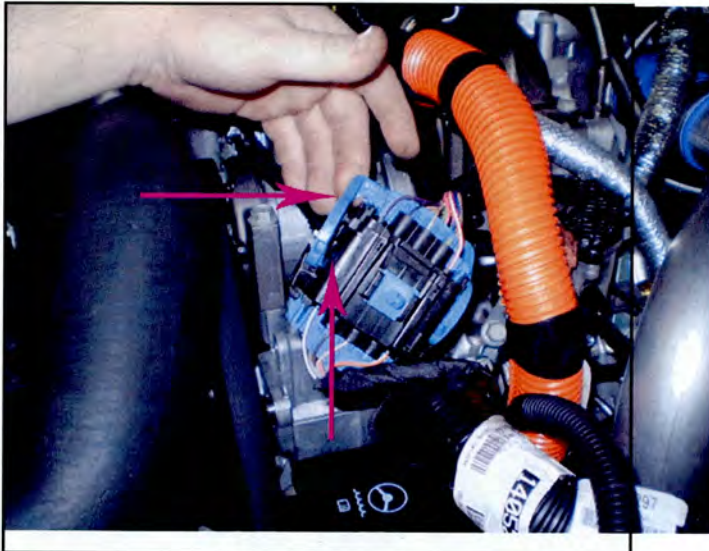
2552352

The wiring harness of connector X107 is chafing on one of the generators on trucks equipped with dual generators and/or the assist lever for connector X107 is not fully or properly seated or has backed out or damaged terminals.

1. Inspect connector X107 and its wiring harness for the following conditions:
  - 1.1. Chafing of the wiring harness insulation from contact on the generator as shown.
  - 1.2. A connector assist lever that is not fully or properly seated as shown.
  - 1.3. Backed out or damaged connector terminals.
  - 1.4. Poor terminal contact or tension. Refer to Testing for Intermittent Conditions and Poor Connections in SI.

**(ARROW LIST)** If any of the above conditions exist, repair as needed. Refer to > Power and Signal Distribution > Wiring Systems and Power Management > Diagnostic Information and Procedures > Wiring Repairs and Repairing Connector Terminals in SI.

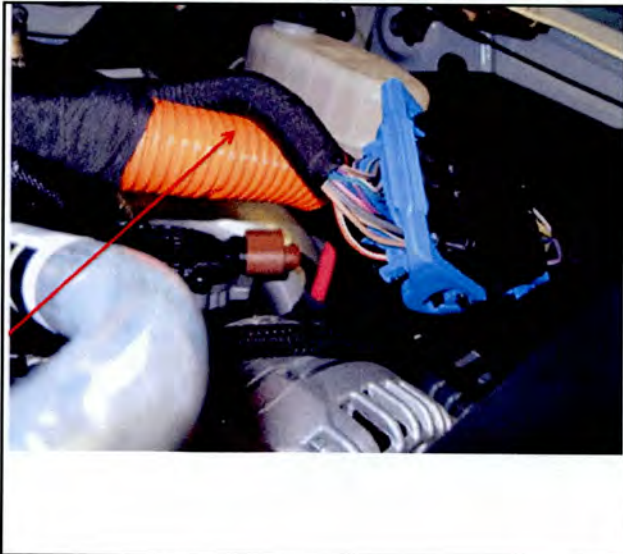
2552339

**Important:** If the wiring harness was contacting the generator, the wiring harness **MUST** be rerouted.

2. Route the harness of the X107 connector over the top of the orange conduit as shown.
3. Clear the DTCs with a scan tool.

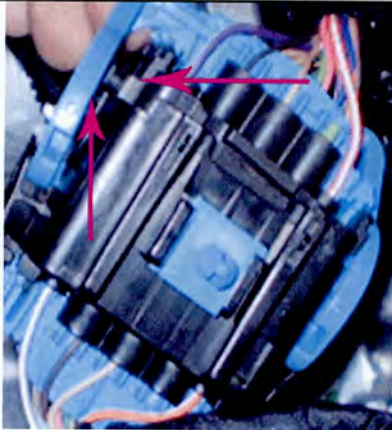
2553066

The assist lever for connector X300 is not fully or properly seated or has backed out or damaged terminals.

Typical View of an Improperly Seated  
Connector Assist Lever

1. Inspect connector X300 for the following:
    - 1.1. A connector assist lever that is not fully or properly seated as shown.
    - 1.2. Backed out or damaged connector terminals.
    - 1.3. Poor terminal contact or tension. Refer to Testing for Intermittent Conditions and Poor Connections in SI.
- (ARROW LIST)** If any of the above conditions exist, repair as needed. Refer to > Power and Signal Distribution > Wiring Systems and Power Management > Diagnostic Information and Procedures > Wiring Repairs and Repairing Connector Terminals in SI.
2. Clear the DTCs with a scan tool.

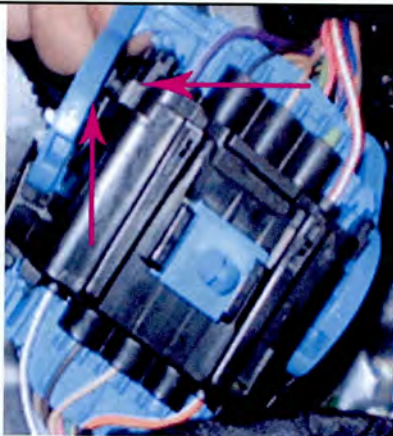
2553066

The assist lever for connector X395 is not fully or properly seated or has backed out or damaged terminals.

Typical View of an Improperly Seated  
Connector Assist Lever

**Note:** Connector X395 engine chassis harness to reductant jumper harness, is near the right side of the frame, above the reductant tank.

1. Inspect connector X395 for the following:

- 1.1. A connector assist lever that is not fully or properly seated as shown.
  - 1.2. Backed out or damaged connector terminals.
  - 1.3. Poor terminal contact or tension. Refer to Testing for Intermittent Conditions and Poor Connections in SI.
- (ARROW LIST)** If any of the above conditions exist, repair as needed. Refer to > Power and Signal Distribution > Wiring Systems and Power Management > Diagnostic Information and Procedures > Wiring Repairs and Repairing Connector Terminals in SI.
- 2. Clear the DTCs with a scan tool.

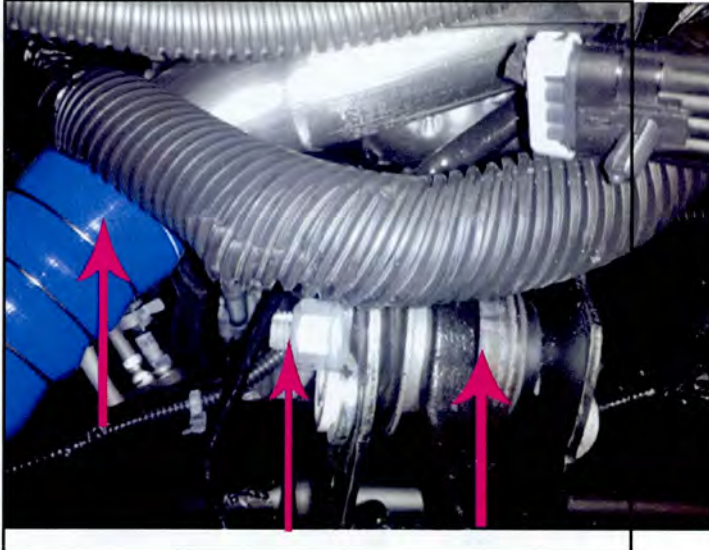
2552582

Chafing of the insulation of the wiring harness that is routed by the left front control arm.

- 1. Inspect the wiring harness insulation for chafing from contact on the left front control arm in the areas as shown. **(ARROW LIST)** If chafing of the wiring harness insulation is observed, repair as needed. Refer to > Power and Signal Distribution > Wiring Systems and Power Management > Diagnostic Information and Procedures > Wiring Repairs in SI.
- 2. Clear the DTCs with a scan tool.
