Applies To: **2012 Civic Hybrid without Navigation** – Check the iN VIN status for eligibility**November 8, 2011**

Product Update: Software Update for the Steering Wheel Audio Controls, Radio Display, and Radio Button Illumination

(Supersedes 11-051, *Product Update: Software Update for the Steering Wheel Audio Controls*, dated September 9, 2011, to revise the information marked by the black bars)

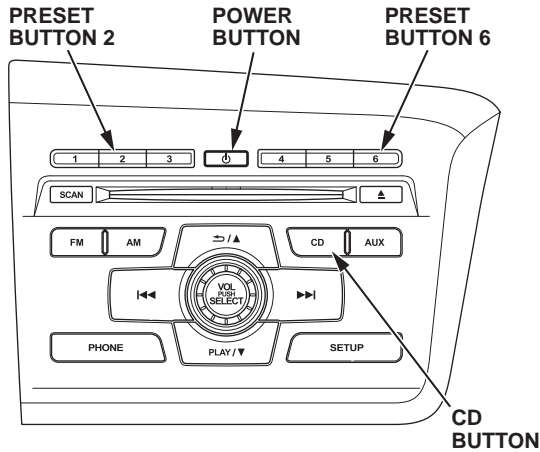
7. To enter the audio update download screen:

- Press and hold the following buttons in the following order, all within 2 seconds:
 - Audio preset button No. 2
 - Audio preset button No. 6
 - CD button
 - Audio unit power button $\text{\textcircled{P}}$

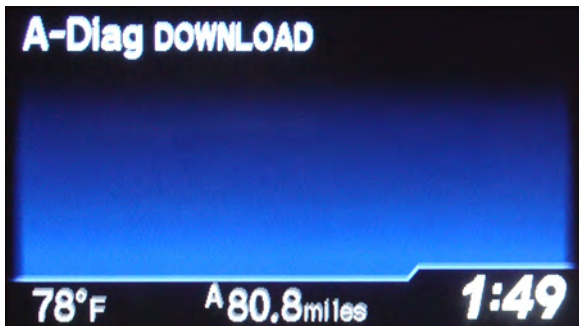
- After about 5 seconds, the A-DIAG DOWNLOAD screen appears. Release the buttons.

NOTE: If the A-DIAG DOWNLOAD message does not appear, or the audio unit turns on, turn the audio unit off and repeat step 6.

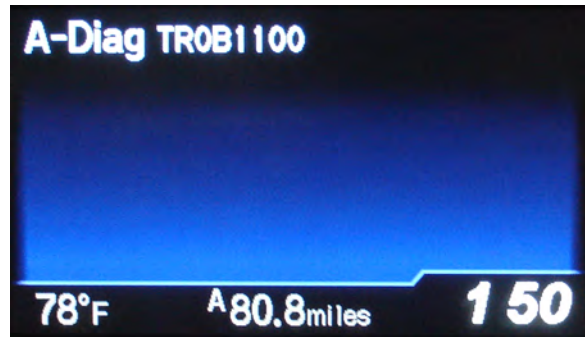
- Insert the update disc into the CD player.
- Wait for the current audio unit software version number to appear on the iMID.

- Start the update by pressing and releasing the power button.
- The audio unit button backlights slowly blink to indicate that the update is loading (about 7 minutes).

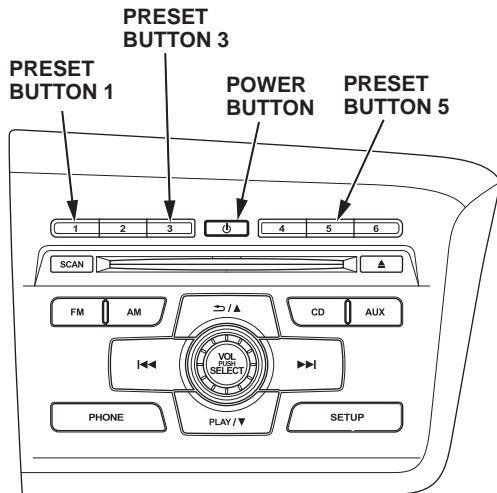
- Turn the ignition switch to ON (II), and make sure the audio menu appears on the iMID.
- Turn off the audio unit.
- Turn the ignition switch to LOCK (0), then remove the key, and wait for the iMID to turn off.
- Start the engine.
- Press and hold the following buttons in the following order, all within 2 seconds:
 - Audio preset button No. 1
 - Audio preset button No. 3
 - Audio preset button No. 5
 - Audio unit power button ϕ

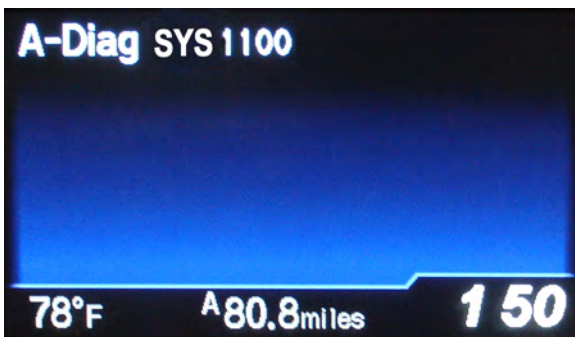
- After about 5 seconds, the audio unit software version screen appears. Release the buttons. The version should be **SYS1100**.

NOTE: If the A-DIAG SYS screen does not appear, or the audio unit turns on, turn the audio unit off and repeat step 8.
