SB-10041995-2177

Title: Realignment of Air Suspension Pressure Sensor

Applies To: Prostars with Advance Brake Systems

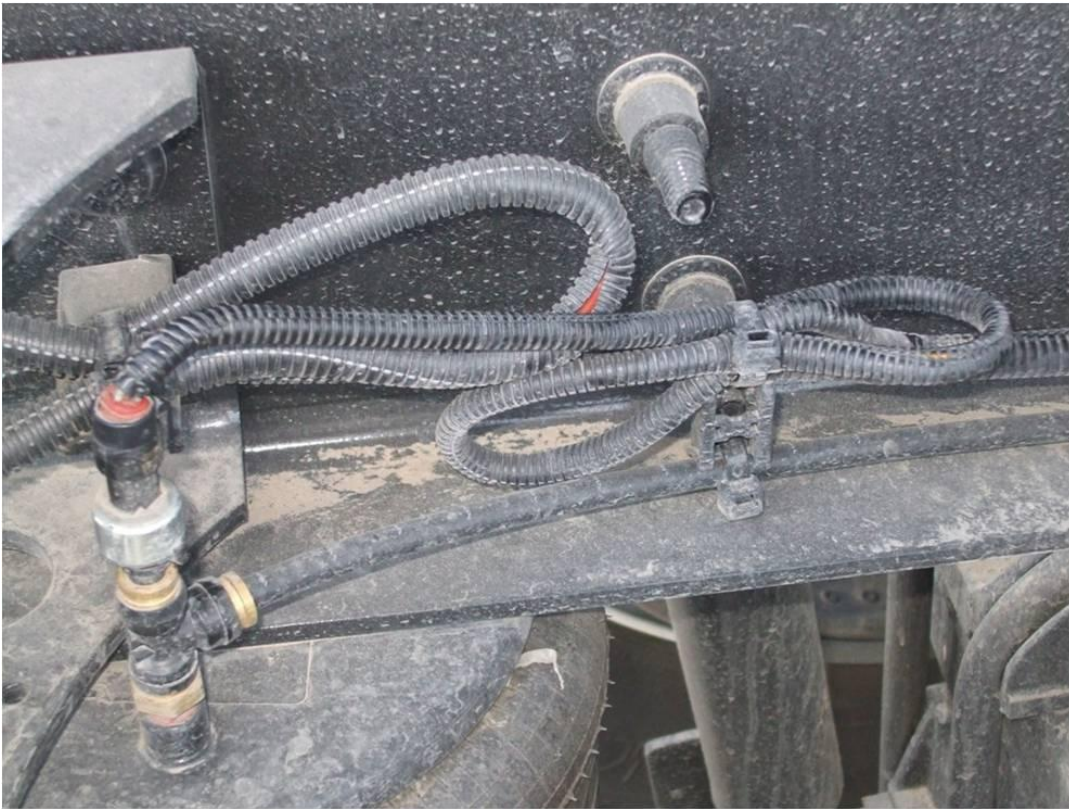
The Air Pressure Sensor may be mounted vertical and needs to be mounted horizontal.

1. Examine the sensor mounting at the left rear air suspension to see if it is mounted vertically.

Remove pressure sensor from vertical mounting. Correct seal placement if needed and clean or replace terminals as required. Obtain item 21 below (2024446C1 - Elbow Quick Connect 3/8" Tube X 3/8" Stem) and install as recommended. Install sensor into added elbow and reattach to harness and secure wiring.

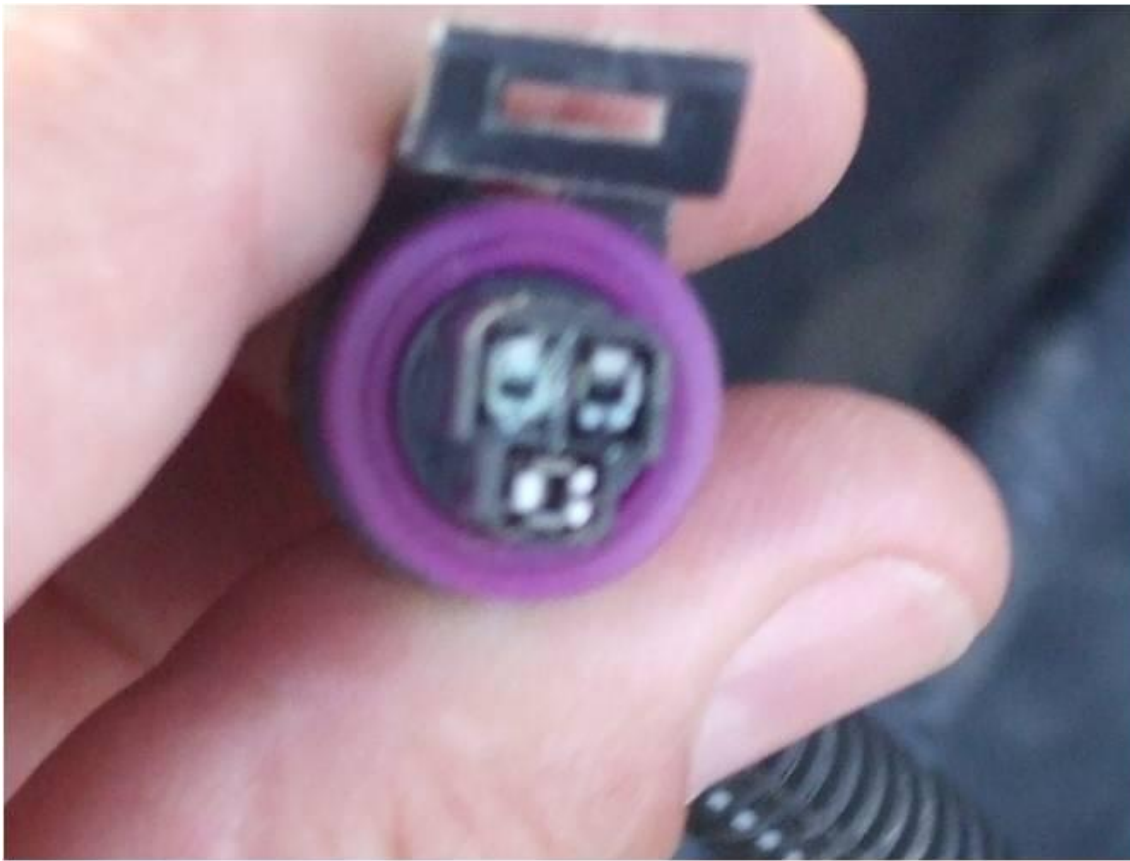
3. Check for corrosion
