SUBJECT: Water Entry into Clutch Housing.

Department: Service
Section: Clutch
Model(s): All w/Manual Transmission
Model Year(s): 2011 and after
Effective Date: 01/01/2012
Form #: TSB CL-08
Rev #:
Supersedes:

To advise dealers the procedures to correct water entry into the clutch housing. This condition may occur on manual transmission vehicles without a body that are in a storage area exposed to outside weather conditions.

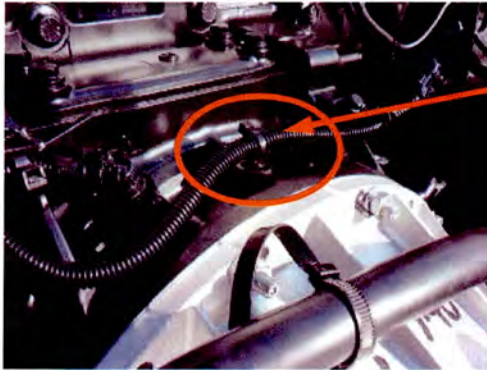
(Figure 1)

1. Cut and remove the plastic tie strap PN# 5200980881 securing the wiring harness to the top of the flywheel housing. (Figures 1 & 2)

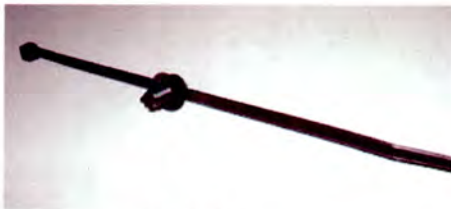
(Figure 3)
PN# 5200980881

2. Apply sealer around the flange on a new plastic tie strap, reinstall and secure wiring harness. (Figures 3, 4 & 5)

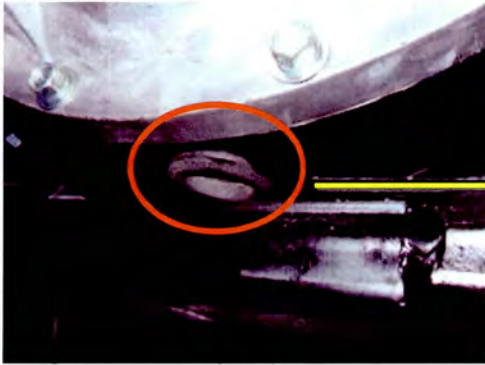
(Figure 6)

3. Remove the rubber plug from the bottom of the flywheel housing. (Figures 6 & 7)

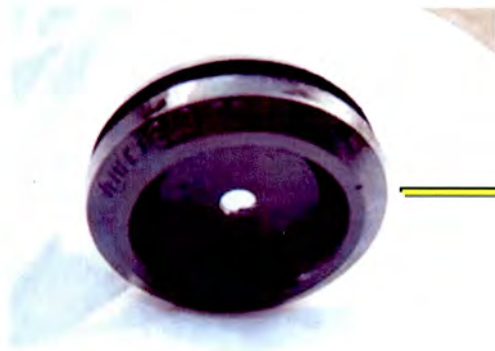
(Figure 8)

4. Drill a 1/4" hole in the rubber plug and reinstall. (Figures 8 & 9)

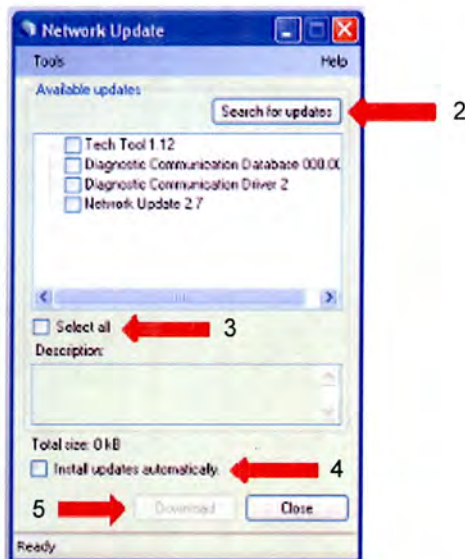
Select "Search For Updates", "Select all", "Install updates automatically" then "Download".
