SUBJECT: SERVICE BULLETIN S10RA BODY CONTROL MODULE

AFFECTED: 2010 D3FE AND D3RE All AMERICAN

Body Control Module

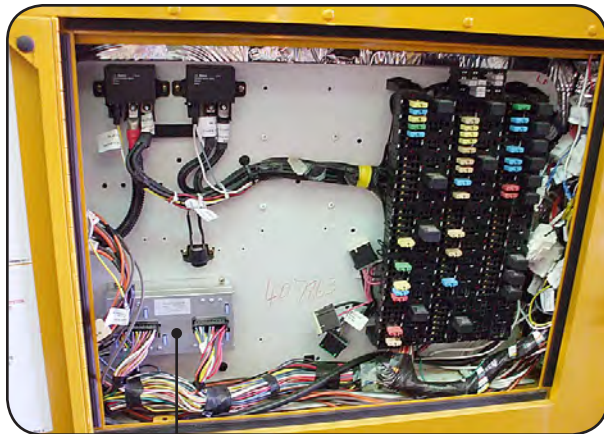
1.2 Open the outside side electrical compartment compartment and locate the Body Control Module.

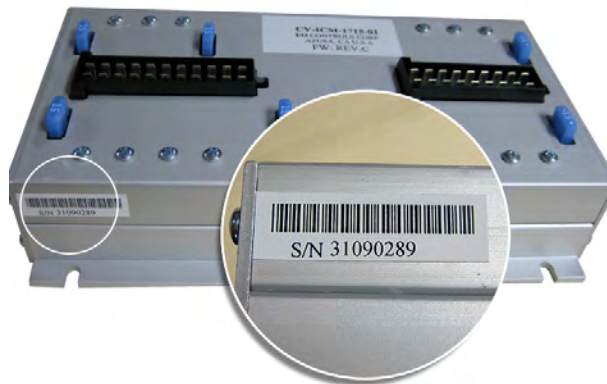
2 Locate the Body Control Module serial number at the bottom left corner of the module. If necessary, remove the mounting screws and carefully shift the module to gain view of the serial number. Compare the serial number to the list on page 2.

3.1 Disconnect the harness plugs from the module. Remove the top two mounting screws, and loosen the bottom two mounting screws. Remove the module.

3.2 Refer to the list on page 2 to determine whether the replacement is 10001559 or 10002011. Place the new module over the bottom two mounting screws. Reinstall the two upper mounting screws. Tighten the four screws. Connect the harness connectors.
