# Authorized Field Change

AFC 11931

**Subject:** HVAC Front Inside Module Drain Repair and Grease Application for Exhaust Gas Recirculation (EGR) Valve

## DESCRIPTION

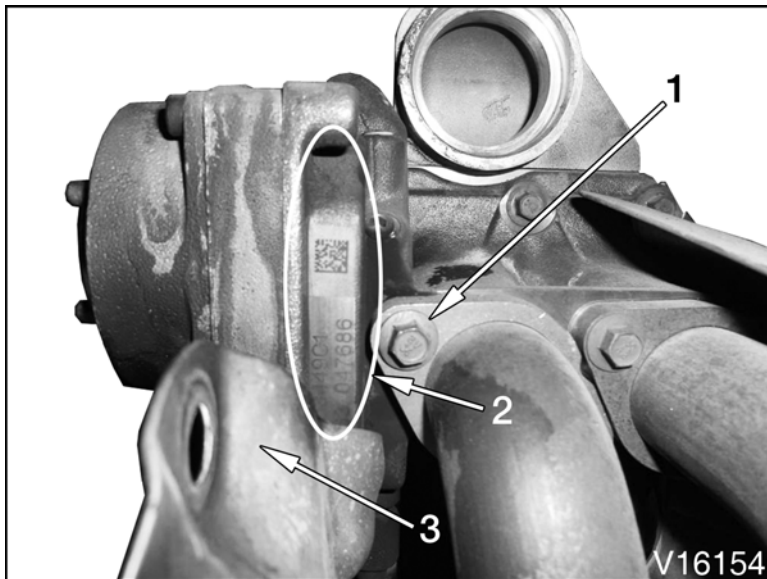
**Figure 1 EGR Valve**

1. M8 x 25 heat resistant bolt
  2. EGR part number and serial number location
  3. EGR heat shield
6. Push EGR heat shield as far inboard as possible to allow room to work.
  7. Thoroughly clean EGR part number and serial number surface with brake cleaner or equivalent.
  8. Remove only one M8 x 25 heat-resistant bolt from EGR inlet tube flange. Discard bolt.

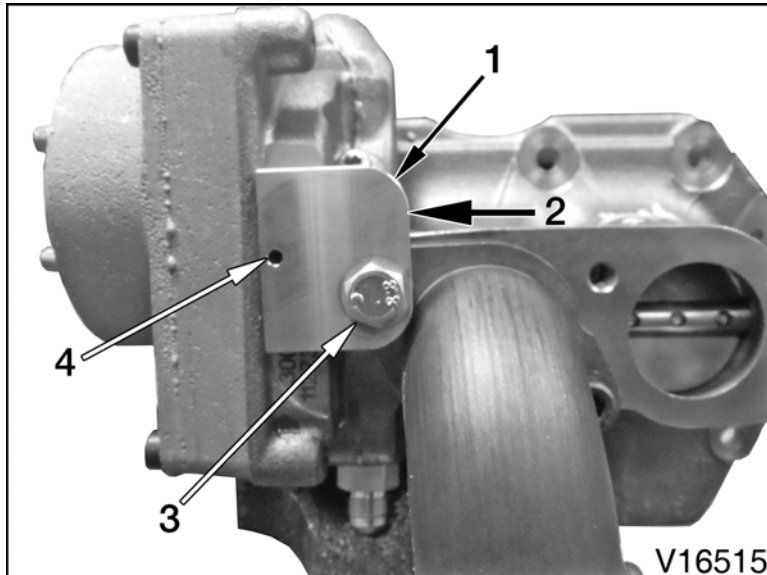
**Figure 2 Drill Jig**

1. Drill jig
2. Push direction
3. Jig bolt
4. Jig drill hole

9. Place drill jig onto EGR housing and install jig bolt finger tight.

10. Push drill jig in the direction as shown and tighten jig bolt to 18 lb-ft (24 N•m).

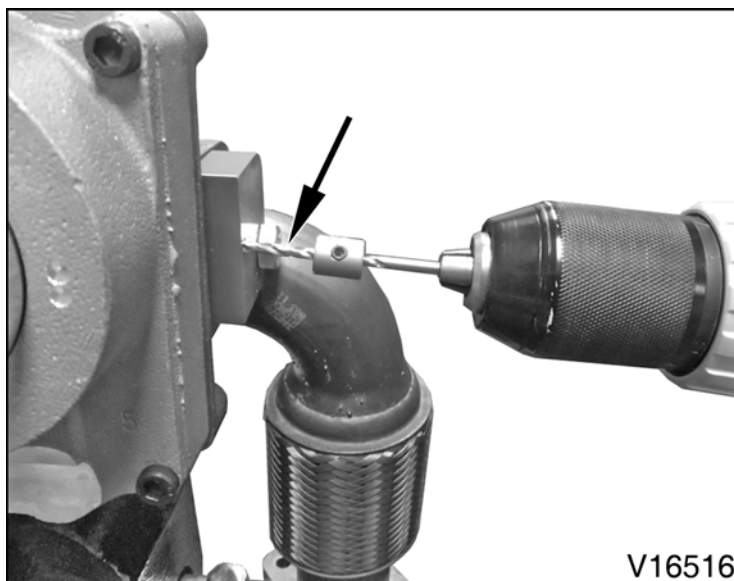
**Figure 3 Drill Hole to Proper Depth**

11. Drill through the hole in the drill jig to the mounted stop collar.
12. Continue to rotate the drill bit while removing.
13. Remove jig bolt and jig. Save jig bolt.

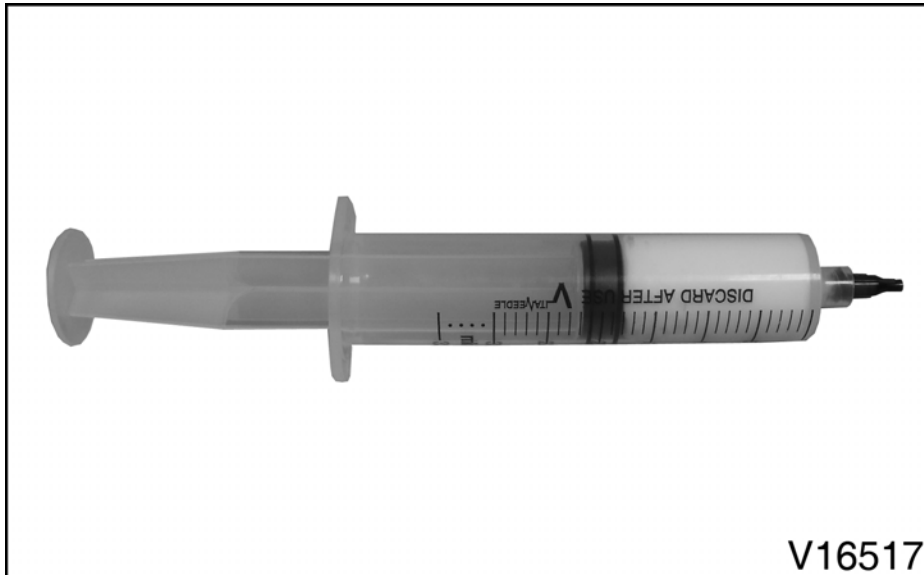
**Figure 4 Syringe Assembly**

14. Remove protective cover from end of syringe assembly by rotating counterclockwise.

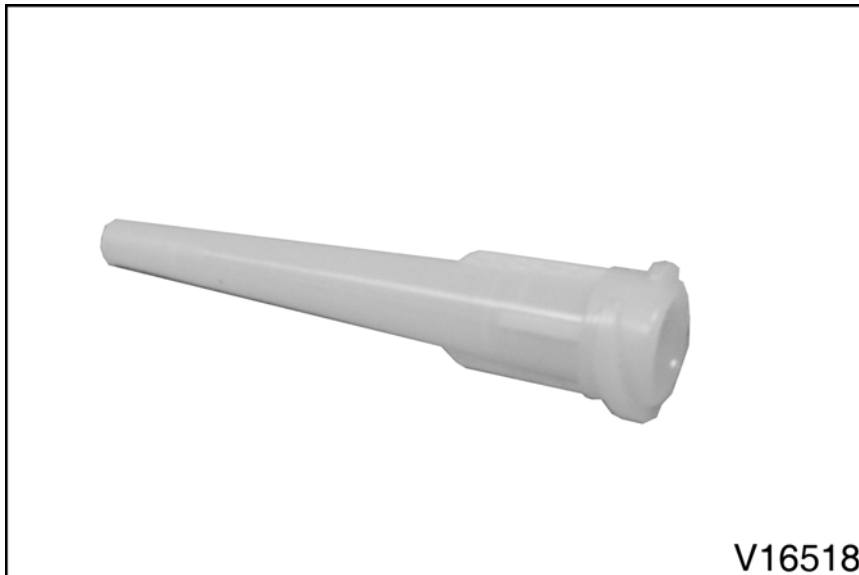
**Figure 5 Syringe Tip**

15. Install syringe tip onto syringe assembly end by rotating clockwise.

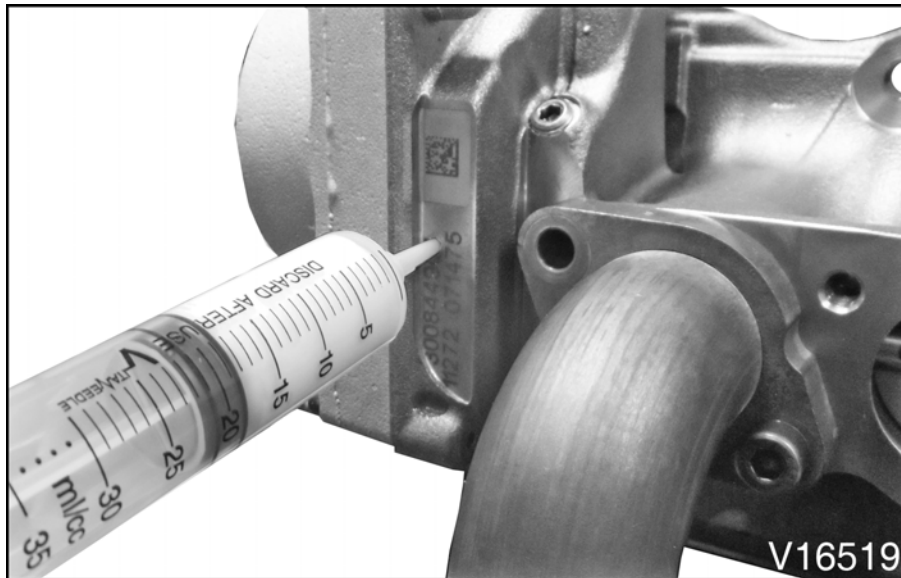
**Figure 6 Inject Grease into EGR Housing**

16. Insert syringe tip fully into drilled hole.

17. Slowly inject 0.3 fl. oz. (9 cc) of grease by pressing plunger.

18. Wait 30 seconds to allow grease to settle.

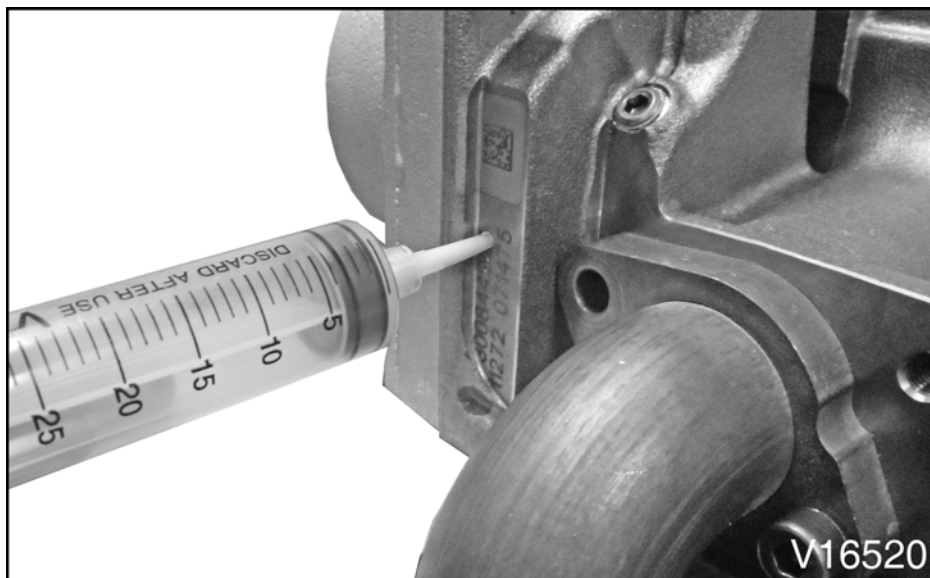
**Figure 7 Empty Syringe**

19. Inject remaining 0.3 fl. oz. (9 cc) grease.

**NOTE – Some grease may squeeze out of the hole. Wipe off excess if this occurs.**

20. Remove syringe assembly with tip and discard.

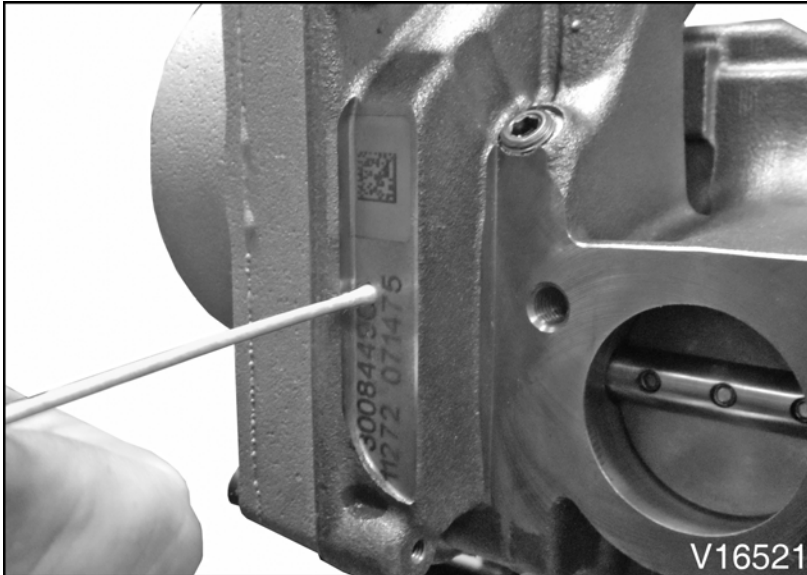
**Figure 8 Clean Drilled Hole**

21. Using one of the cotton swabs, insert to full depth of cotton end while rotating.

22. Continue to rotate in the same direction while removing.

23. Repeat with second cotton swab.

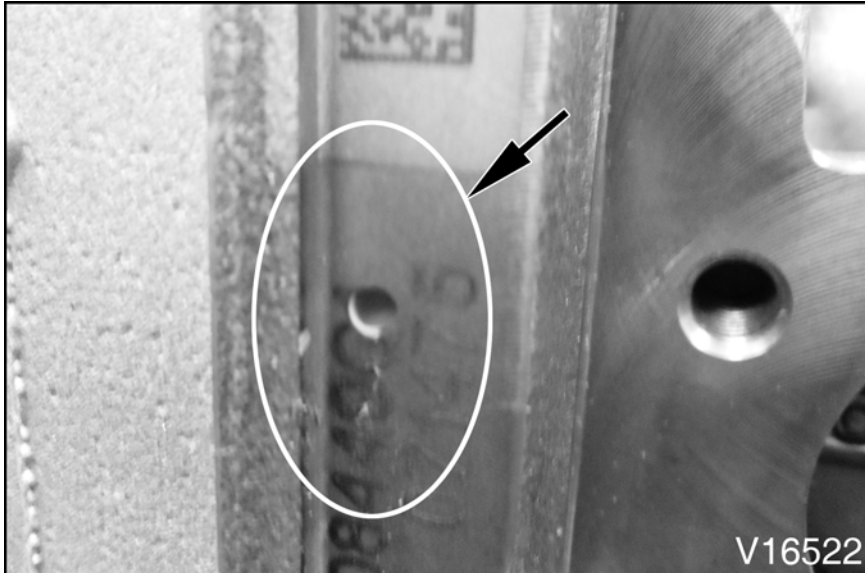
**Figure 9 EGR Housing Surface**

24. Apply brake cleaner or equivalent to a clean shop towel and wipe EGR housing surface clean of any grease.

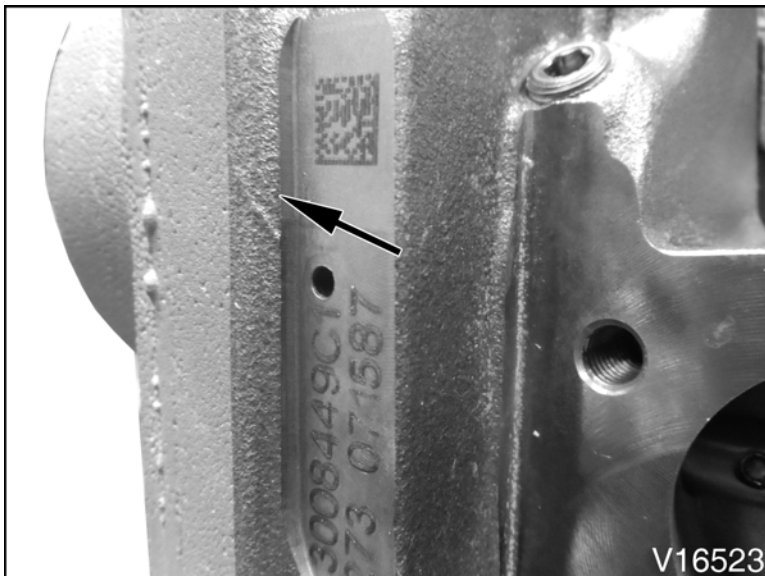
**Figure 10 EGR Housing Surface Height Difference**

**NOTE – Due to the difference in height between the as-cast and machined surfaces of the EGR housing, it will be necessary to use a spacer to install the blind rivet.**

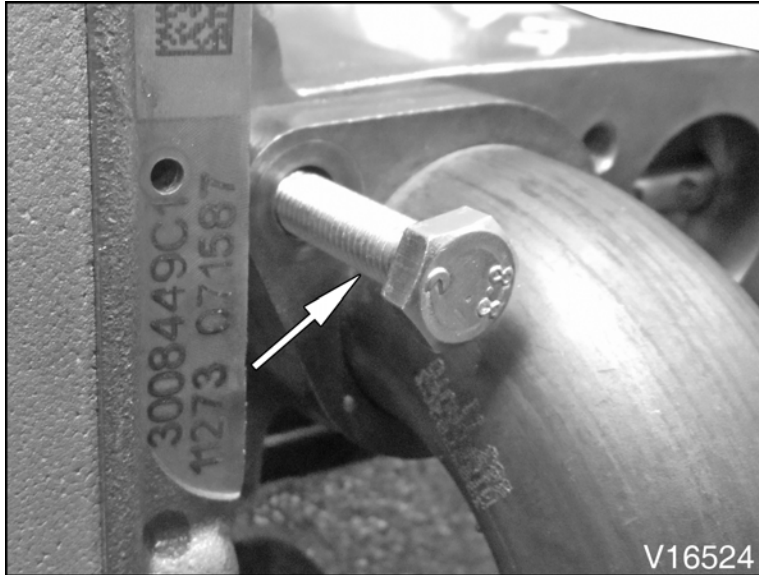
**Figure 11 Jig Bolt**

25. Reinstall the jig bolt in the EGR housing to where there is approximately 1.0 in. (26 mm) of thread left above the exhaust flange.

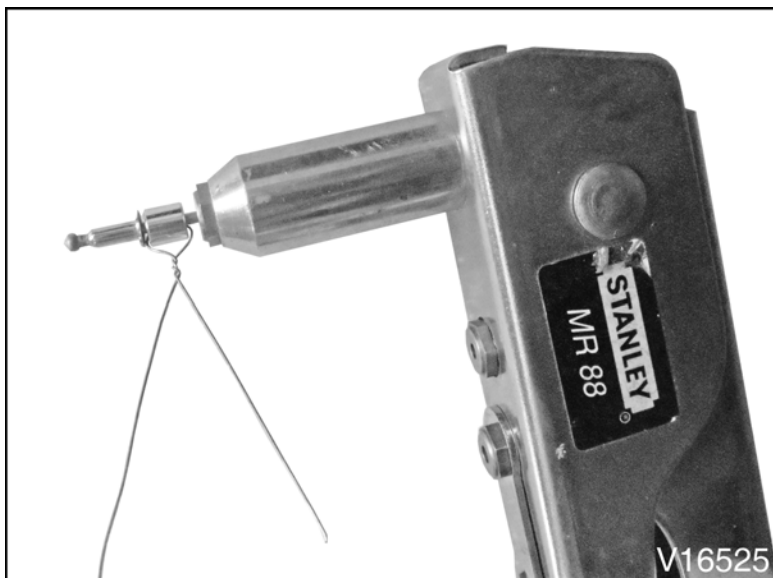
**Figure 12 Rivet Gun and Rivet/Spacer Assembly**

26. Install blind rivet into spacer assembly.

27. Install blind rivet/spacer assembly into locally obtained rivet gun. Use the appropriate rivet guide on the rivet gun for rivet supplied in the kit.

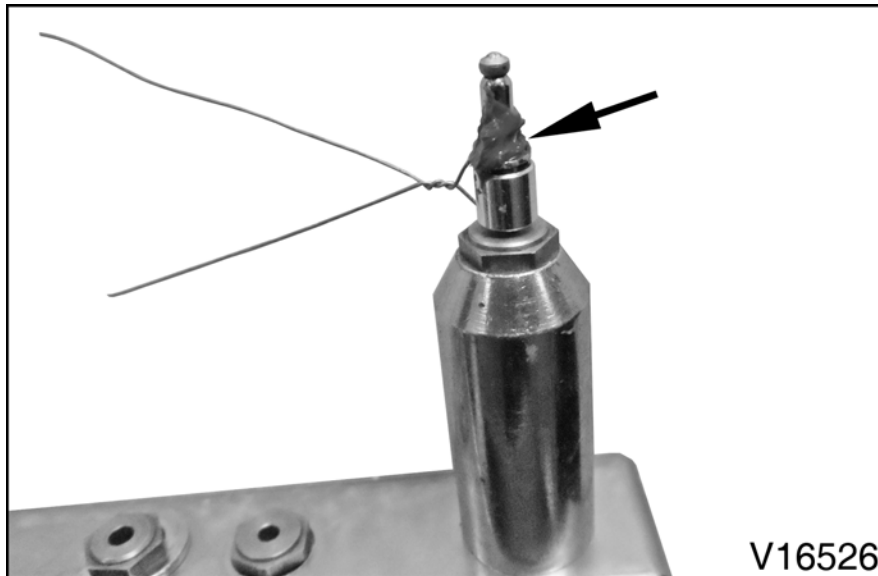
**Figure 13 Rivet/Spacer Assembly Positioned in the Rivet Gun**

28. Using the rivet gun to hold the rivet/spacer assembly, apply RTV sealant around the diameter of the blind rivet shank as shown.

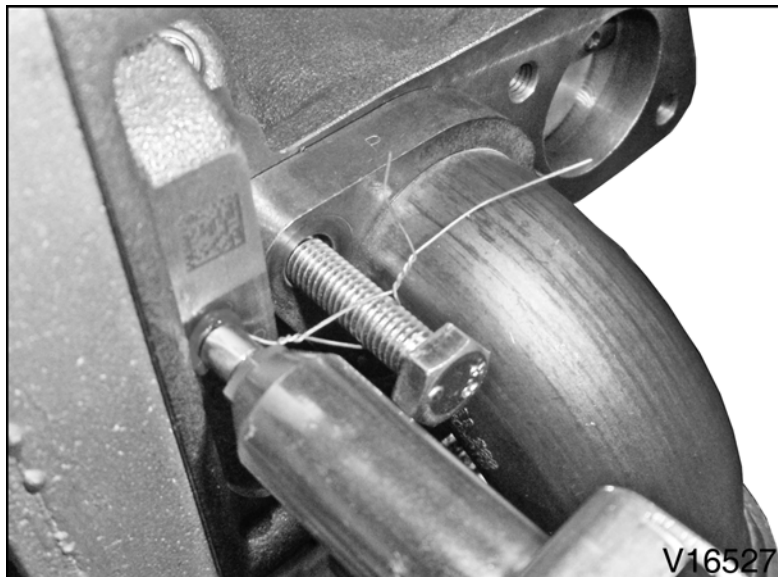
**Figure 14 Tether Rivet/Spacer Assembly to Jig Bolt**

29. After coating the blind rivet with RTV sealant, insert the blind rivet/spacer assembly into the drilled hole. Position tether wire on rivet/spacer assembly in such a way where the wire can be tied to the jig bolt.

30. Tie the tether wire of the blind rivet/spacer assembly around the jig bolt to retain the spacer when the mandrel on the blind rivet breaks off.
31. Squeeze riveter handles until rivet stem pulls free from the blind rivet. Tether wire should keep spacer assembly attached to jig bolt.

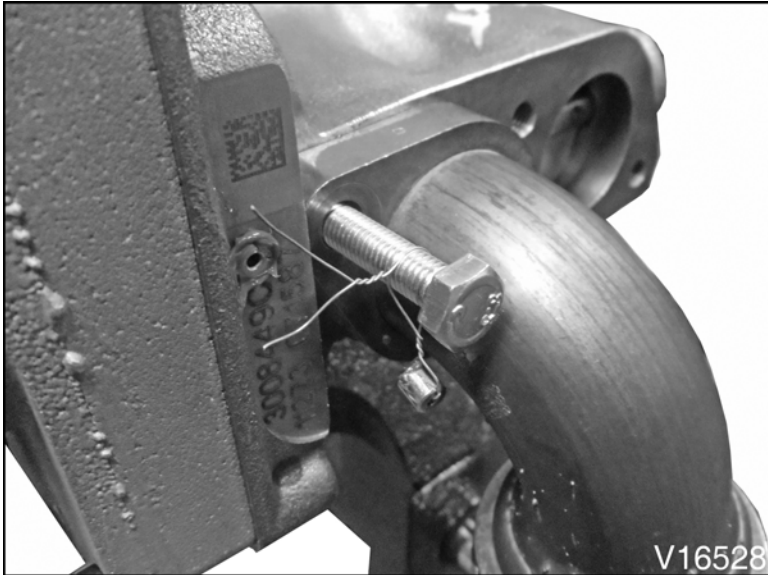
**Figure 15 Blind Rivet Installed**

32. Remove spacer assembly and jig bolt from EGR valve and discard.

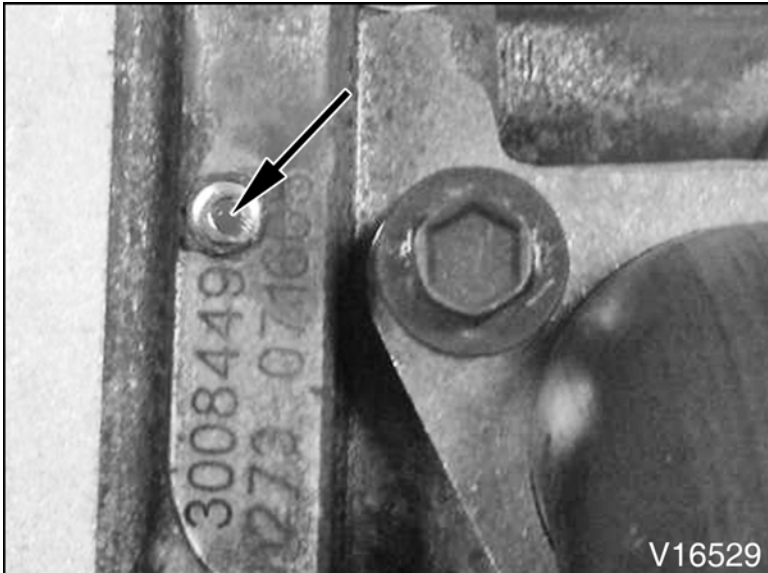
**Figure 16 Rivet Filled with RTV**

33. Apply a small amount of RTV sealant to remaining hole. Additional RTV sealant over the head of the blind rivet is acceptable and does not need to be removed.
34. Install new M8 x 25 heat resistant bolt to EGR inlet tube flange and tighten to 18 lb·ft (24 N·m).
35. Install coolant manifold (rear of EGR) according to installation procedure in the “Exhaust Gas Recirculation (EGR) System” section of the *EGES-465 Engine Service Manual*.
36. Refill the cooling system using the Navistar Coolant Management tool.
37. Start engine and check for coolant leaks.
38. Stop engine.

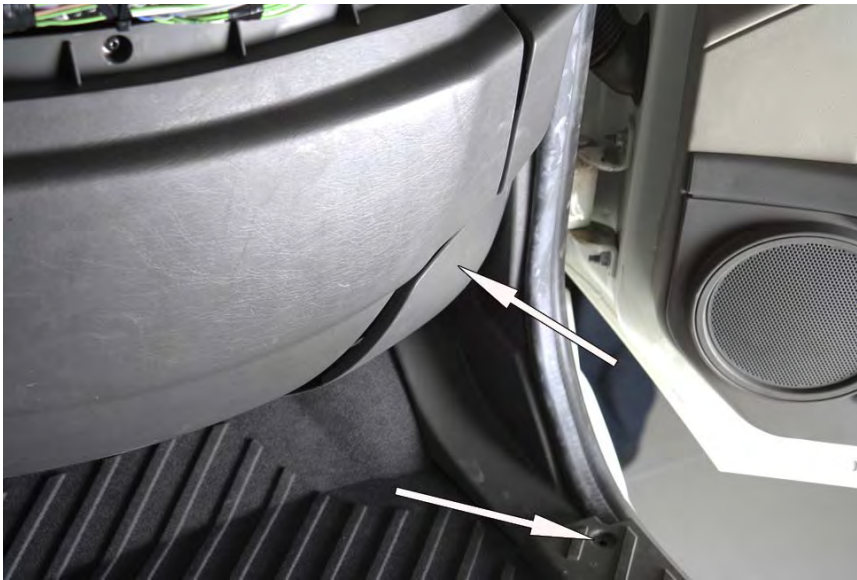
**Figure 17 Removing Kick and Scuff Panels**

1. Remove the kick panel and scuff panel on the passenger side of the truck (See Figure 17, page 14).

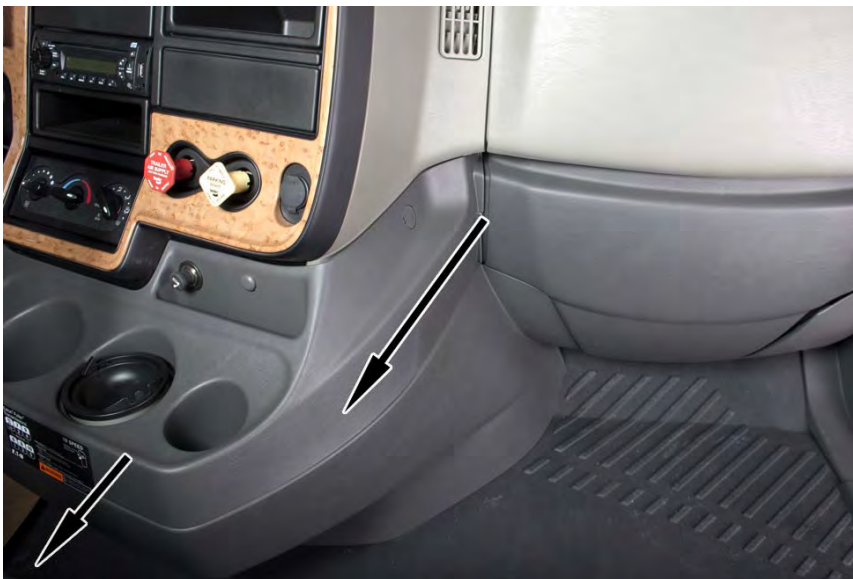
**Figure 18 Removing Center Console**

2. Detach and pull back the center console to expose the floor mat (See Figure 18, page 14).

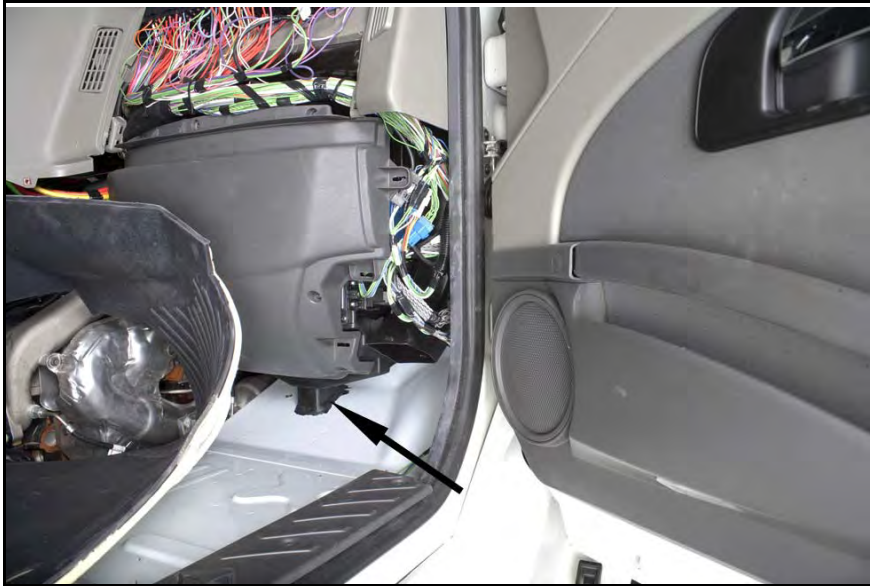
**Figure 19 Pulling Floor Mat Away from Drain Area**

3. Pull the floor mat away from the drain area (See Figure 19, page 15).

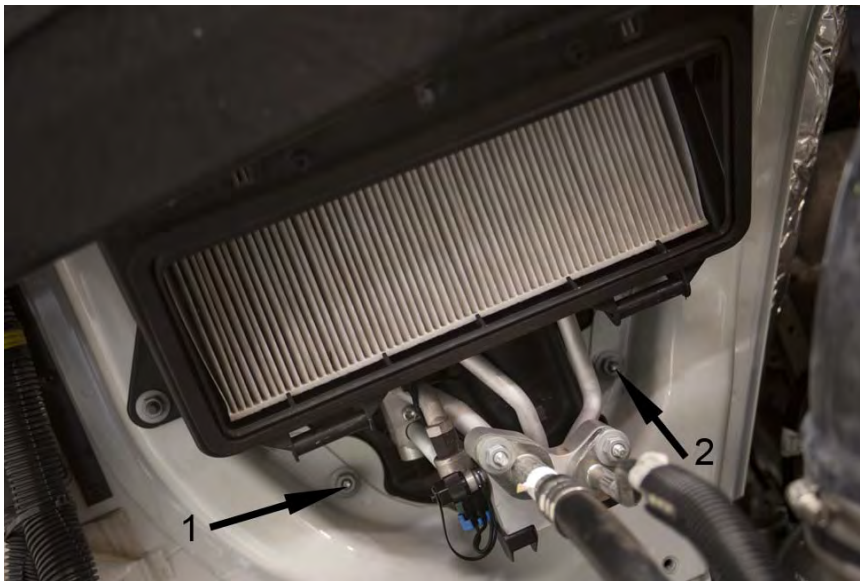
**Figure 20 Loosening Mounting Nuts**

- a. In the engine compartment on the firewall, loosen the lower mounting nuts from area shown (See Figure 20, page 15).

1. Outboard Nut next to HVAC TXV
  2. Inboard Nut next to HVAC TXV
- b. Back the nuts off the studs until the end of the nut is approximately flush with the end of the stud (do not remove completely).

5. Tighten the HVAC module mounting nuts (See Figure 20, page 15).
6. Using a thin piece of cardboard / credit card, place the cardboard between the floor and the HVAC module.
  - a. Push the cardboard  $\frac{1}{2}$  way under the HVAC module.
  - b. Continue this operation for all sides of the drain. This will make sure the drain valve is not caught.
  - c. Slide the cardboard / credit card from the firewall side completely under the HVAC housing to ensure it is not folded under. You will be able to see the drain valve end as you slide the cardboard / credit card under the module between HVAC Module and Floor (See Figure 24, page 17).

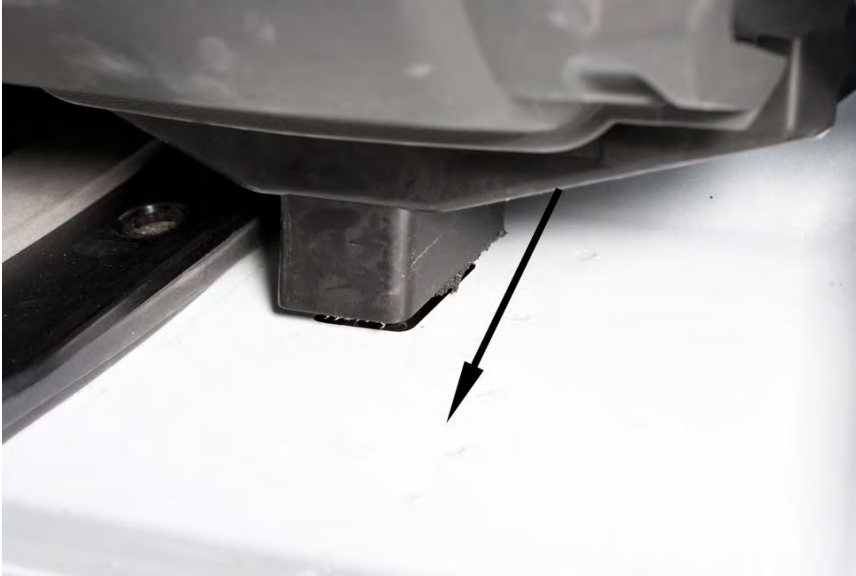
Figure 21 Pulling the HVAC Unit Rearward

- c. With the mounting nuts loosened, gently pull the HVAC unit rearward to expose the drain seal for easier removal (See Figure 21, page 16) and (See Figure 22, page 16) and (See Figure 23, page 17). Remove the foam seal and not the rubber drain valve.

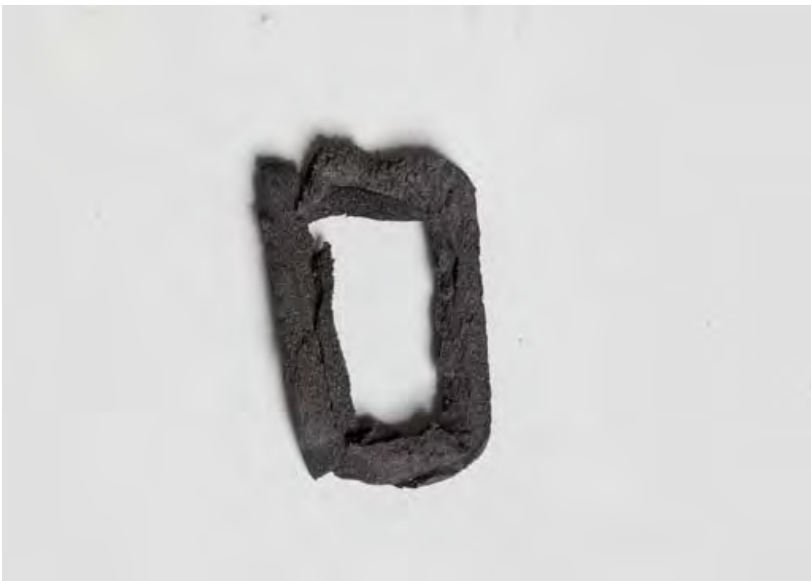
Figure 22 Typical Condition of the Foam Seal after Removal

1. The HVAC module floor seal interferes with the drain tube and forces it open or closed. Condensate inside the module does not properly drain and instead is pulled into the blower motor.
2. The floor seal is mis-positioned or damaged during HVAC module installation.

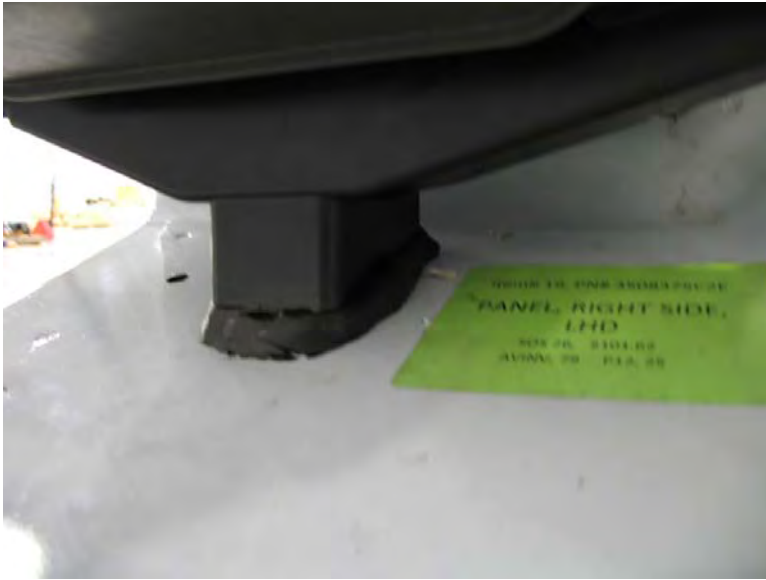
**Figure 25 Sealing HVAC Unit to the Floor**

7. Use sealant (p/n 8000934R91) to seal the HVAC unit to the floor. Make sure not to force excessive sealant into the gap (See Figure 25, page 18).

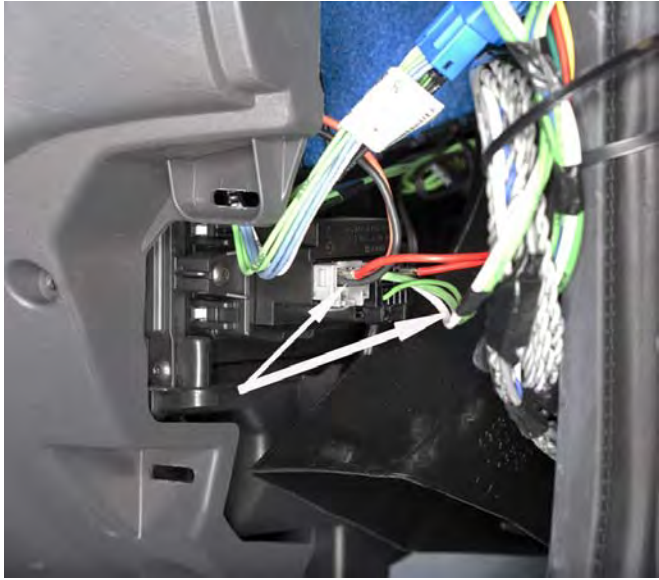
**Figure 26 Locating the LPM**

8. Reposition the floor mat in place.
9. Do the following to test the blower motor:
  - a. Turn the ignition key to the On position.
  - b. Turn the control to high blower speed.
  - c. If the blower turns on, go to each blower speed and verify that the blower is operational. If the blower is operational, go to step 10.
  - d. If the blower does not turn on or has limited airflow, locate the Linear Power Module (LPM) behind the passenger-side kick panel (See Figure 26, page 19) and do the following:

- Black wire on the two-cavity connector.
- White heavy ground wire on the 6-way connector.

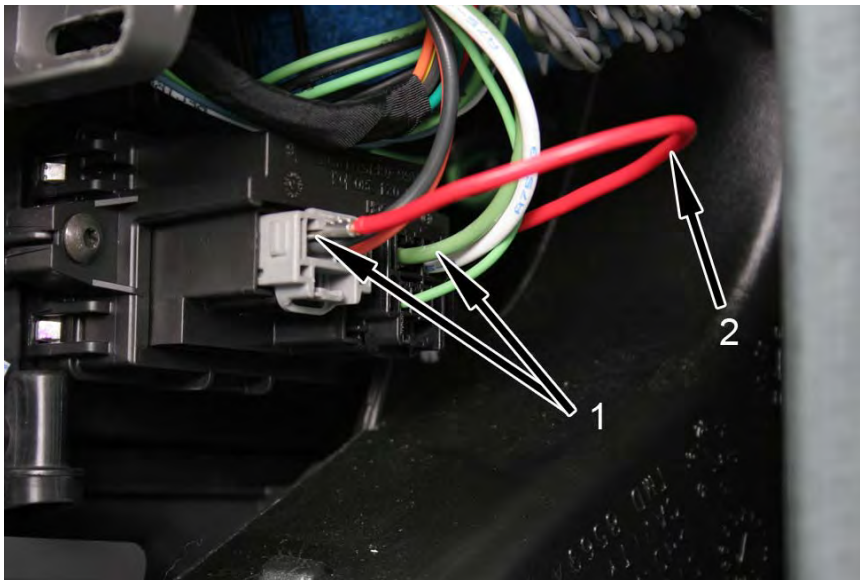
**Figure 27 Using 12-gauge Jumper Harness**

e. Use a 12-gauge jumper harness to place the jumper across these two wires (See Figure 27, page 19).

1. Jumper wire on the two-cavity connector and on the 6-way connector.
2. 12-gauge jumper harness

f. The blower motor should operate.  
g. Remove the jumper wire.
