**SB-10044066-3037**

**Title: Block Heater Element Hitting the Front Crossmember****Applies To: 7600 with 2010 EPA Maxx Force 11 and 13 with feature code 0012864**

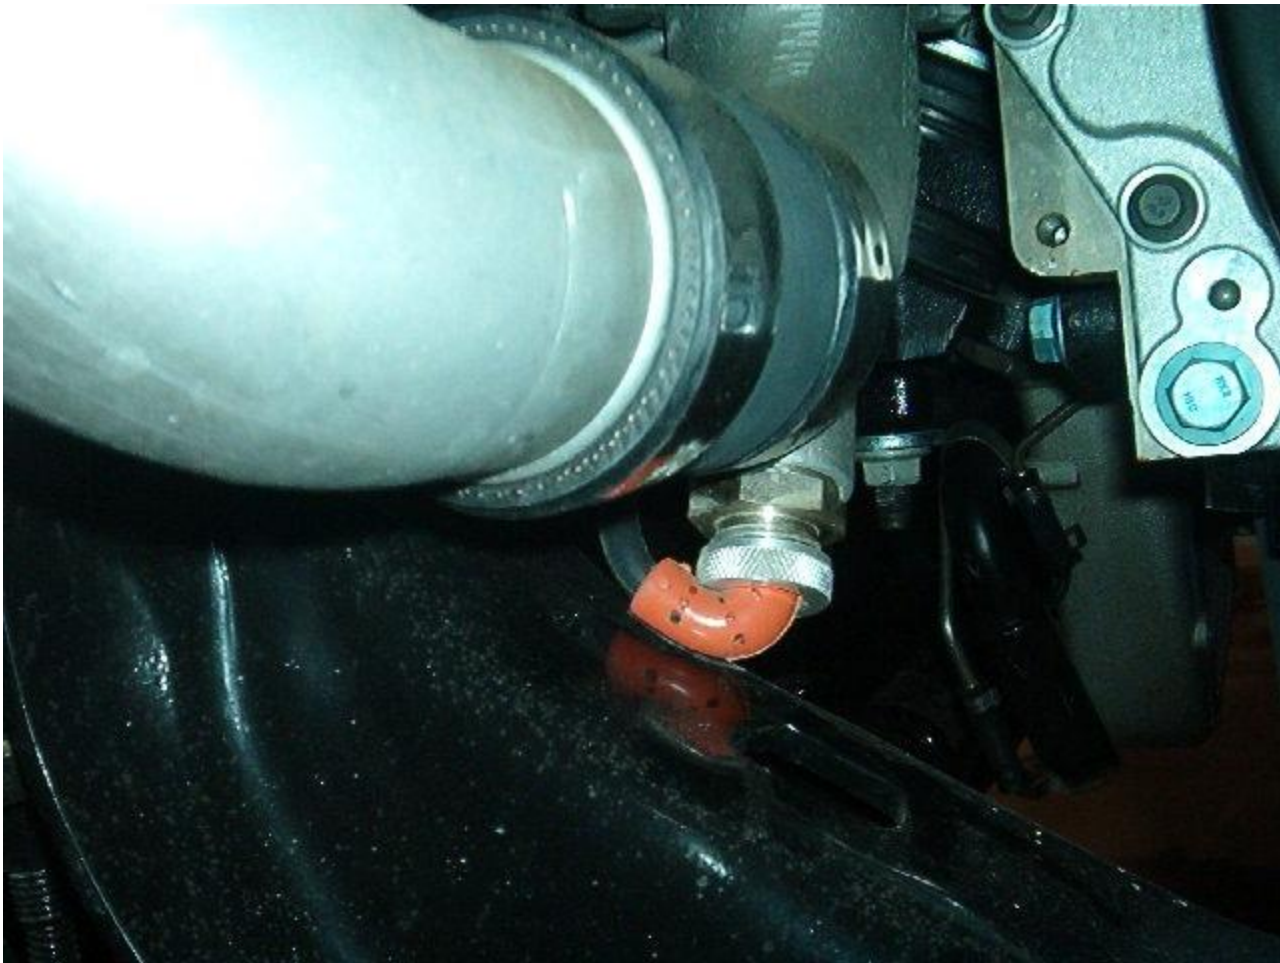
Figure 1

The below information is the repair for the block heater element coming in contact with the front crossmember.
