**WC35 - Checking Relays for Engine-Compartment Blower (Workshop Campaign)**

Vehicle Type: **Boxster (981)/Boxster S (981)**

Model Year: **2013**

Concerns: **Relay for engine-compartment blower**

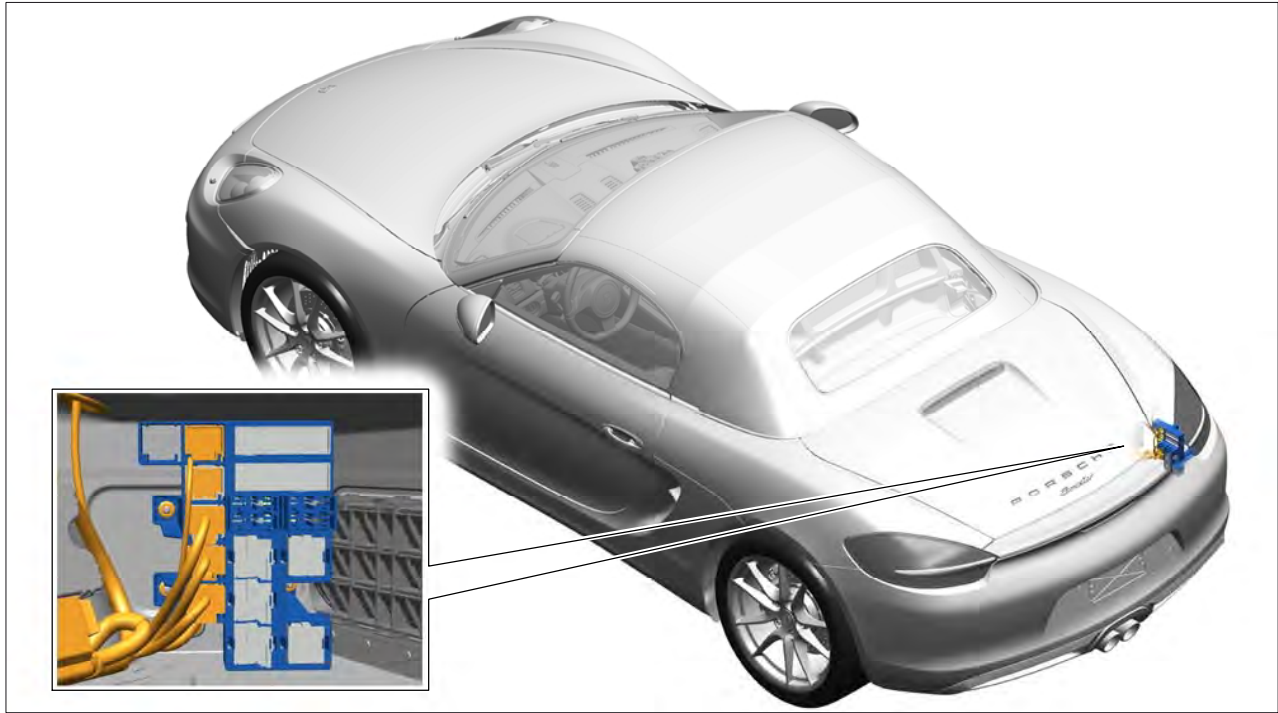
*Installation position of relays for engine-compartment blower*

The engine-compartment blower relays to be checked are in relay carrier 2 at the rear right of the luggage compartment ⇒ *Installation position of relays for engine-compartment blower.*

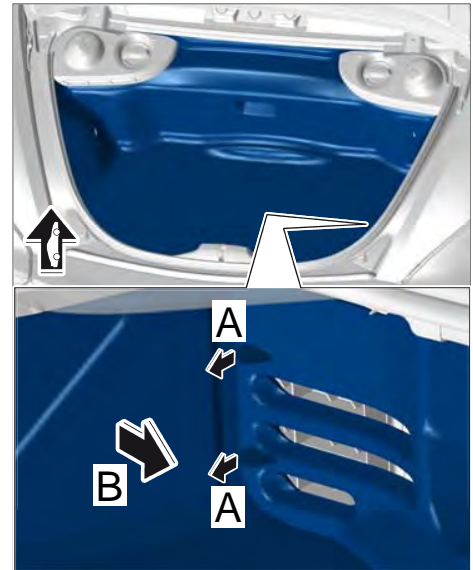
Figure 1

- Disengage trim panel for rear luggage compartment at the right at the catch ⇒ *Figure 1 -arrows A-* and fold it inwards ⇒ *Figure 1 -arrow B-*.

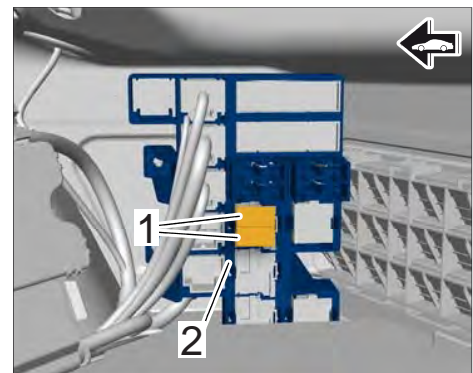
Figure 2

- Remove both engine-compartment blower relays ⇒ *Figure 2 -1-* from the relay carrier ⇒ *Figure 2 -2-*.

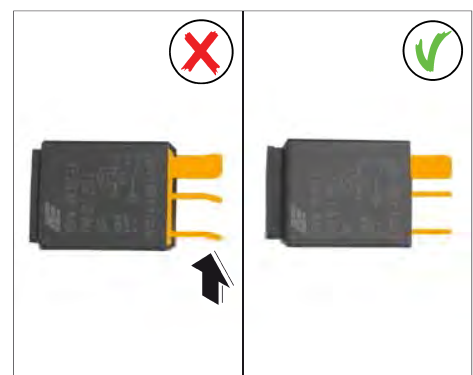
Figure 3

- Check both engine-compartment blower relays.  
**If one of the flat plugs on the relay is bent ⇒ *Figure 3 -arrow-*, the relay **must be replaced**.**

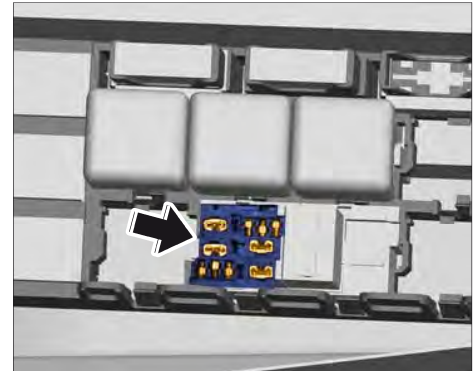
Figure 4

If a flat plug is bent, check the **plug sockets** in the relay carrier ⇒ *Figure 4 -arrow-* for **deformation** and bend them into shape again using a suitable tool if necessary.

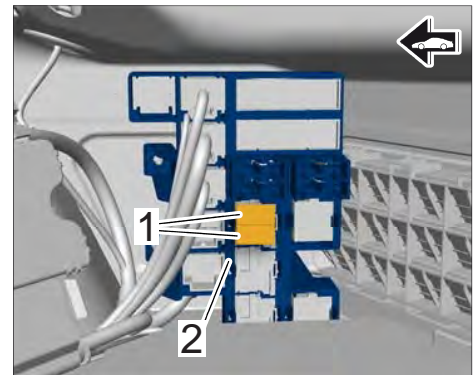
Figure 5

- 6 Press both engine-compartment blower relays ⇒ *Figure 5 -1-* into the defined slot on the relay carrier ⇒ *Figure 5 -2-* and check that they are seated correctly.

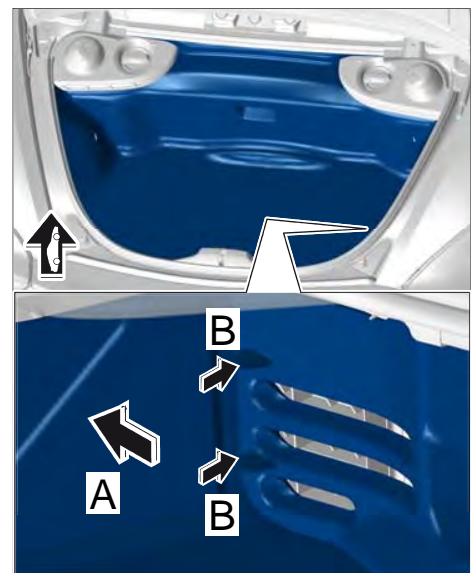
Figure 6

- 7 Swivel the luggage-compartment trim panel upwards ⇒ *Figure 6 -arrow A-* and press in the catches ⇒ *Figure 6 -arrows B-*.

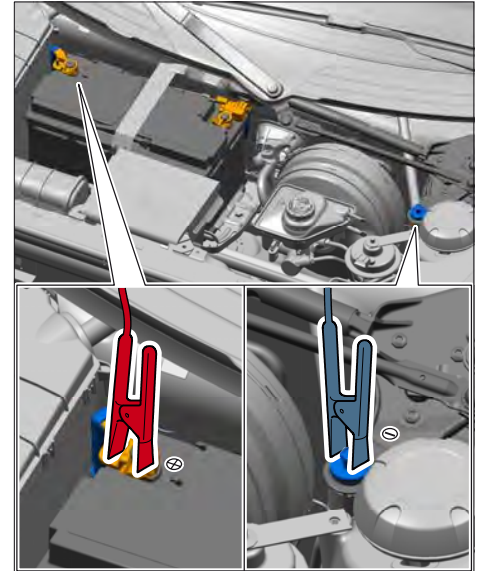
*External power connection*

- 1.1 Connect a battery charger with a current rating of **at least 40 A**.  
First connect the positive cable of the charger to the positive terminal of the battery and then connect the negative cable of the charger to the ground point for jump-lead starting ⇒ *External power connection*.
- 1.2 PIWIS Tester II 9818 must be connected to the vehicle communication module (VCI). Then, connect the communication module to the vehicle and switch on the PIWIS Tester.
- 1.3 On the PIWIS Tester start screen, call up the ⇒ **'Diagnostics'** menu and select the vehicle type.
