Technical Bulletin

01 12 20 June 29, 2012 **2027458** Supersedes T. B. V011207 dated March 19, 2012 to update warranty claiming service number information.

MIL ON DTCs P310B, P129F, P008B, P129E, P008A, P2540 or P0087 Stored in ECM Fault Memory

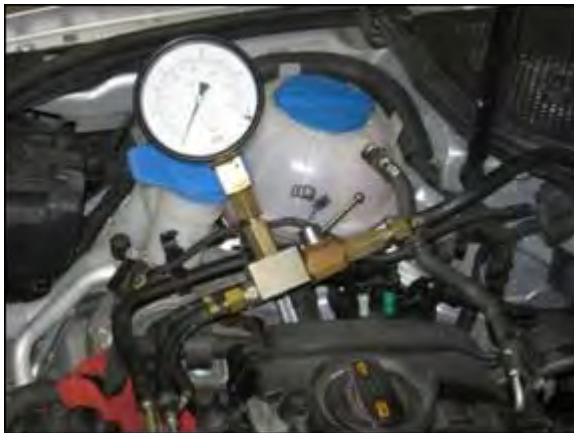
Figure 1. VAG 1318 gauge installed on a 2.0L TFSI.

- 4a. Start engine and allow it to idle for at least one minute.
- 4b. Stop the engine.
- 4c. Keep the ignition switch ON.
- 4d. Measure actual low-side fuel pressure via mechanical gauge (VAG 1318) on the low pressure supply line in the engine compartment (Figure 1).

5. Add 1 bar (14.5 psi.) to the value obtained from the mechanical gauge to calculate the adjusted gauge measurement value.
6. Compare the adjusted gauge measurement value to the Actual Value stored in MVB 103 field 1.

7. If the MVB 103 field 1 value deviates more than ± 1.0 bar (± 14.5 psi.) from the adjusted gauge measurement value, then the DTC was likely triggered by a faulty -G410- low-side fuel pressure sensor. In this case, document the adjusted gauge measurement value and MVB value on the Repair Order and perform the [Sensor replacement procedure below](#).

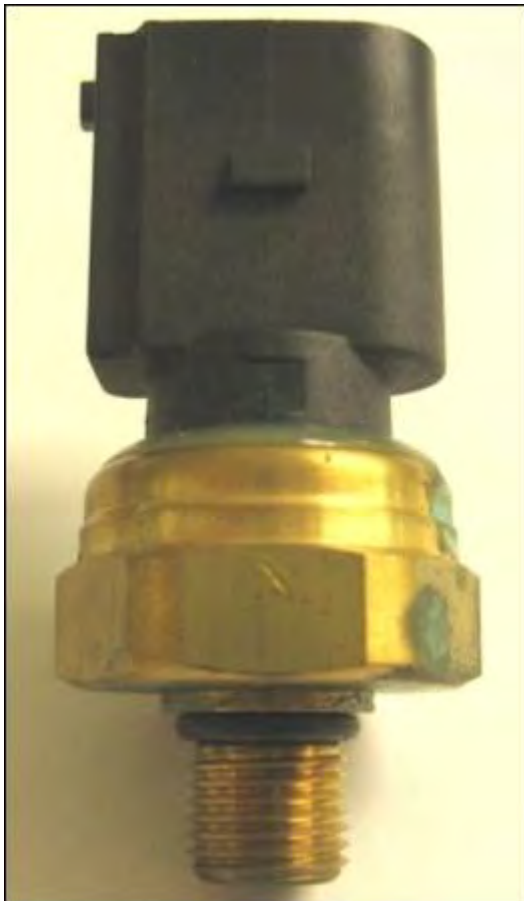
Figure 2. Improved fuel pressure sensor
06E 906 051 K.

1. Verify the customer did not run out of fuel at the time the DTCs were stored.
2. Inspect that latest fuel pressure sender P/N **06E 906 051 K** (Figure 2) is installed, if not replace the old style component with the new style component and run Basic Settings 103 to adapt system.

1. Replace the -G410- low-side fuel pressure sensor with P/N 06E 906 051 K.
2. Clear DTCs and verify that the problem was eliminated.
3. Run Basic Settings 103 to adapt system.
4. **DO NOT** replace the high pressure fuel pump, electrical fuel pump, fuel pump control module or fuel filter unless problem persists and further diagnosis indicates a malfunction of any of these components.
