Technical Service Bulletin

91 Rearview backup camera image quality complaints (distorted image)

91 12 42 2029903/1 June 20, 2012.

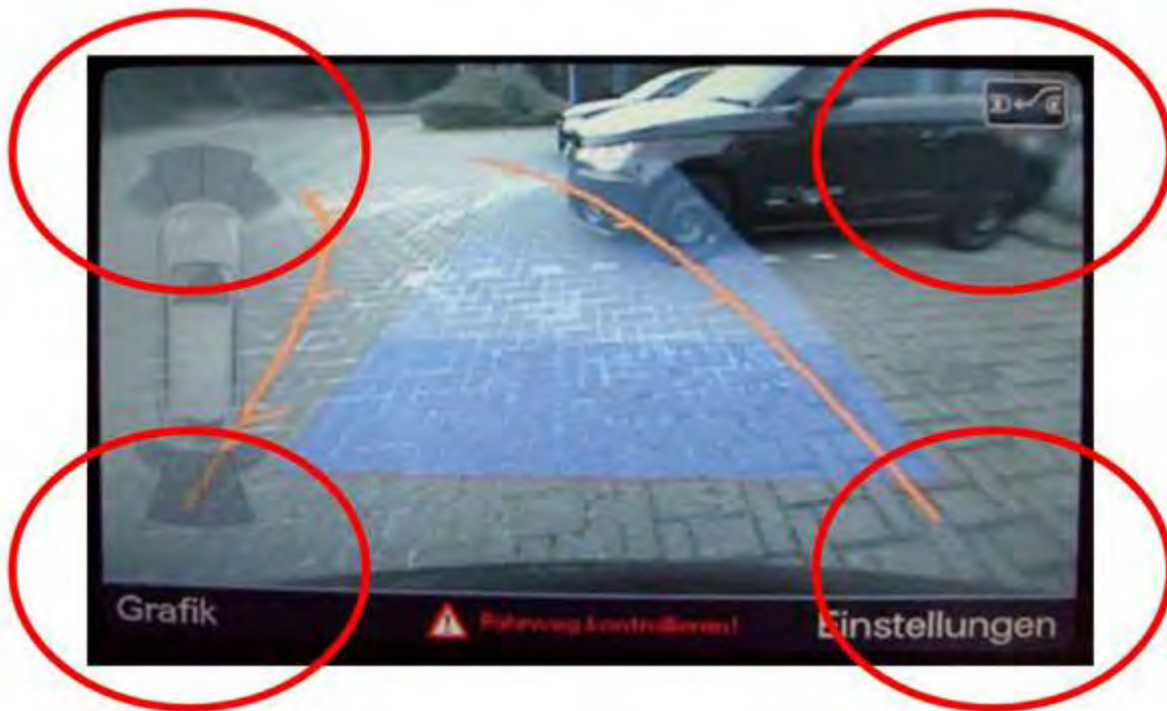
Complaint 1: The picture is fuzzy or distorted.

Explanation: The wide angle backup camera lens (about 140°) provides a round or curved image (fish-eye). The software inside the MMI must straighten out this “curved” image to fit the rectangular area of the MMI screen. As a result, the picture from the camera shown in the MMI screen is less sharp or focused in the corners of the image than compared to the center of the image. This is more noticeable in vehicles with a larger MMI screen because the image is expanded or “blown up”.

Figure 1. Distorted or fuzzy corners of backup camera image in MMI.

These are normal conditions and no replacements of the backup camera, MMI Screen, MMI Main unit, and the Camera Control unit should be performed.

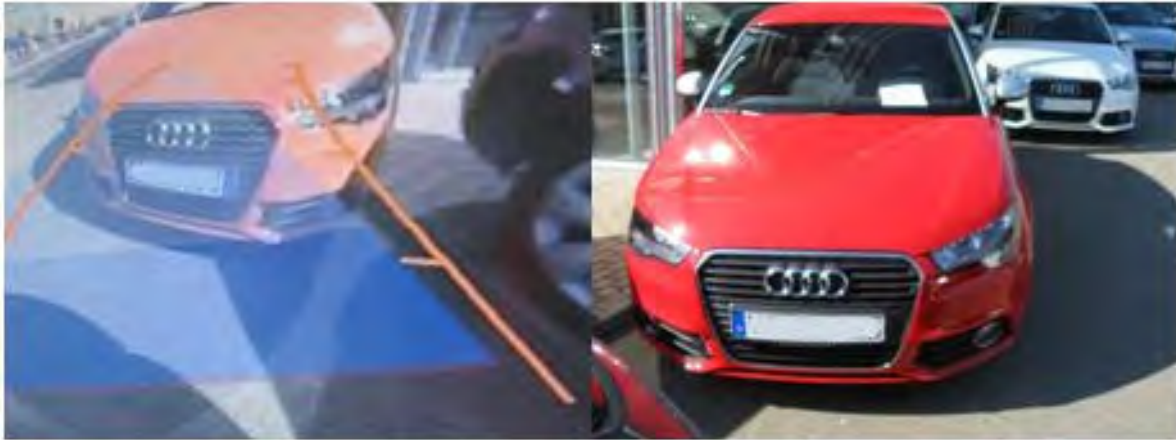
Explanation: The backup camera adjusts the image in the MMI screen dynamically in response to the ambient light and tries to find the optimal representation of brightness, contrast, and color (comparable to the exposure control of a camera). As a result the overall brightness, contrast, and colors of the backup camera image in the MMI may appear to be different than the actual color seen by the human eye.

The camera is not equipped with an infrared filter for night time viewing. This also leads to differences in color. The brightness of the image can be adjusted in the MMI menu for the whole screen for all MMI menus, but color and contrast cannot be changed.

Figure 2: Camera image in MMI screen (left) and actual color of objects as seen by human eye (right).

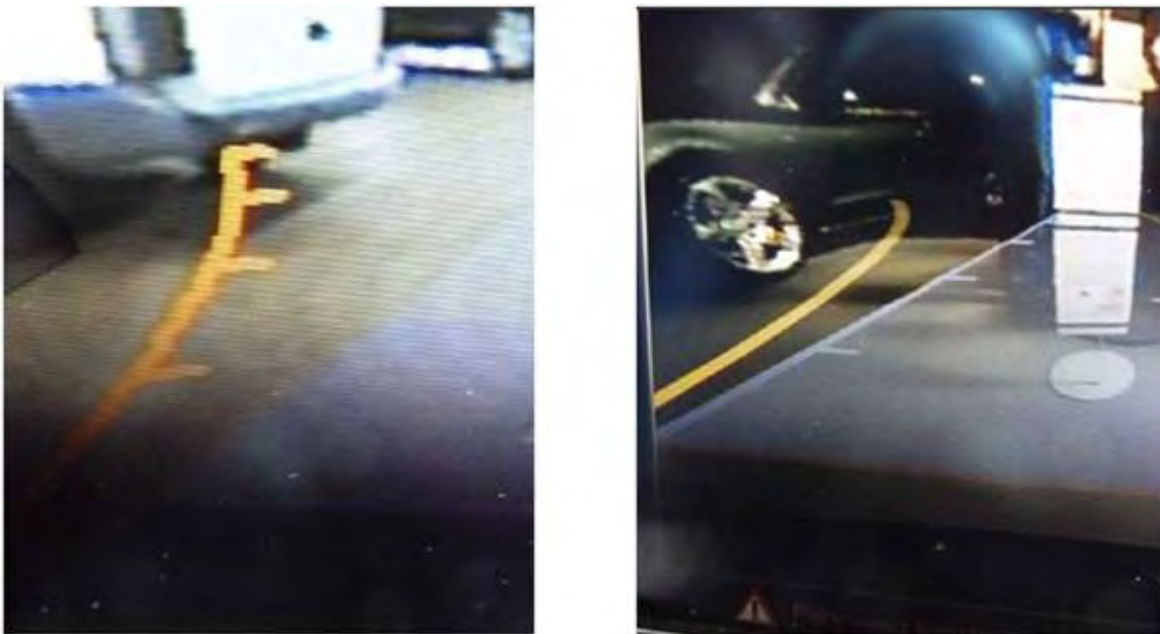
Complaint 4: The guide lines used for parking are fuzzy, distorted, or pixelated when compared with another vehicle.

Explanation: For vehicles *without* the Peripheral View Camera (No Top View and No Corner View), the guide lines are pre-stored images in the MMI memory which are overlaid on top of the rearview camera image at the different steering angles (the guide line images are masked over the camera image). Due to the large size of some of the MMI screens, the lines appear to be pixelated because they are “blown up” (Figure 3). For vehicles with the Peripheral View Camera (with Top View and Corner View), the lines are dynamically generated as vector graphics (scaled) and as a result the lines are sharper or more focused.

Figure 3. Guide lines of a vehicle without Peripheral View Camera (left) and guide lines of a vehicle with Peripheral View Camera (right).
