Service Bulletin

Bulletin No.: PI0464A

Subject: Tire Wear Characteristics of 16" Goodyear® Integrity Low Rolling Resistance Tires

Models: 2009-2013 Chevrolet Impala

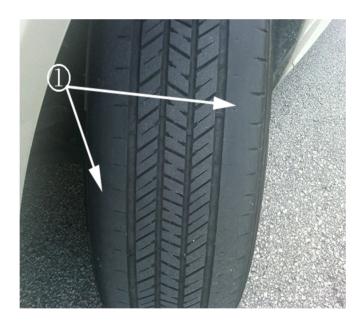
2608997

The 16" Goodyear Integrity tires used on the Chevrolet Impala are of a low rolling resistance design. As part of this design, the shoulder tread bars are shallower than the center three tread bars. This type of construction contributes to maximized fuel economy but limits the life expectancy of the outside tread blocks (1).

Normal Wear Pattern

Tires that exhibit this type of wear are considered normal. There is no need for wheel alignment, nor is this any indication of the tires being run at too low an air pressure.

Follow the tire rotation schedule as explained in the vehicle owners manual and assure that the tires are kept at the recommended pressure as shown on the vehicle tire placard. More frequent tire rotations may be desirable if the vehicle is driven aggressively, or signs of uneven wear occur ahead of the recommended rotation intervals.
