## Service Bulletin

Bulletin No.: PIC5751

Subject: Service Park Brake Message C0558

Models: 2013 Chevrolet Malibu

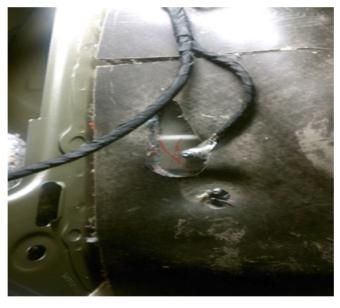
2915786

A customer or technician may indicate there is a Service Park Brake Message displayed. The technician may indicate the following DTC's are set C0558 sym5A and/or C0558 sym55. The park brake may not release or cannot perform park brake calibration in GDS2.

Please check that G401 is secure and there is no paint or tape affecting contact. See picture below left rear wheel house.
