# Service Bulletin

Bulletin No.: PIC5751A

**Subject:** Service Park Brake Message C0558

**Models:** 2013 Chevrolet Malibu

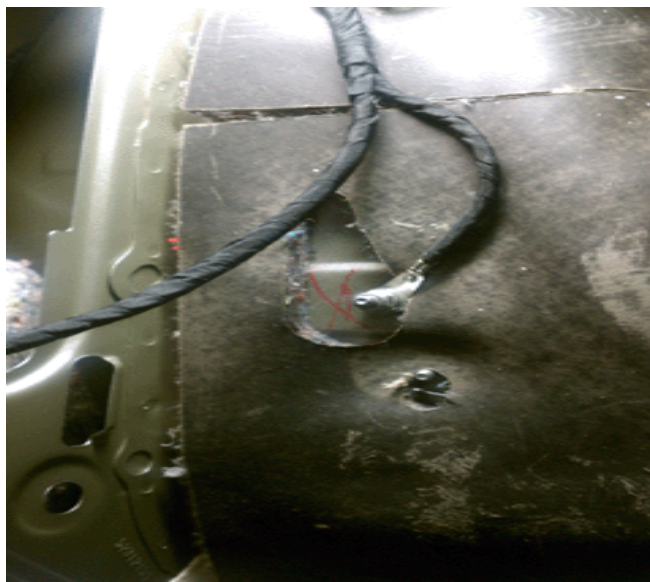
2915786

A customer or technician may indicate there is a Service Park Brake Message displayed. The technician may indicate the following DTC's are set C0558 sym5A and/or C0558 sym55. The park brake may not release or cannot perform park brake calibration in GDS2.

Please check that G401 is secure and there is no paint or tape affecting contact. See picture below left rear wheel house.
