SB-10049639-4540

Title: Sleeper Side Sill/Underbody Cross-Member Weld Check and Repair

Applies To: ProStar Sleepers

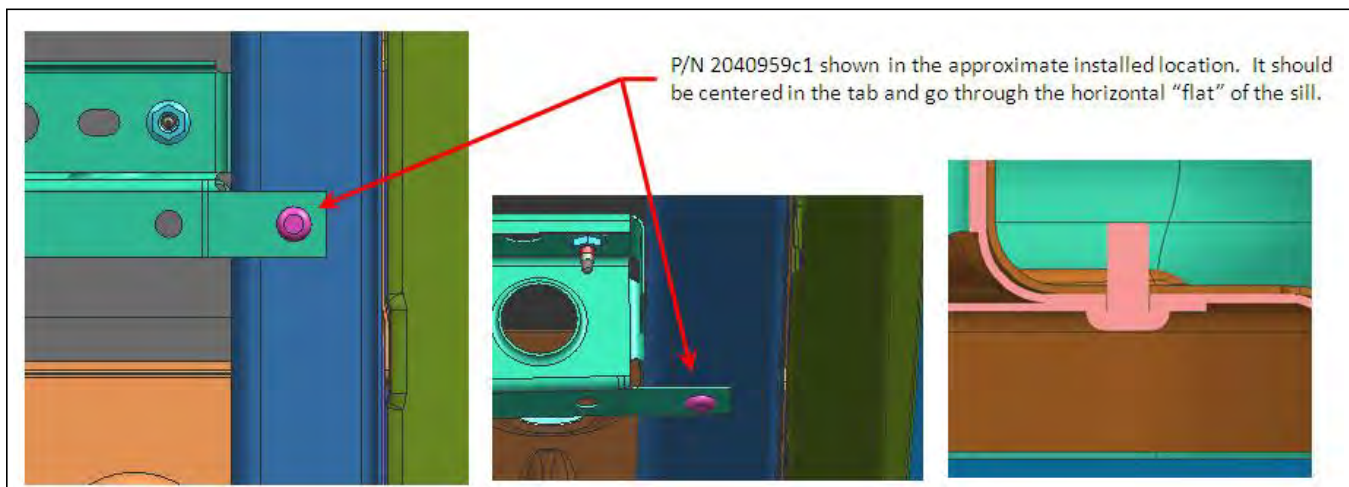
- If the weld is satisfactory, the job is complete.
- If the weld breaks, install a structural rivet.
 - Drill a 17/64" (0.2656") hole directly through the tab, drilling perpendicular to the surface of the tab. The hole should be equidistant from between the 3 edges that make up the tab.

- Install P/N 2040959c1 (or equivalent blind structural rivet: Steel; 1/4" diameter; .08"-.375" grip range; 0.261" to 0.272" hole size; 2400lb shear strength; 1850 lb tensile strength; 300 lb mandrel retention strength.)
