**Number:** FS-2012-05

**Subject:** Exhaust System Flex Pipe Change

## **FIELD SERVICE BULLETIN**

**For replacement of Red Silicone (Linkeo) exhaust bellows with All Metal (Tru-Flex) exhaust bellows on 2010 Emissions year engine equipped buses**

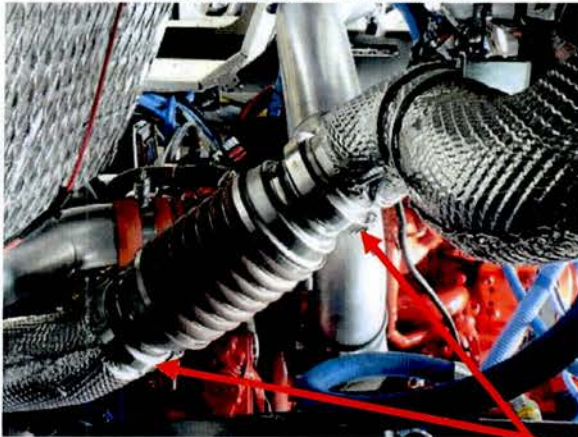
**FIGURE 1. ISB DIESEL HYBRID ENGINE**

LOOSEN V-BAND CLAMPS  
SHOWN TO REMOVE THE  
EXISTING BELLOWS  
(CLAMP LOCATION "C")

1. Remove the existing red silicone exhaust bellows from the bus by loosening the two V-Band clamps.

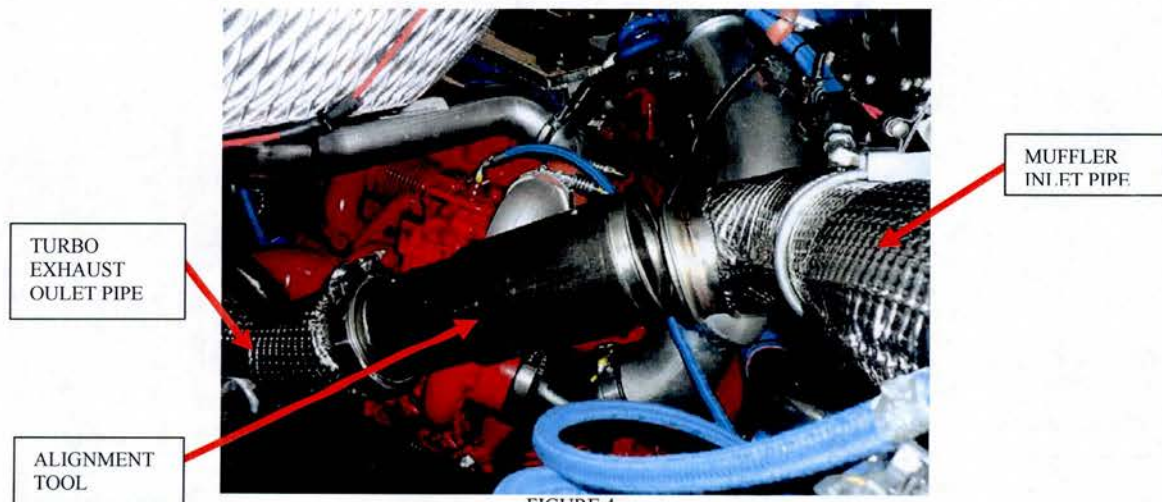
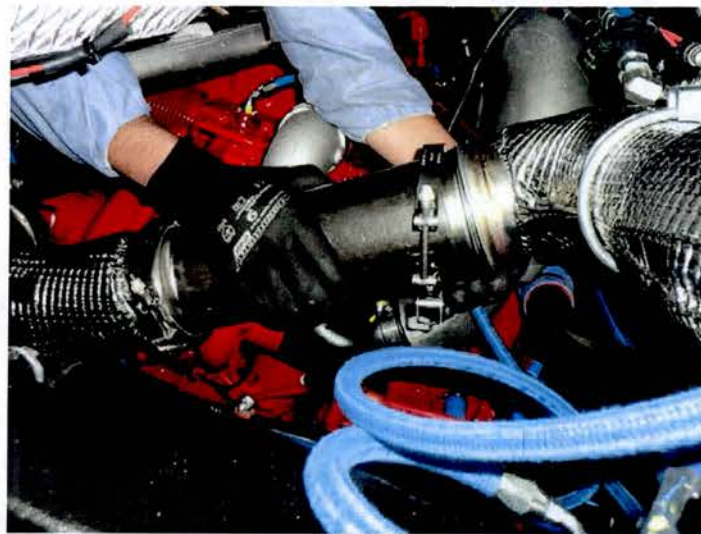
2. Insert the alignment tool between the turbo outlet pipe & muffler inlet pipe (as shown below), tighten the bottom V-Band clamp to approximately 6 ft-lb and align the other end of the tool with muffler inlet pipe.  
*NOTE: DO NOT FORCE THE ALIGNMENT TOOL TO FIT.*

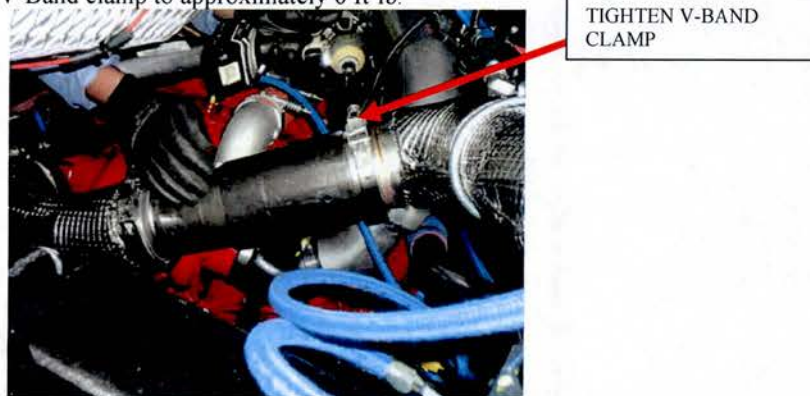
3. Then tighten the upper V-Band clamp to approximately 6 ft-lb.

If alignment tool fits between the pipes with V-Band clamps installed to approximately 6 ft-lb, remove the alignment tool and install new all metal bellows (jump to step 9).

If alignment tool does not fit then continue to step 4.

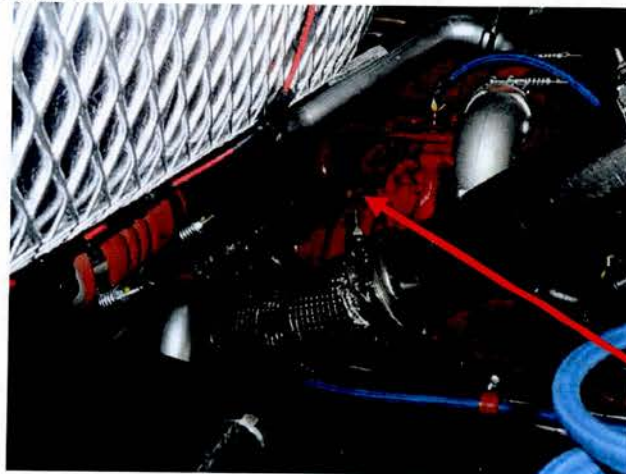
FIGURE 7.

VIEW FROM  
SETTEE HATCH

4. To access the turbo outlet pipe V-Band clamps, remove the settee hatch from inside the bus.
5. Loosen both Cummins cast turbo outlet elbow V-Band clamp and exhaust turbo outlet pipe V-Band clamp through the settee hatch access.

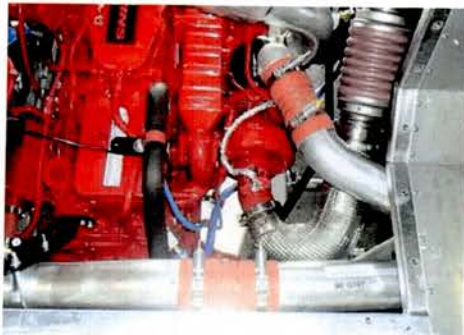
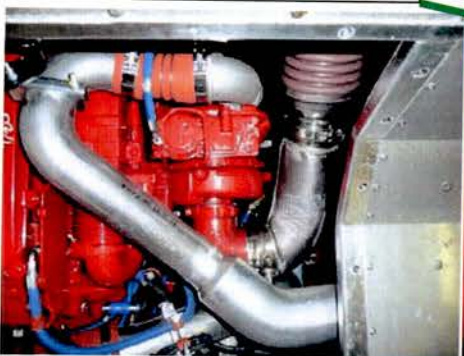
FIGURES 8 & 9. ISB DIESEL HYBRID ENGINE SHOWN

CAST ELBOW AT TURBO  
OUTLET V-BAND CLAMP  
(CLAMP LOCATION "A")

- CAST TURBO OUTLET ELBOW V-BAND CLAMP *LOCATION "A", SEE FIGURES:  
8 & 9 FOR ISB on page 4  
10 & 11 FOR ISL on page 4  
12 & 13 FOR ISL-G on page 5*
- EXHAUST TURBO OUTLET PIPE V-BAND CLAMP *LOCATION "B", SEE FIGURES:  
8 & 9 FOR ISB on page 4  
10 & 11 FOR ISL on page 4  
N/A for ISL-G*
- ALIGNMENT TOOL UPPER & LOWER V-BAND CLAMPS *LOCATION "C", SEE FIGURE 16 BELOW*
- MUFFLER INLET PIPE V-BAND CLAMP *LOCATION "D", SEE FIGURES:  
14 FOR ISB on page 5  
14 FOR ISL on page 5  
15 FOR ISL-G on page 5*
- MUFFLER INLET PIPE U-CLAMP *LOCATION "E", SEE FIGURES:  
14 FOR ISB on page 5  
14 FOR ISL on page 5  
15 FOR ISL-G on page 5*

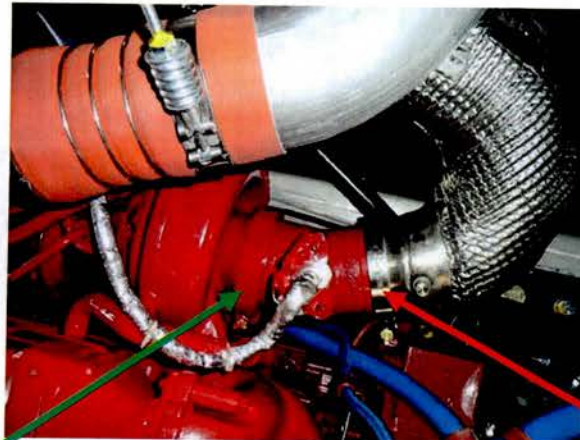
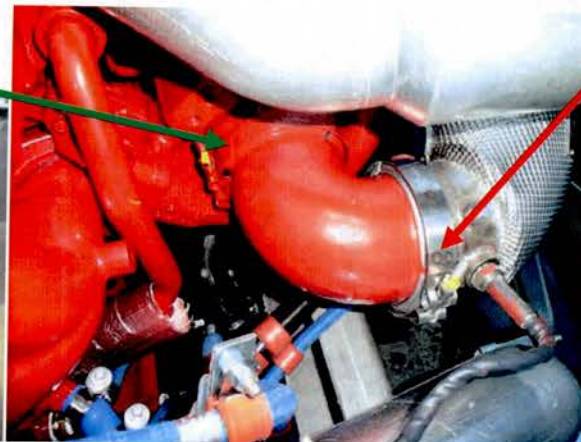
FIGURE 10 & 11. ISL ENGINE SHOWN

TURBO OUTLET  
PIPE INLET  
V-BAND CLAMP  
(CLAMP  
LOCATION "B")

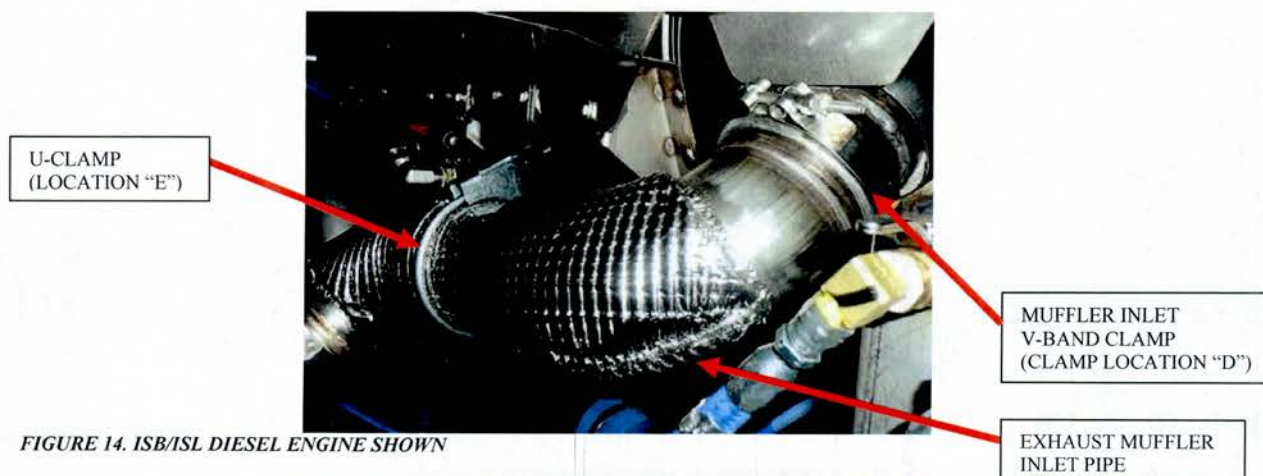
FIGURE 14. ISB/ISL DIESEL ENGINE SHOWN

6. Loosen the V-Band & U clamps on exhaust muffler inlet pipe. Loosening the clamps will allow the pipes to move into alignment.

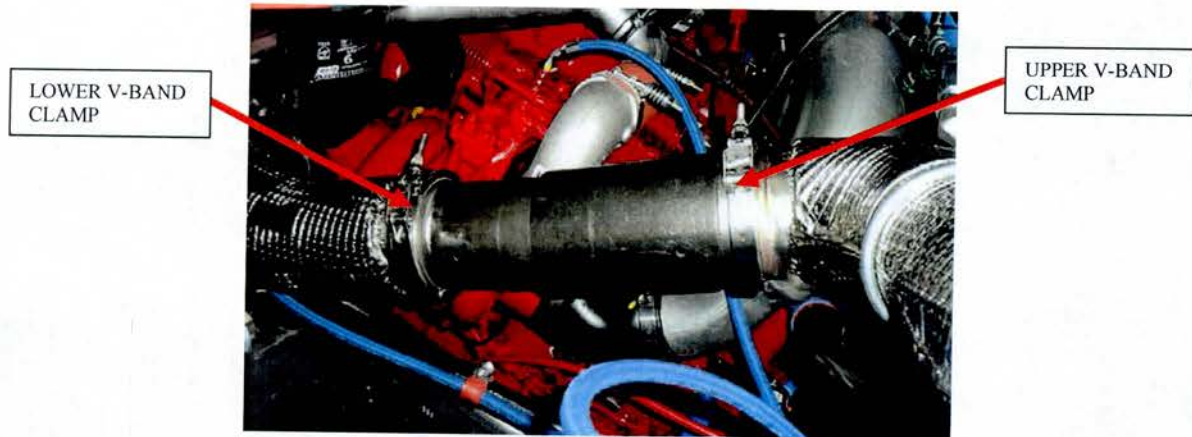
FIGURE 16.

7. Align the pipes with alignment tool & torque all clamps to 13+/- 0.5 ft-lb in the following order:

8. After torquing all the clamps to 13+/- 0.5 ft-lb, remove the alignment tool by loosening upper & lower V-Band clamps.
9. Insert new all metal exhaust bellows between the turbo outlet pipe & muffler inlet pipe noting the flow direction labeled on the bellows, and then torque bellows V-Band clamps to 13+/- 0.5 ft-lb.
10. After completing the installation:
  - Confirm the exhaust bellows is not damaged or interfering with surrounding components.
  - Start the engine and check for exhaust leaks.
  - Reinstall the settee hatch (if removed).
