Clutch Pedal Squeak/Creak Noise

Service Category Drivetrain

Section Clutch

The information contained in this bulletin supersedes SB No. TC004-06.

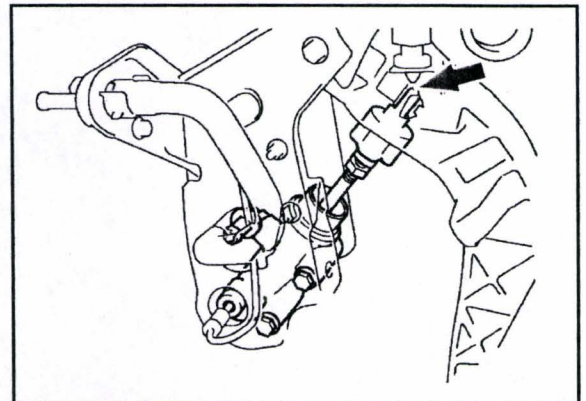
Figure 1.

Be sure to apply MP Grease where the clutch master cylinder clevis and clutch pedal meet in addition to the locations identified in the Repair Manual (See Figure 1.)

2. Replace the clutch pedal and clutch master cylinder assembly.
