Technical Service Bulletin

94 - A6 (C7) Headlight Repair Authorization

94 12 94 2031228/1 October 25, 2012.

Model(s)	Year	VIN Range	Vehicle-Specific Equipment
A6	2012-2013	All	Not Applicable

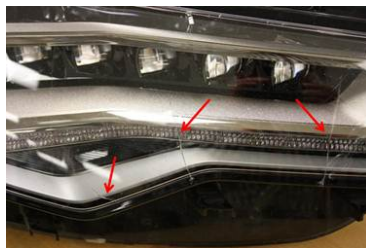
Figure 1. Cracks at bottom of headlight lens.

1. Create a ticket using the Technical Assistance Center (TAC) System in ElsaWeb.
2. Activate the TAC ticket promptly by calling the TAC for further instruction before proceeding with any repairs.

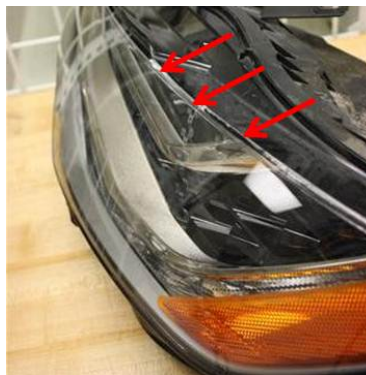
Figure 2. Cracks and separation along top edge of headlight lens.

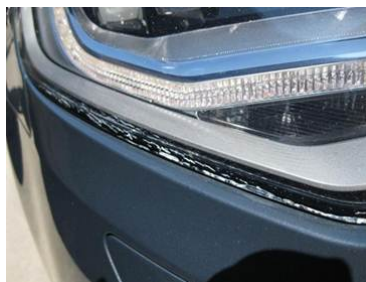
Figure 3. Stress fractures along lower edge of headlight lens.
